Campaign No. 2016090005, March 2016

SUBJECT: **Model 906 (Sprinter), Model Years 2007-2011
Freightliner and Mercedes-Benz
Replace Front Passenger-side Air Bag**

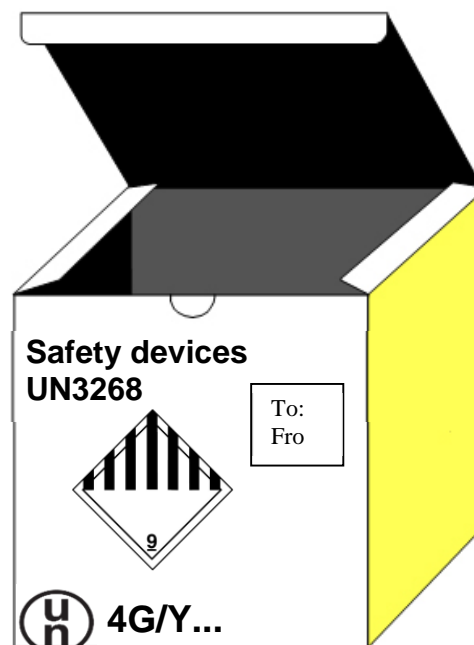
- A Class 9 Miscellaneous label must be clearly visible on one side of the box.

- The following words ("marking") must also be clearly visible on the same side of the box as the Class 9 label:
 - Safety devices**
 - UN3268** (font size must be $\geq \frac{1}{2}$ inch)
- Affix "To/From" address label to same or adjacent packaging face as the hazardous markings/labels.
- The UN 4G code preprinted near the bottom edge of the box must also be clearly visible.

- Note:** The Packing Group and the EX# are no longer required to be printed on the HAZMAT bill of lading.
- Package example:**

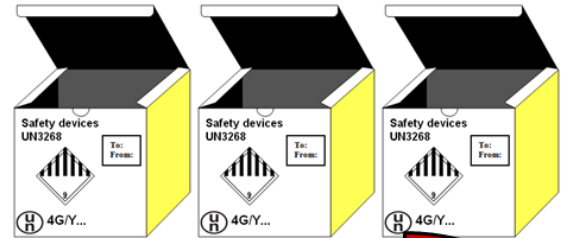
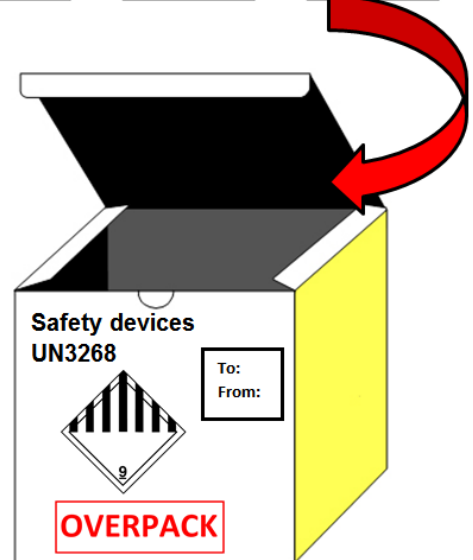
- Package each airbag in a separate UN spec box prepared with the labels/markings described above.
- Place each individual airbag box inside a larger non-UN spec box to keep the shipment together.
- This larger box is called an "OVERPACK."
- The OVERPACK must have the identical markings and label as the boxes contained inside.

- The OVERPACK must have the "OVERPACK" statement on the same face as the hazard markings and labels.

Package example:
