TO: Mercedes-Benz Dealer Principals, General Managers, Sales Managers, Service Managers, Parts Managers	FROM: Gregory Gunther, Department Manager, Vehicle Compliance and Analysis, Engineering Services
RE: Recall Campaign Launch Notification 2017110009 Panoramic Roof Panel Bonding MY17 253 (GLC-Class)	DATE: December 1, 2017

Campaign No. 2017110009, December 2017

SUBJECT: **Model 253 Model Years 2017 and 2018
Panoramic Roof Panel Bonding**

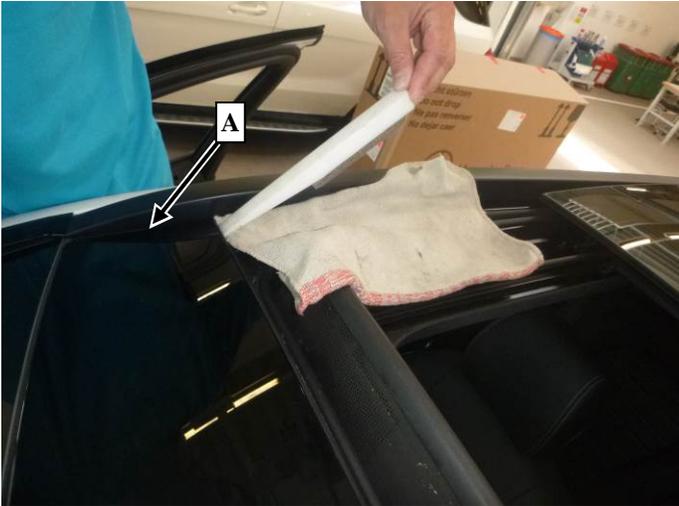
Figure 1

1. Open the panoramic roof and check the bonding of the front glass top sliding roof trim (**A, figure 1**) and side trim strips (**B, figure 2**) on the right- and left-hand sides using an assembly wedge.

i Insert the assembly wedge between the front glass top sliding roof trim and trim strip (right and left sides), press flat onto the trim strip and **lift up carefully**.

If the glass top sliding roof trim/trim strips bend upwards only at the corner, the bonding is OK.

- a. If the glass top sliding roof trim or the right and/or left trim strip separates: Create a **PTSS case**.
- b. If the glass top sliding roof trim and the two trim strips do not separate: End measure.

i If the glass top sliding roof trim or a trim strip separates, obtain a **repair approval via PTSS case** and include conclusive photographs of (bead of residual adhesive).

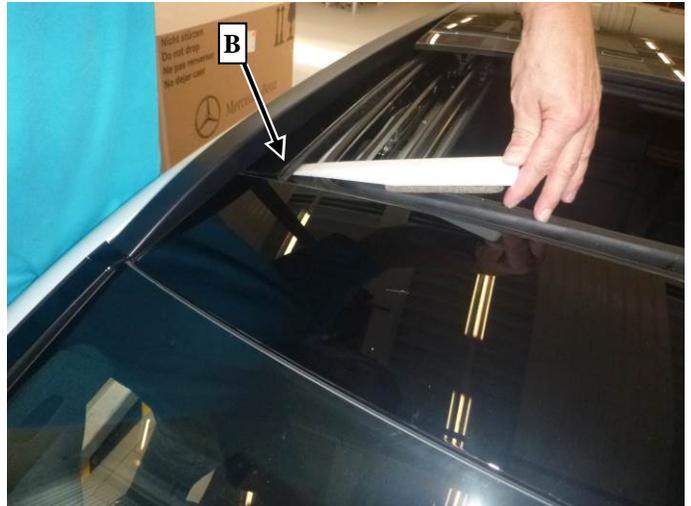
Figure 2

i Use felt or a rag to protect the side trim strips from scratches.
