TO: Mercedes-Benz Dealer Principals, General Managers, Sales Managers, Service Managers, Parts Managers	FROM: Gregory Gunther, Department Manager, Vehicle Compliance and Analysis, Engineering Services
RE: Recall Campaign 2018010009 Launch Notification Left Rear Door Locks MY17-18 166 222 292 (GLE-Class, GLS-Class, S-Class, GLE-Coupe Class)	DATE: March 2, 2018

Campaign No. 2018010009, March 2018

SUBJECT: **Models 222, 166, and 292 Model Years 2017 and 2018**
Check Left Door Locks, Replace if Necessary

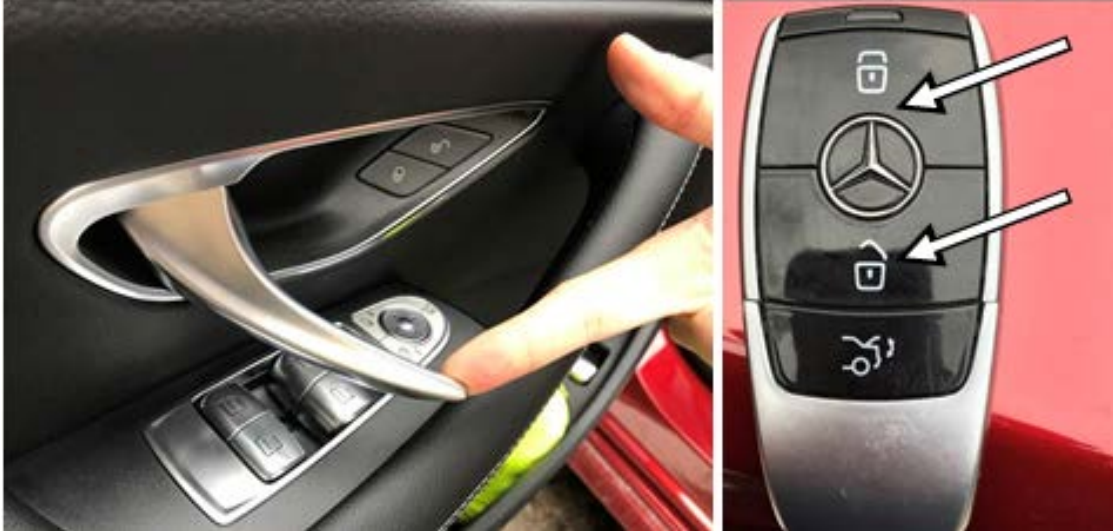
Figure 1

1. Open left rear door, pull on the inside door handle of the rear door. At the same time, lock and unlock the vehicle five times using the remote control.

2. Close the left rear door and lock the vehicle completely using the remote control.
3. On the locked vehicle, pull on the left rear door's outside door handle.
 - a. If the door on a locked vehicle can be opened: Carry out **work procedure**.
 - b. If the door on a locked vehicle **cannot** be opened: **End measure**.
