# Recall 17E - 052

## Checking Turn Indicator

### Service Information No. **SI 77 002 17**

## Recall 17E-052 Checking Turn Indicator

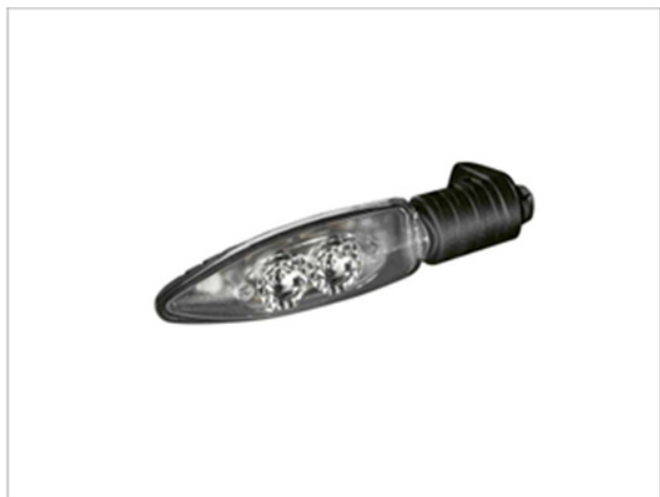
In the course of quality observations, BMW Motorrad has established that for some vehicles, LED flashing turn indicators were offered as an accessory, which do not meet NHTSA and DOT requirements.

Fig. 1: optional accessories, LED flashing turn indicator

In case the original BMW Motorrad accessory turn indicators are installed, they must be replaced with the standard turn indicators. The removed turn indicators must be scrapped. The customer must be reimbursed for the purchasing price. A copy of the invoice must be attached to the warranty claim. A copy of the TREAD ACT that the customer will receive with their recall notice has been included at the end of this bulletin.

In case of a conversion, the required parts specific to the vehicle have to be determined in the EPC and main group 63. The conversion is done in accordance with the repair positions for turn indicators according to the Repair and Service Data BMW Motorrad (AIR).
