# IMPORTANT UPDATE

## TECHNICAL INSTRUCTIONS FOR SAFETY RECALL G0R FRONT PASSENGER AIRBAG INFLATOR MODULE CERTAIN 2009-2010 MODEL YEAR MATRIX

**Updated 7-17-18**

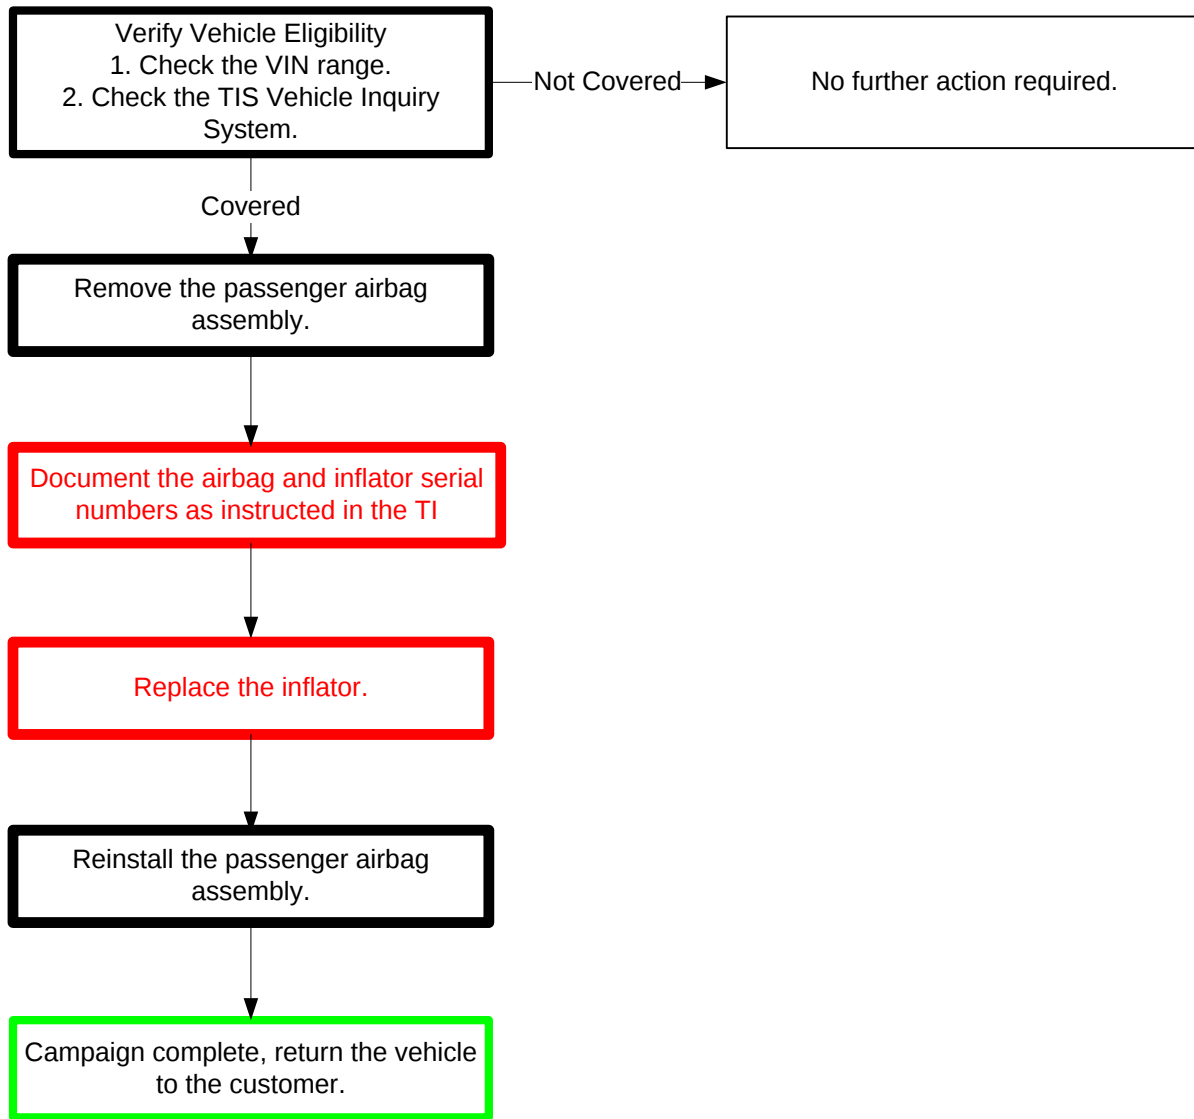
## I. OPERATION FLOW CHART

The flow chart is for reference only. **DO NOT** use it in place of the full technical instructions. Follow **ALL** steps as outlined in the full technical instructions to confirm the campaign is completed correctly.

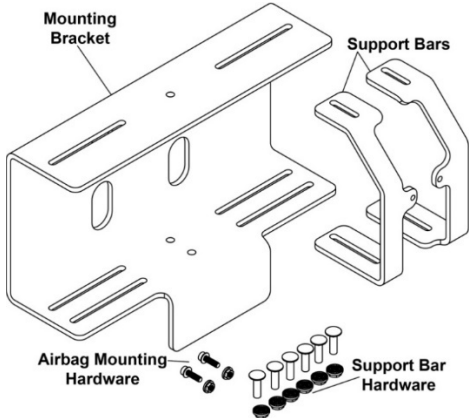
| Image | Name | Quantity |
|---|---|---|
| | Airbag Mounting Bracket & hardware | 1 |

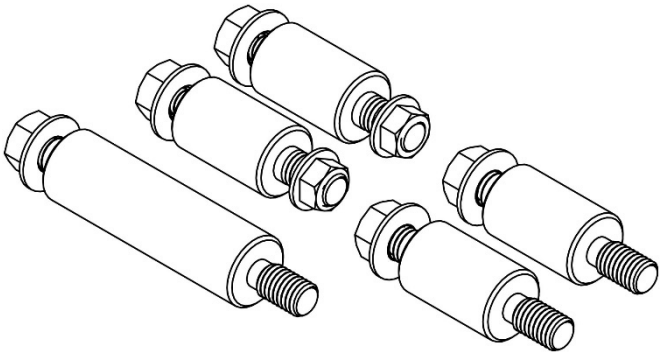
| Image | Name | Quantity |
|---|---|---|
| | Adaptor set* | 1 |

\*The adaptor set was sent to dealers at the start of this campaign.

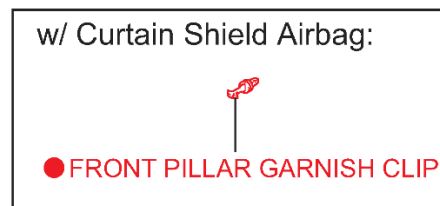
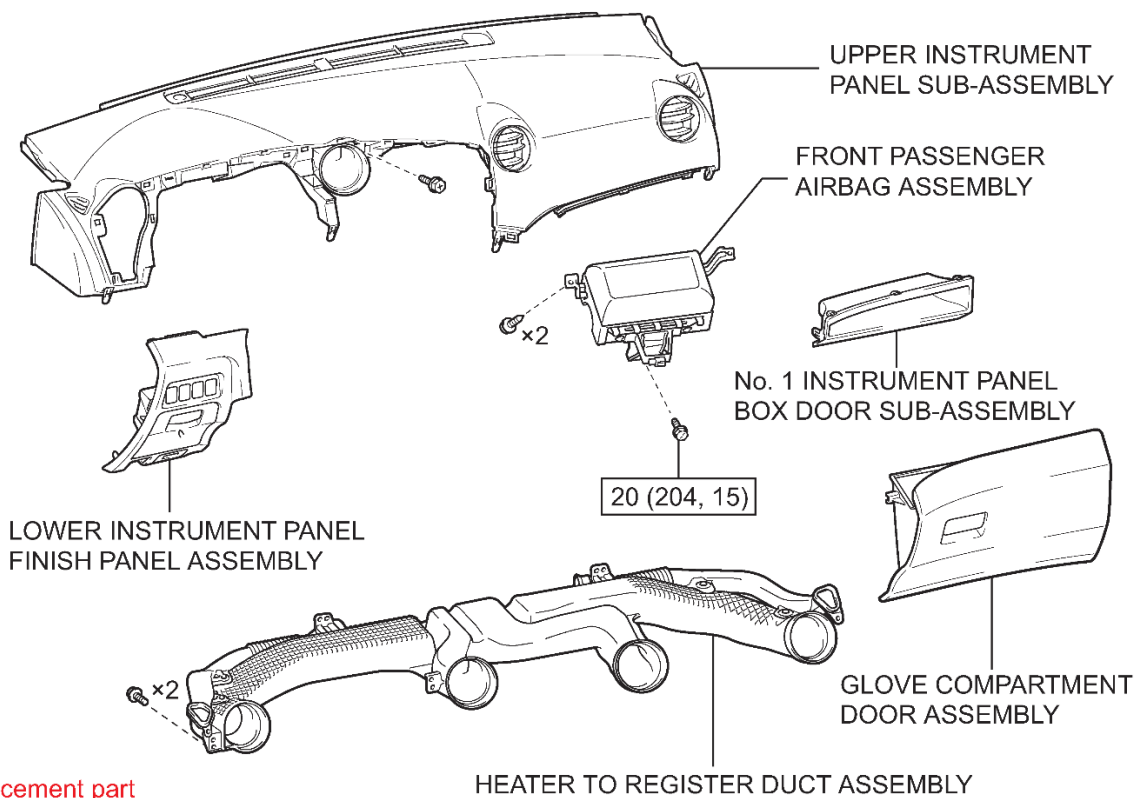
R1703010003

● : Replacement part

N\*m (kgf\*cm, ft.\*lbf) : Specified torque

**3.9 N·m (40, 35 in.\*lbf)**  
**Be careful not to**  
**overtighten.**

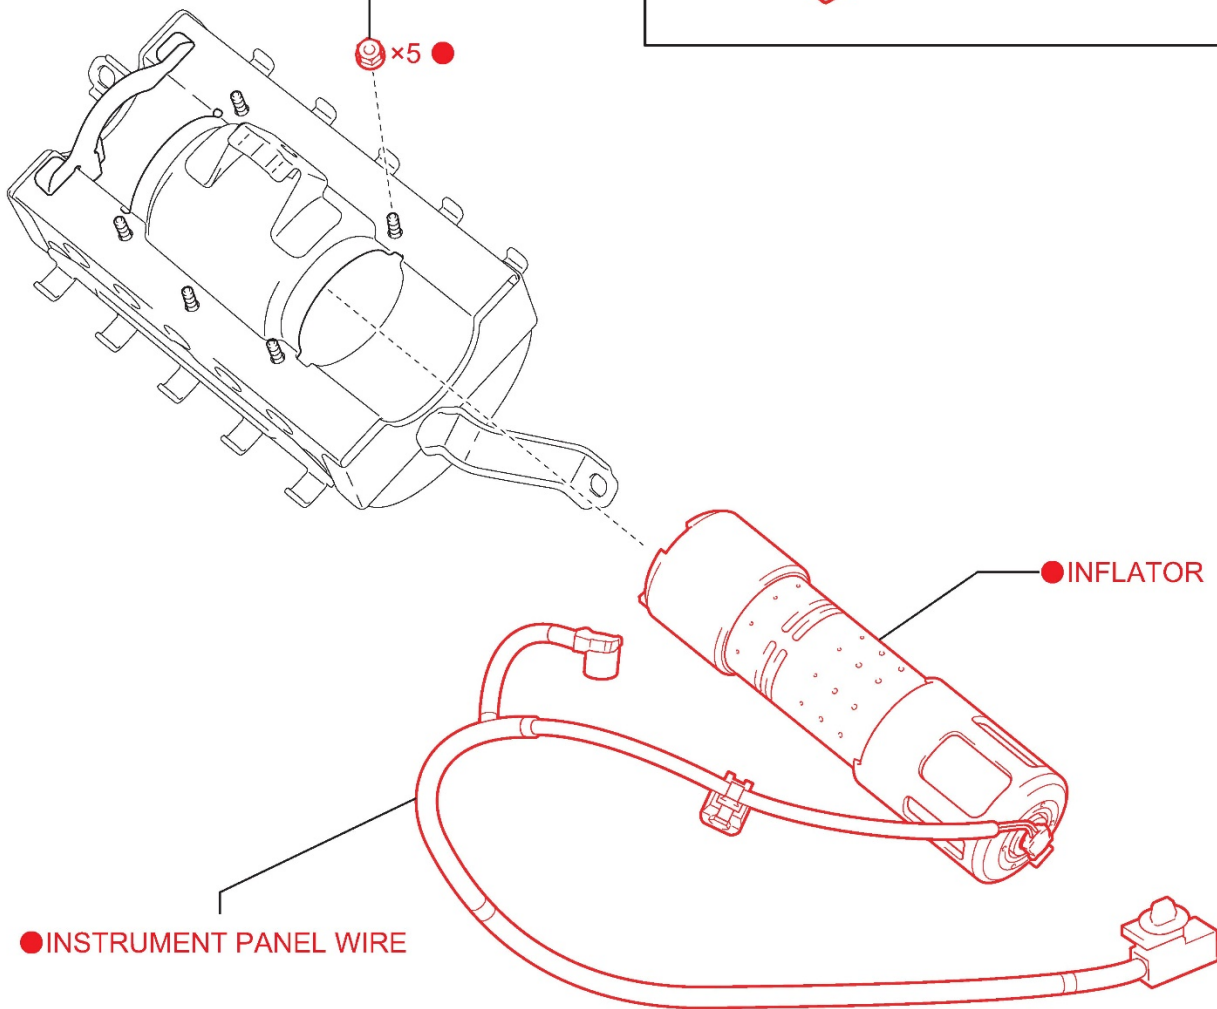
R1702270035

for MATRIX:

● : Replacement part

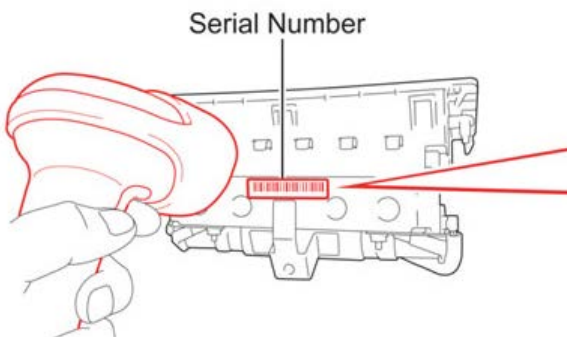
**Airbag Serial Number Label Example**

- The airbag serial number is **ALWAYS** the **12 DIGITS** located between the asterisks.
- The 3 digits before the asterisk **ARE NOT** part of the serial number, and **SHOULD NOT** be entered or an inaccurate response may be returned.

The **AIRBAG ASSEMBLY** serial number and the **INFLATOR** serial number are **DIFFERENT**. The **AIRBAG ASSEMBLY** serial number **MUST** be recorded prior to replacement.

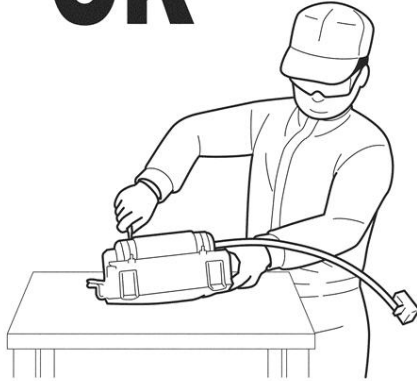
# OK

- Carefully place the airbag on the bench inflator side up.

**NOTE: Place clean sheet(s) of paper on the bench to protect the airbag.**

- Avoid standing directly over the inflator.

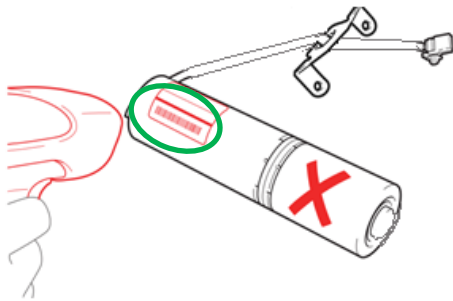
### Step a) Old Inflator (bar code)

- Scan the **OLD** inflator bar code.
- Scan the **NEW** inflator QR code.

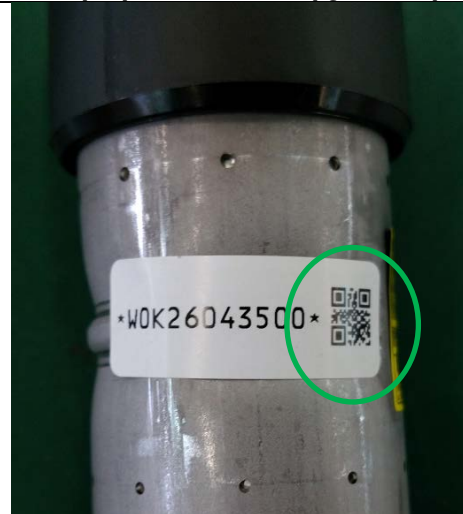
### Step b) New Inflator (QR code)

- Discard the positioning determination plate included with the new inflator. It is for Corolla only. The Matrix requires an additional bracket kit see the parts section for details

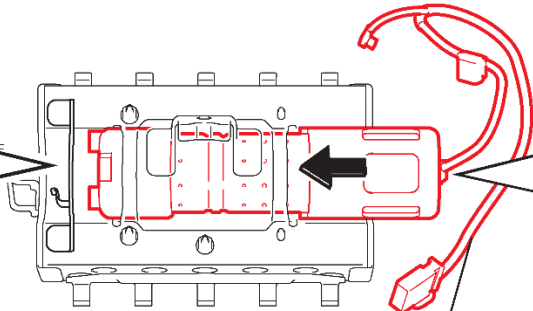
R1702270040

- a) Carefully slide the new inflator into the airbag assembly and align as shown.

- DO NOT** connect the inflator harness at this time. It is **CRITICAL** to first confirm that the inflator is installed in the correct position before connecting the harness.

**DO NOT** insert fully.

Check orientation

Upper side

Bottom

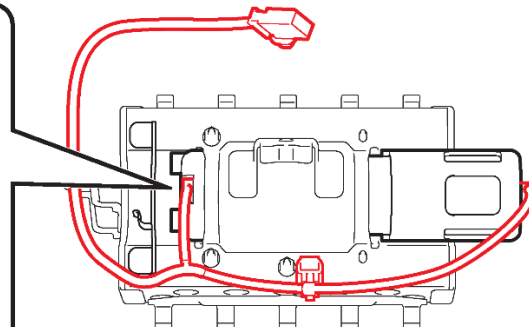
R1702270041

- b) Connect the connector to the inflator and ensure that the connector lock is fully engaged as shown.  
c) Route and secure the wire harness as shown.

**ALIGN CONNECTORS**

Wire Harness Side:

Inflator Side:

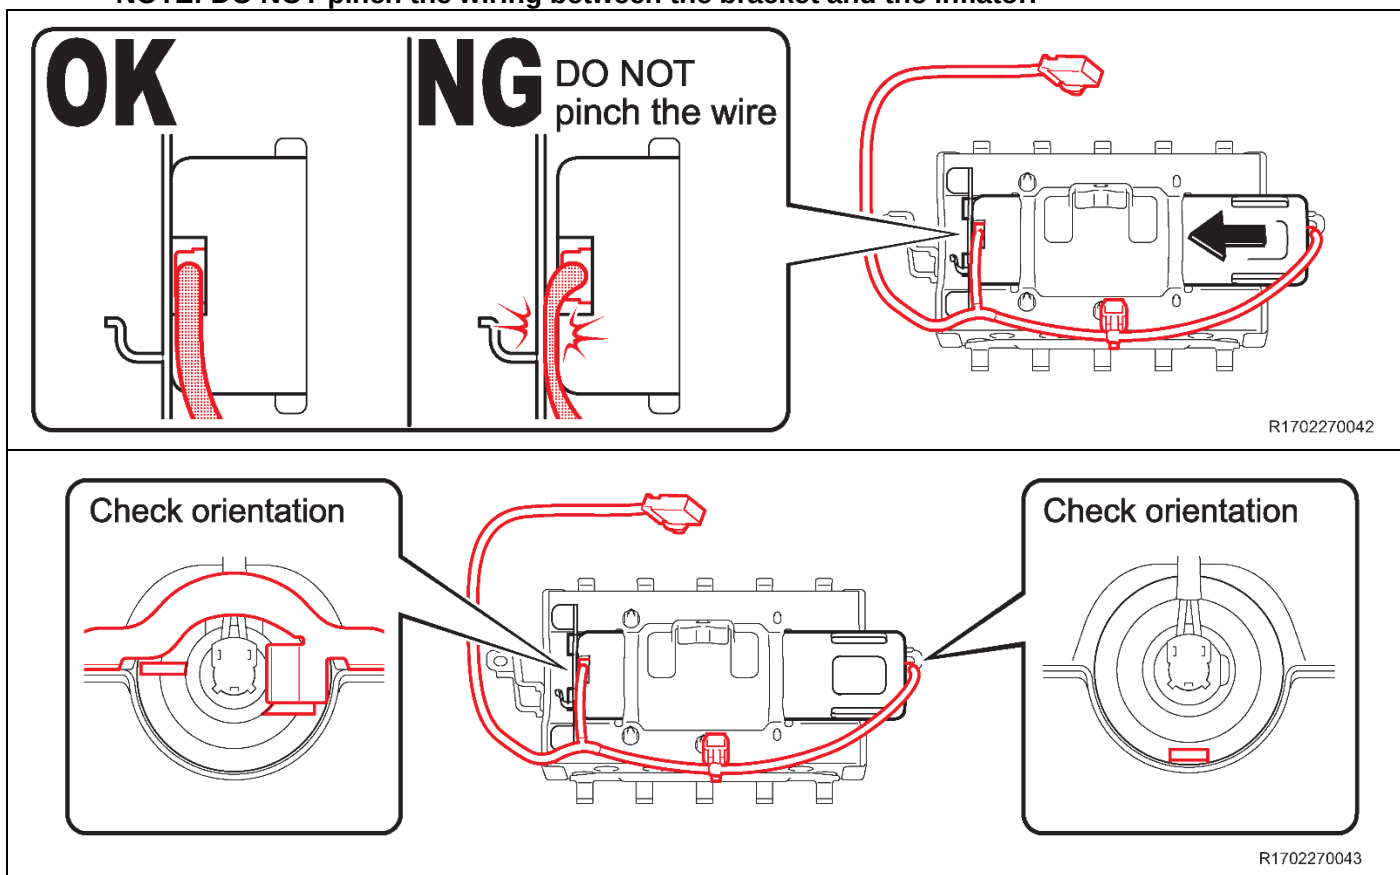
d) Fully insert the inflator and ensure that the inflator is correctly oriented as shown.

**NOTE: DO NOT pinch the wiring between the bracket and the inflator.**

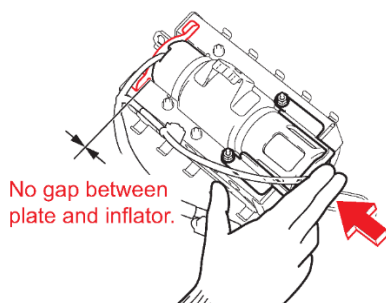
**OK**

- a) Tighten the 5 nuts evenly in several increments in the sequence shown. Use a socket driver or torque wrench to tighten the nuts.

Torque: 35in. lbf (3.9N·m)

- There will be some resistance when tightening the nuts because they are self-locking, confirm the nuts are tightened correctly.
- **DO NOT** use a power tool, T-handle, or ratchet when tightening the nuts to avoid overtorquing and deforming the studs.
- You may need to turn the airbag to the left or right with in the mounting bracket to access the center nut.

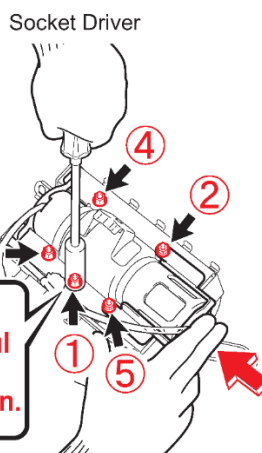
3.9 N·m  
Be careful  
not to  
overtighten.
