## TECHNICAL INSTRUCTIONS FOR SAFETY RECALL GLG FRONT PASSENGER AIRBAG INFLATOR REPLACEMENT CERTAIN 2007 – 2012 MY ES 350

### UPDATE 4-18-18

## I. OPERATION FLOW CHART

## II. BACKGROUND

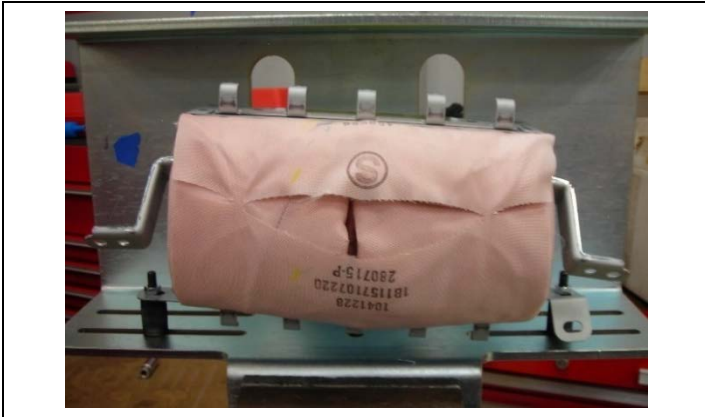
- c) Mount the airbag to the mounting bracket as shown.

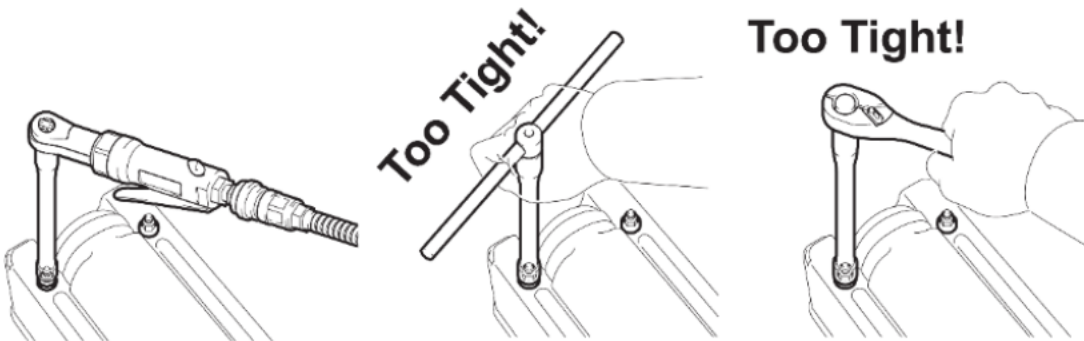
R1701260011Z01

- There will be some resistance when tightening the nuts because they are self-locking, confirm the nuts are tightened correctly.
- **DO NOT** use a power tool, T-handle, or ratchet when tightening the nuts to avoid over torqueing and deforming the studs.
- You may need to slide the airbag to the left or right with in the mounting bracket to access the center nut.

**OK**

**These tools cause overtightening !**
