# IMPORTANT UPDATE

## TECHNICAL INSTRUCTIONS FOR SAFETY RECALL G0R FRONT PASSENGER AIRBAG INFLATOR MODULE CERTAIN 2008 - 2010 MY SCION xB

**UPDATED 7-17-2018**

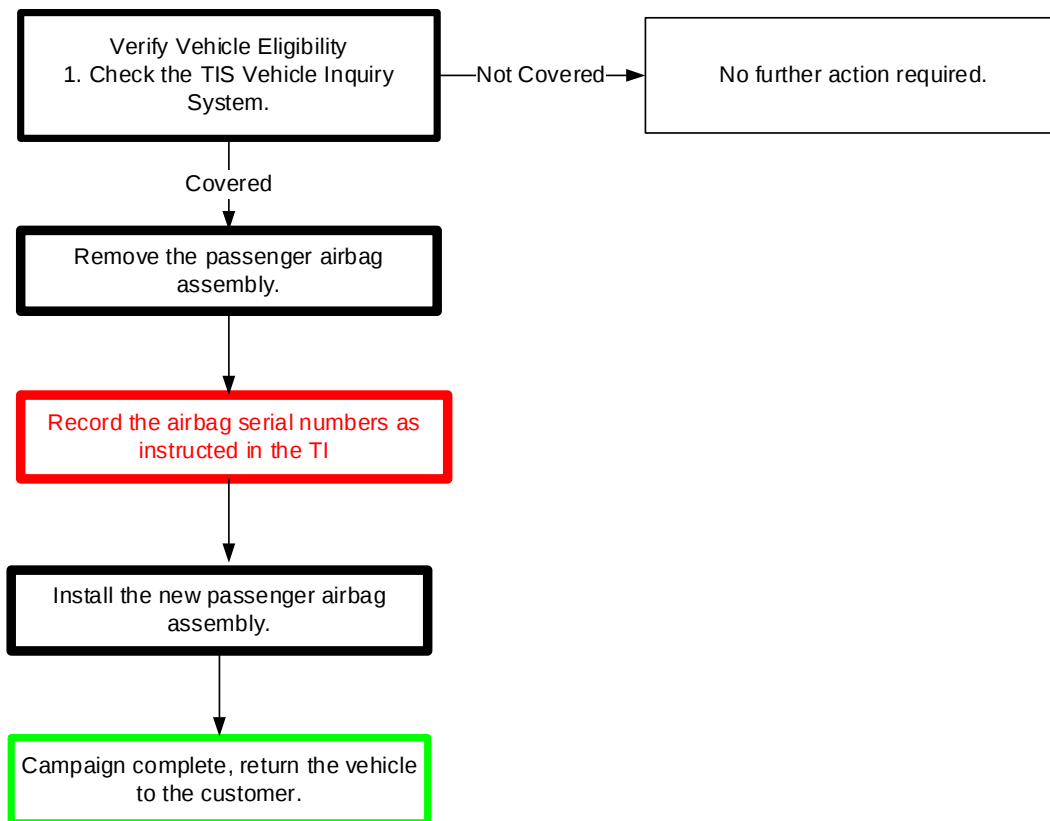
## I. OPERATION FLOW CHART

The flow chart is for reference only. **DO NOT** use it in place of the full technical instructions. Follow **ALL** steps as outlined in the full technical instructions to confirm the campaign is completed correctly.

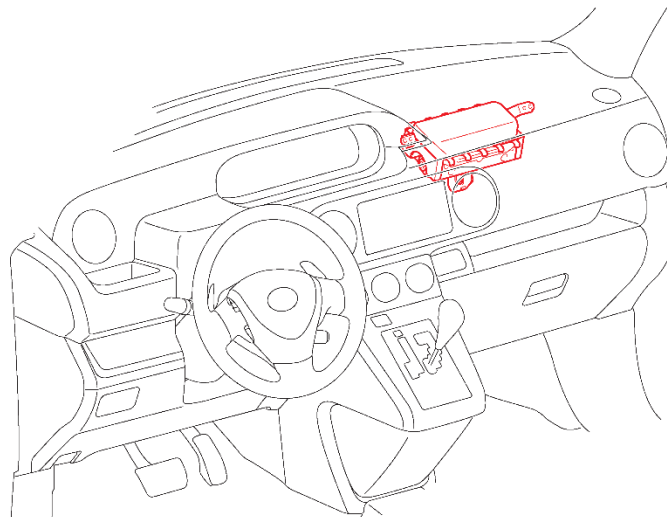
C162294

The subject vehicles are equipped with front passenger airbag inflators produced by Takata. According to Takata, the propellant in these inflators may degrade after prolonged exposure to high absolute humidity and fluctuating high temperatures. Degraded propellant can cause inflator rupture during airbag deployment. In the event of an inflator rupture, metal fragments could pass through the airbag cushion material, striking the vehicle occupants, and result in serious injury or death.

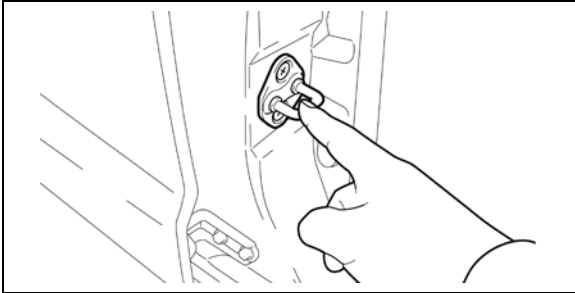
#### 1. ELIMINATE STATIC ELECTRICITY

- Before starting work and periodically while working on the vehicle, touch a metallic part of the vehicle to discharge static electricity in the body.

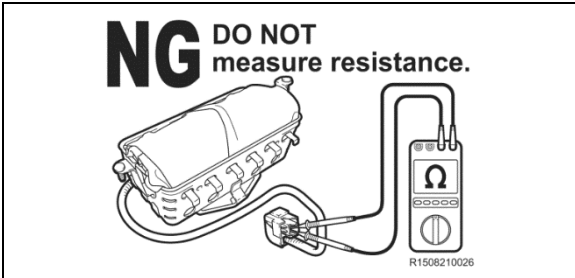
#### 2. DO NOT MEASURE RESISTANCE

- DO NOT** measure resistance of airbag components, this may cause accidental activation.

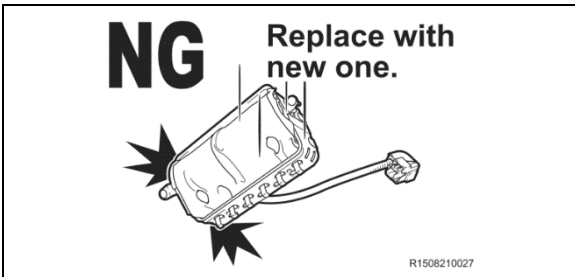
#### 3. HANDLE THE AIRBAG CAREFULLY

- If an airbag is dropped, replace it with a **NEW** one.

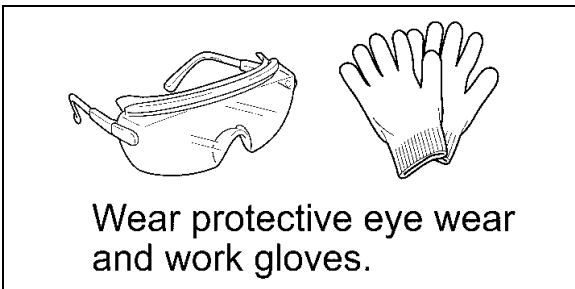
#### 4. WEAR PROTECTIVE EQUIPMENT

- Always wear appropriate protective equipment when working on the SRS.

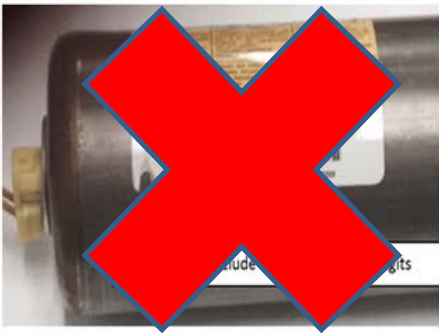
**Original Inflator**

How to Identify the Inflator serial code on the Original and Replacement Inflator can?

The Inflator serial code is an 11 digit code on the Inflator can. It can be found with a bar code on removing the Inflator can from the Airbag Assembly unit.

The first two characters of the Original Inflator Serial code will be from [AA, AB, AJ, FD or JD].

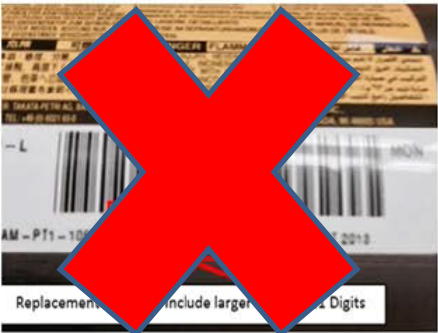
**Replacement Inflator**

The first two characters of the Replacement Inflator Serial code will be either 'LT' or 'LR'.

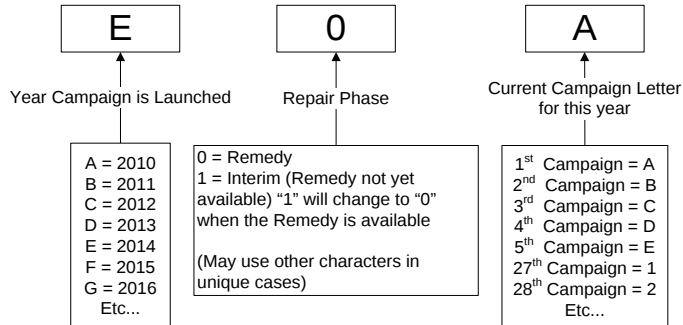
### A. CAMPAIGN DESIGNATION DECODER

Examples:

A0D = Launched in 2010, Remedy Phase, 4<sup>th</sup> Campaign Launched in 2010

B1E = Launched in 2011, Interim Phase, 5<sup>th</sup> Campaign Launched in 2011

C1C = Launched in 2012, Interim Phase, 3<sup>rd</sup> Campaign Launched in 2012
