# TECHNICAL INSTRUCTIONS FOR SAFETY RECALL G0P/G0R/H0A FRONT PASSENGER AIRBAG INFLATOR CERTAIN 2008 – 2015 MY SCION xB

**Updated 1-9-2019**

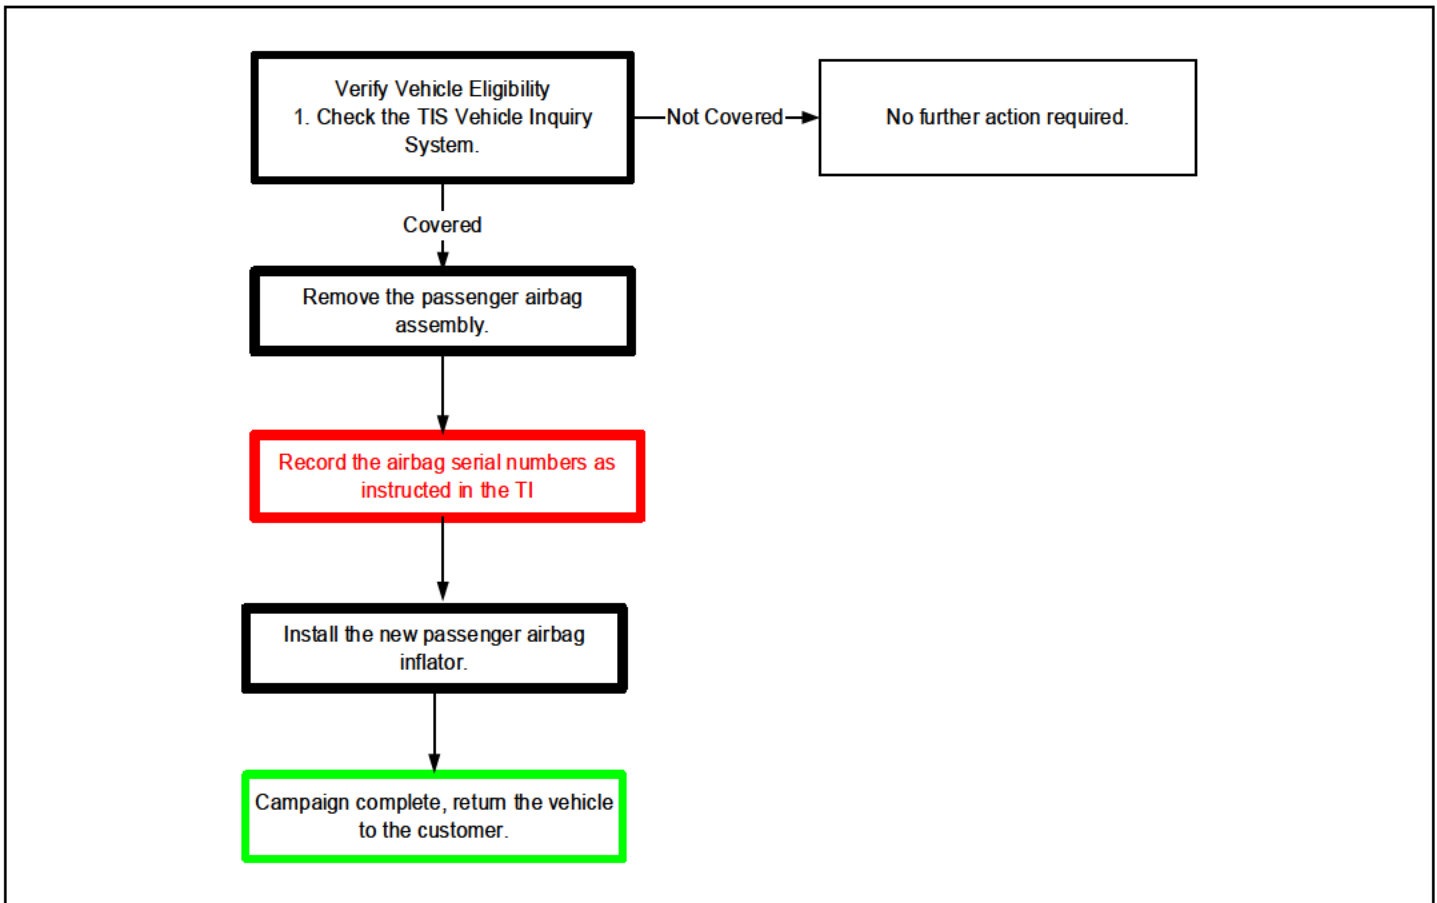
## I. OPERATION FLOW CHART

The flow chart is for reference only. **DO NOT** use it in place of the full technical instructions. Follow **ALL** steps as outlined in the full technical instructions to confirm the campaign is completed correctly.

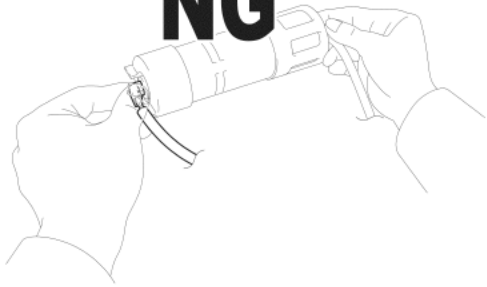
R170128000

DO NOT CONNECT PREMATURELY  
CANNOT DISCONNECTED

**NG**

1. **IMPORTANT NOTICE WHEN CONNECTING INSTRUMENT PANEL WIRE CONNECTOR TO AIRBAG INFLATOR**
  - a) Once connected, the instrument panel wire connector cannot be disconnected from the airbag inflator. If the instrument panel wire connector is incorrectly connected to the inflator, replace the instrument panel wire and inflator with new ones.

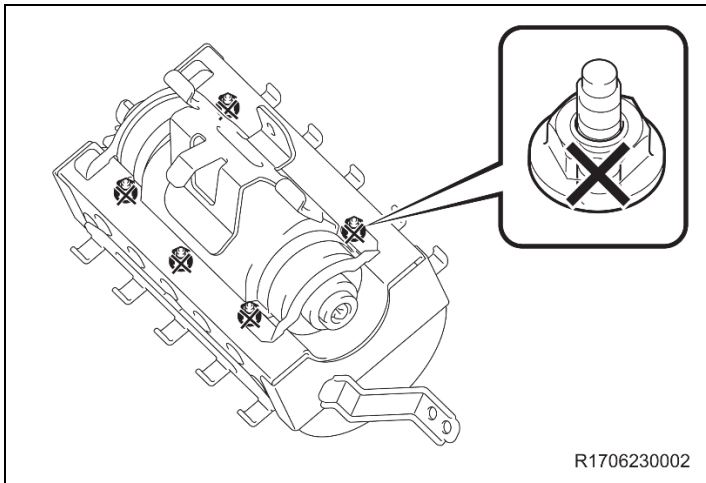
### 1. REMOVE THE INFLATOR

- a) Mark the 5 self locking nuts to prevent reuse.

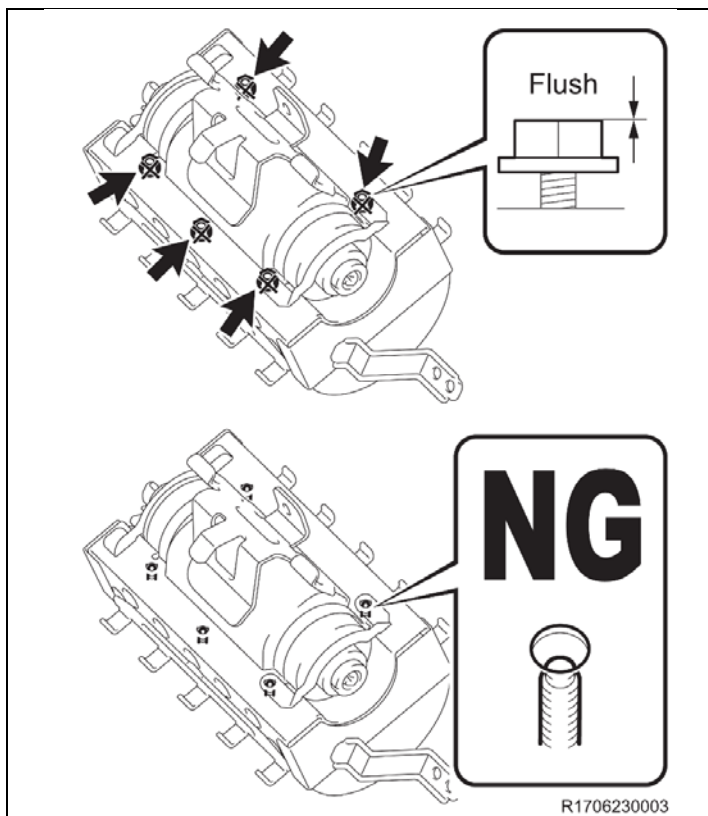
- c) Loosen the 5 nuts until each nut is flush with the top of the stud as shown.

**NOTE:** You may need to slide the airbag to the left or right to access the middle nut. **DO NOT** use power tools to remove the nuts.

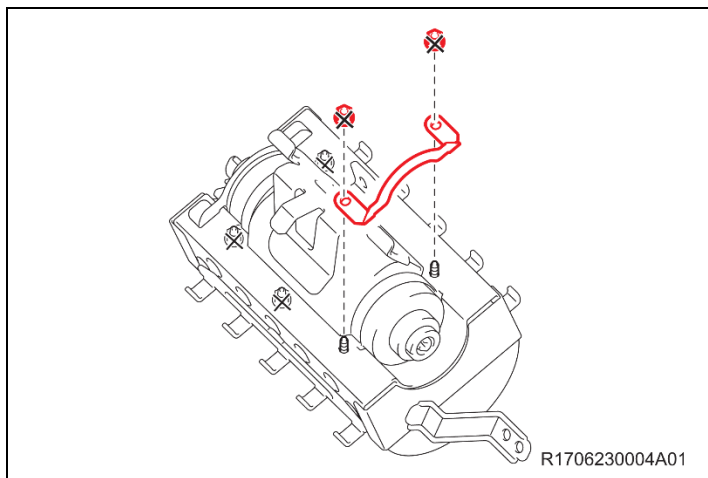
- d) Loosen and discard the 2 nuts on the end where the positioning plate is removeable.

- e) Remove and discard the plate.

**DO NOT** use power tools.

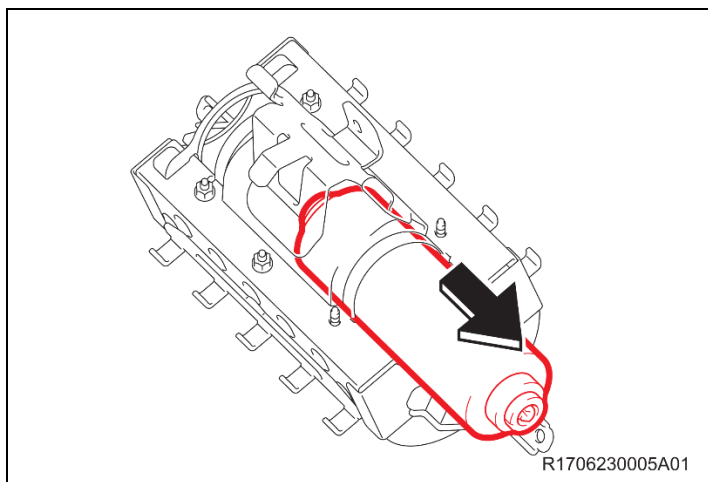
- f) Remove the inflator.

- g) Mark the old inflator so it is not reused.  
**NOTE: Return the old inflator to the parts department for recovery.**

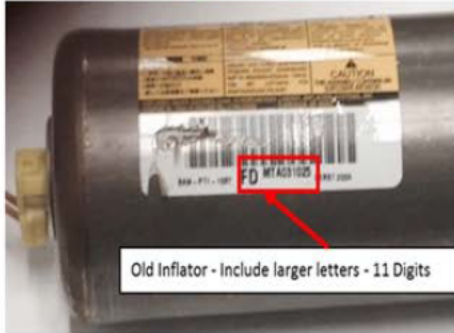
### Original Inflator

How to Identify the Inflator serial code on the Original and Replacement Inflator can?

The Inflator serial code is an **11 digit code** on the Inflator can. It can be found with a bar code on removing the Inflator can from the Airbag Assembly unit.

The first two characters of the **Original Inflator Serial code** will be from [AA, AB, AJ, FD or JD].

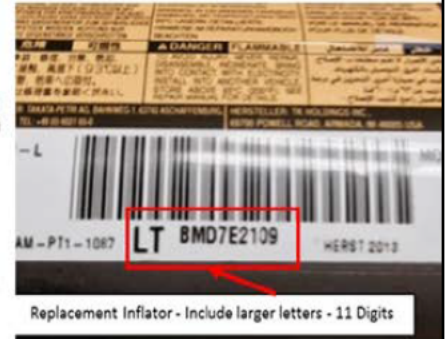
### Replacement Inflator

The first two characters of the **Replacement Inflator Serial code** will be either 'LT' or 'LR'.

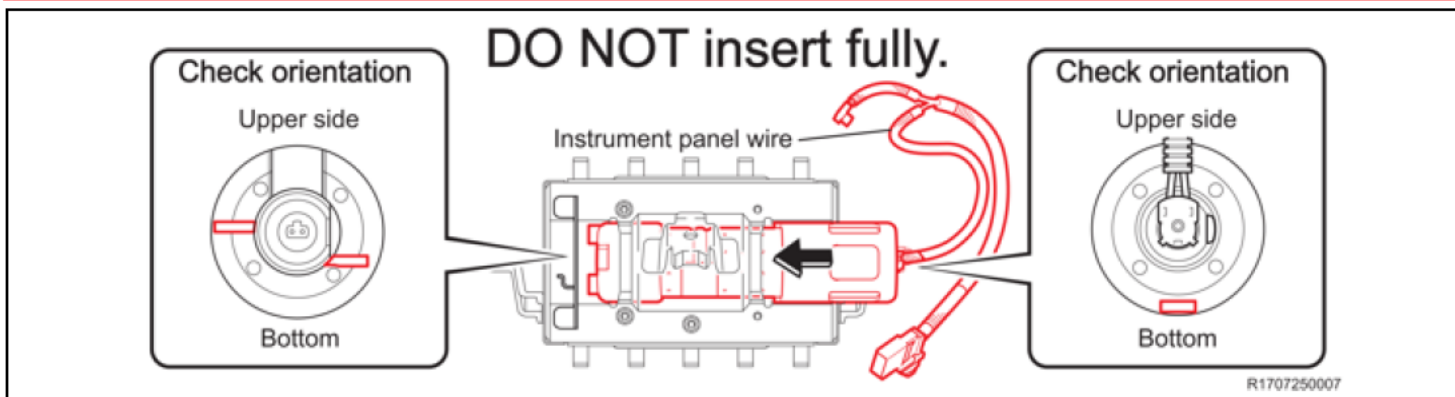
- Make sure that the passenger airbag inflator is oriented correctly as shown in the illustration, not upside down.
- If the passenger airbag inflator is upside down, it will not be able to be fully inserted.

- b) Connect the airbag connector to the instrument panel passenger airbag assembly and then push in the airbag connector lock as shown in the illustration.
