# TECHNICAL INSTRUCTIONS FOR SAFETY RECALL GLG/GLH/HLA FRONT PASSENGER AIRBAG INFLATOR REPLACEMENT CERTAIN 2010-2015 MY IS 250/350 CONVERTIBLE

**UPDATED 1-9-2019**

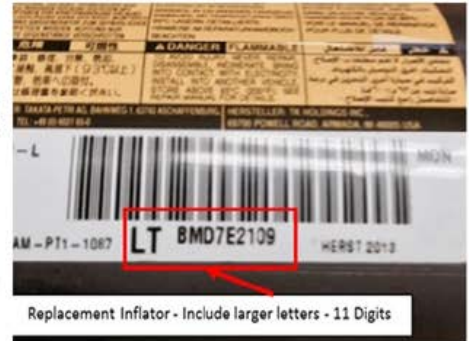
### Replacement Inflator

The first two characters of the Replacement Inflator Serial code will be either 'LT' or 'LR'.

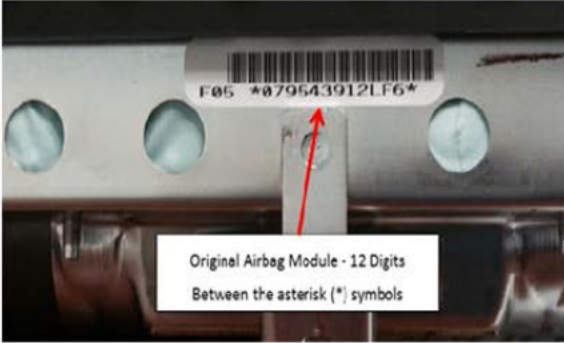
Original Airbag Module - 12 Digits  
Between the asterisk (\*) symbols

The Airbag module Assembly serial number is a **12 digit code**. It can be found along with a bar code on opening the Airbag assembly unit. To manually enter these details into the application, the technician has to identify the 12 digit code between two Asterisks (\*) inside the Airbag assembly unit. The first seven characters of this 12 digit code are numbers and the 10<sup>th</sup> digit is either 'K' or 'L' always.

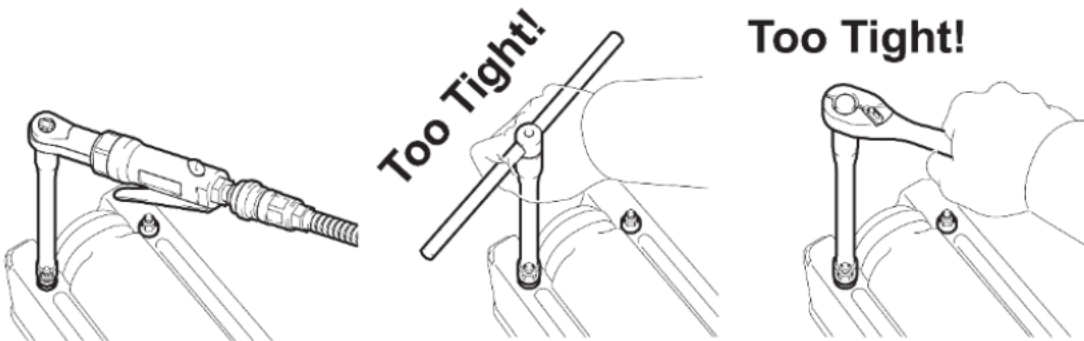
R1701260011Z01

**NG**

**These tools cause overtightening !**
