TECHNICAL INSTRUCTIONS
FOR
SAFETY RECALL G0P
FRONT PASSENGER AIRBAG INFLATOR MODULE
CERTAIN 2008 – 2012 MY SCION xB

Updated 08-31-17

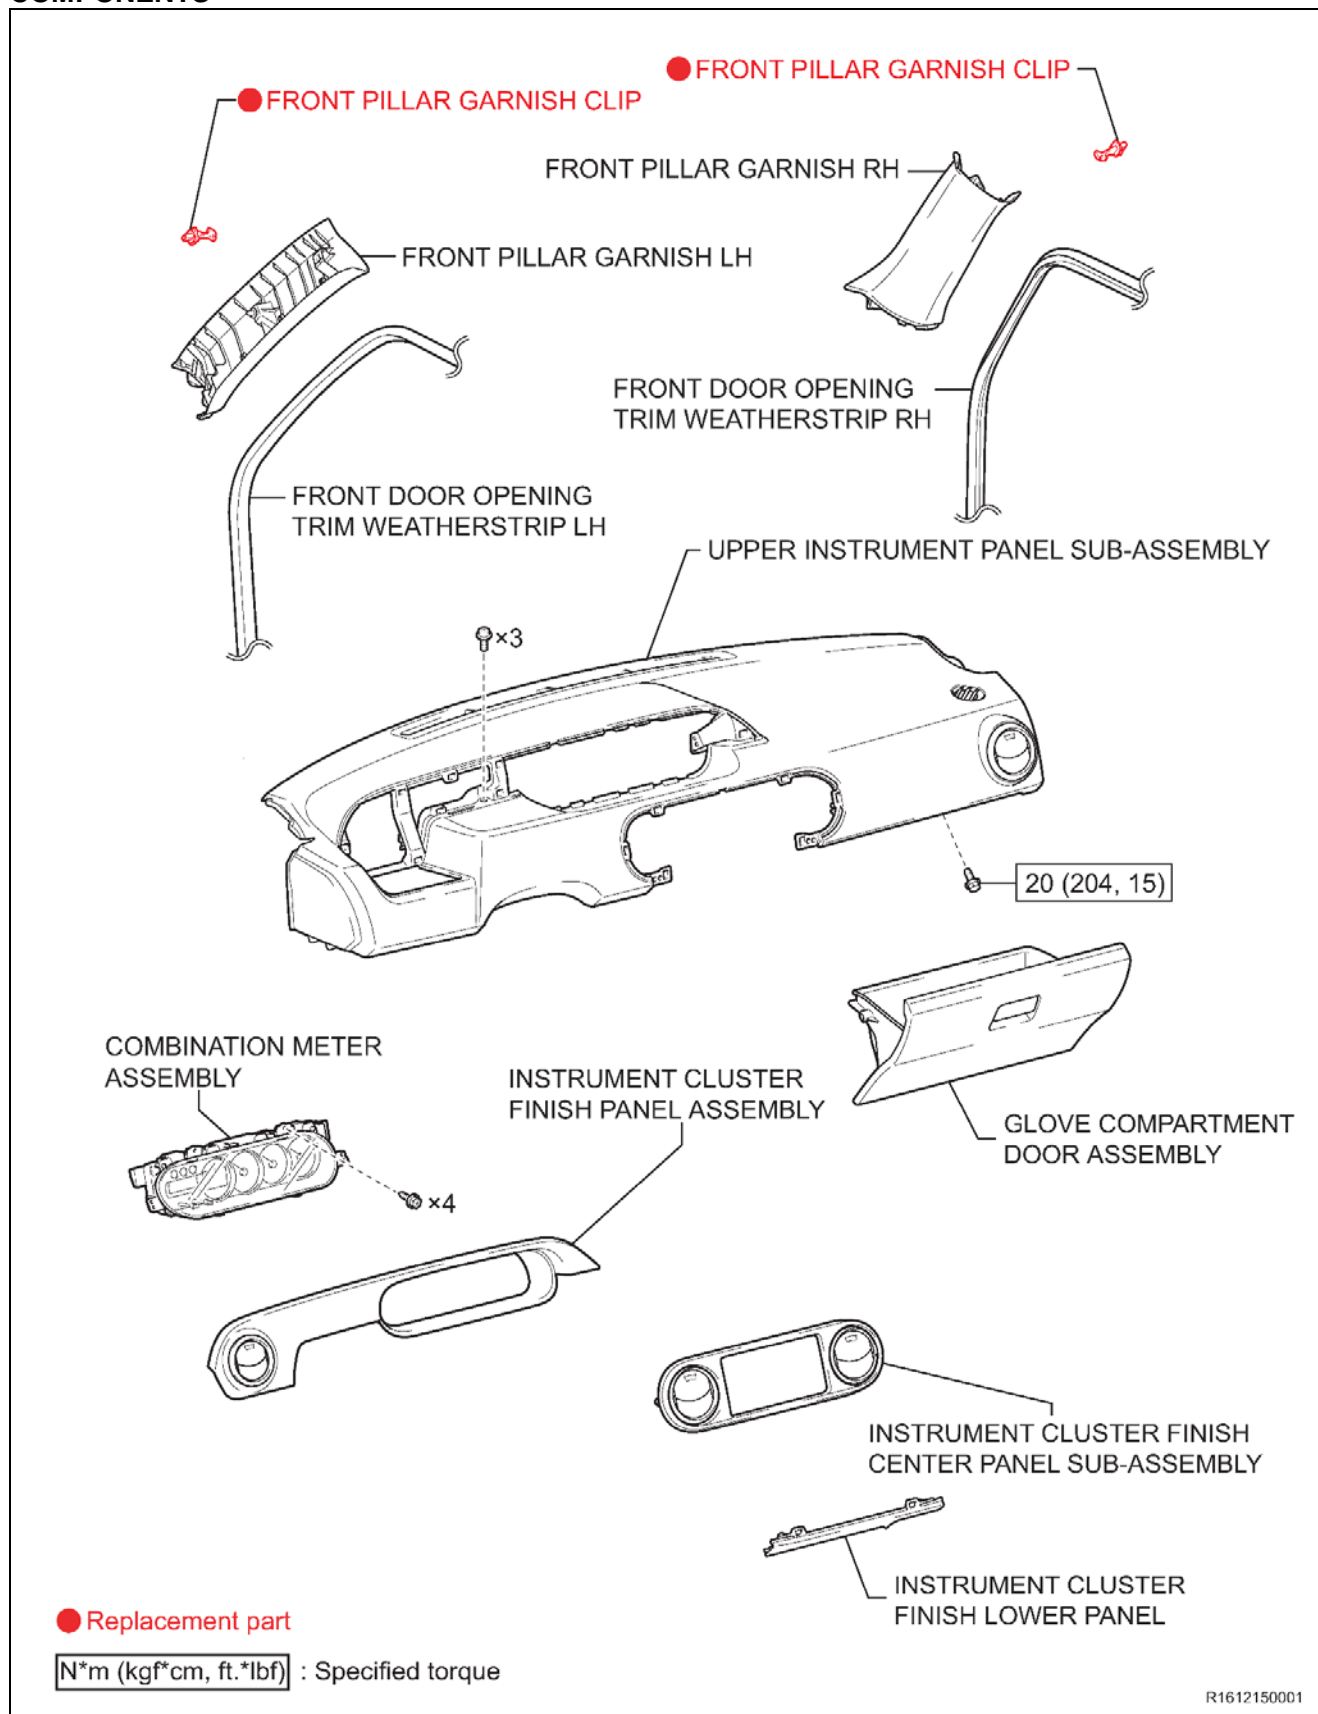
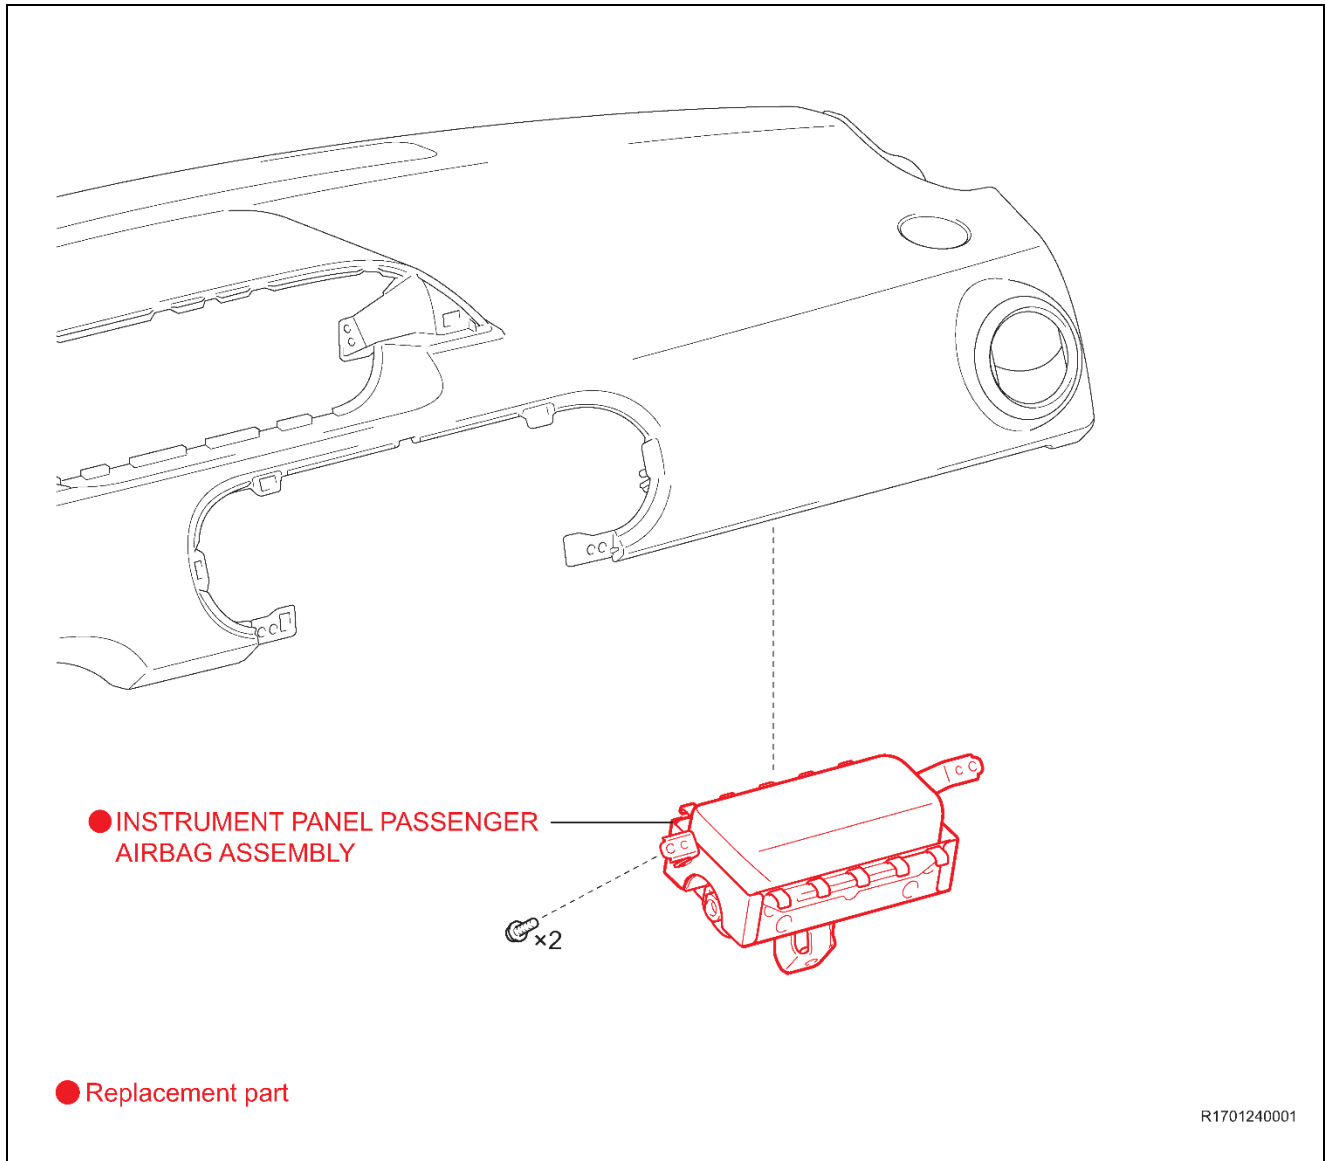
COMPONENTS

1. REMOVE THE AIRBAG MODULE

a) Refer to TIS for instructions on airbag removal:

- Wait at least 90 seconds after disconnecting the cable from the negative battery terminal to prevent airbag and seat belt pre-tensioner deployment.
- Follow all precautions as outlined on TIS before servicing the SRS system.
