TECHNICAL INSTRUCTIONS
FOR
SAFETY RECALL H0A
FRONT PASSENGER AIRBAG INFLATOR MODULE
CERTAIN 2008 MY SCION xB

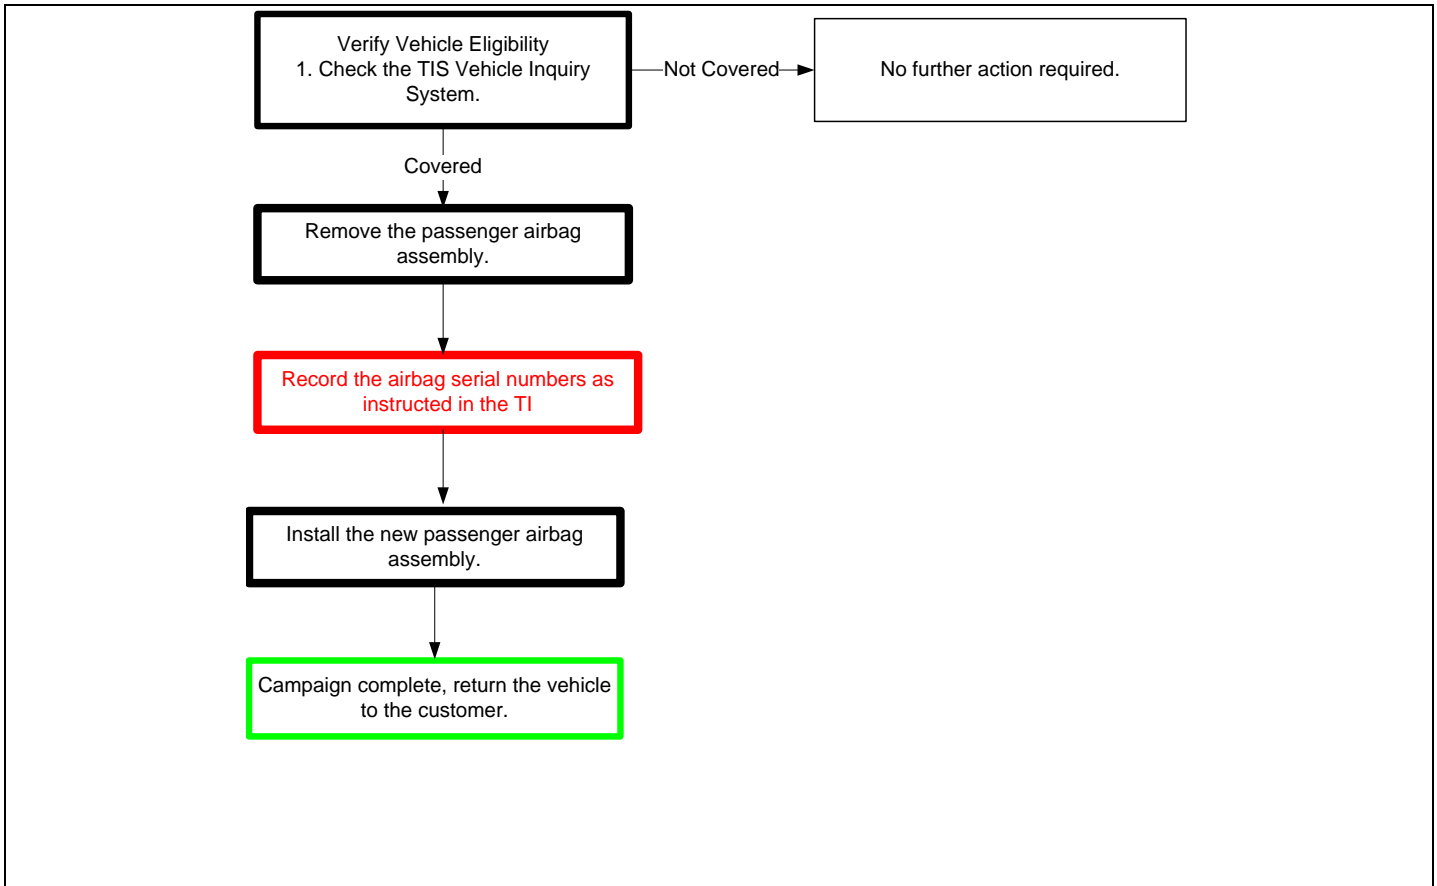
I. OPERATION FLOW CHART

The flow chart is for reference only. **DO NOT** use it in place of the full technical instructions. Follow **ALL** steps as outlined in the full technical instructions to confirm the campaign is completed correctly.

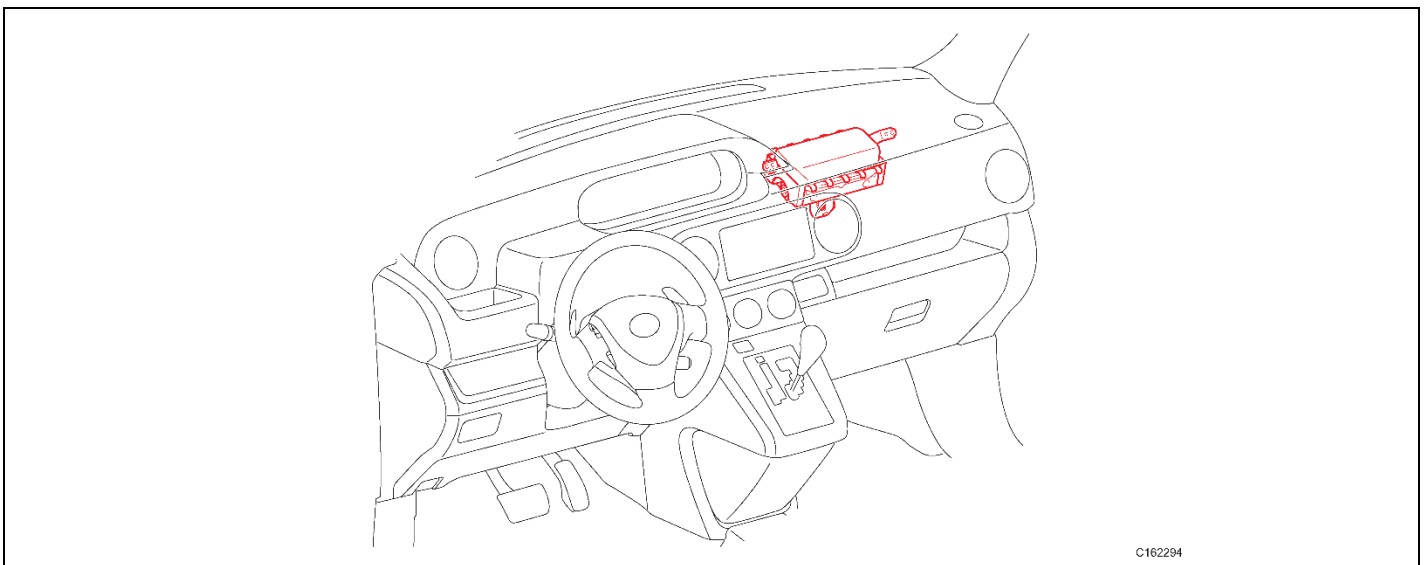
The subject vehicles are equipped with front passenger airbag inflators produced by Takata. According to Takata, the propellant in these inflators may degrade after prolonged exposure to high absolute humidity and fluctuating high temperatures. Degraded propellant can cause inflator rupture during airbag deployment. In the event of an inflator rupture, metal fragments could pass through the airbag cushion material, striking the vehicle occupants, and result in serious injury or death.

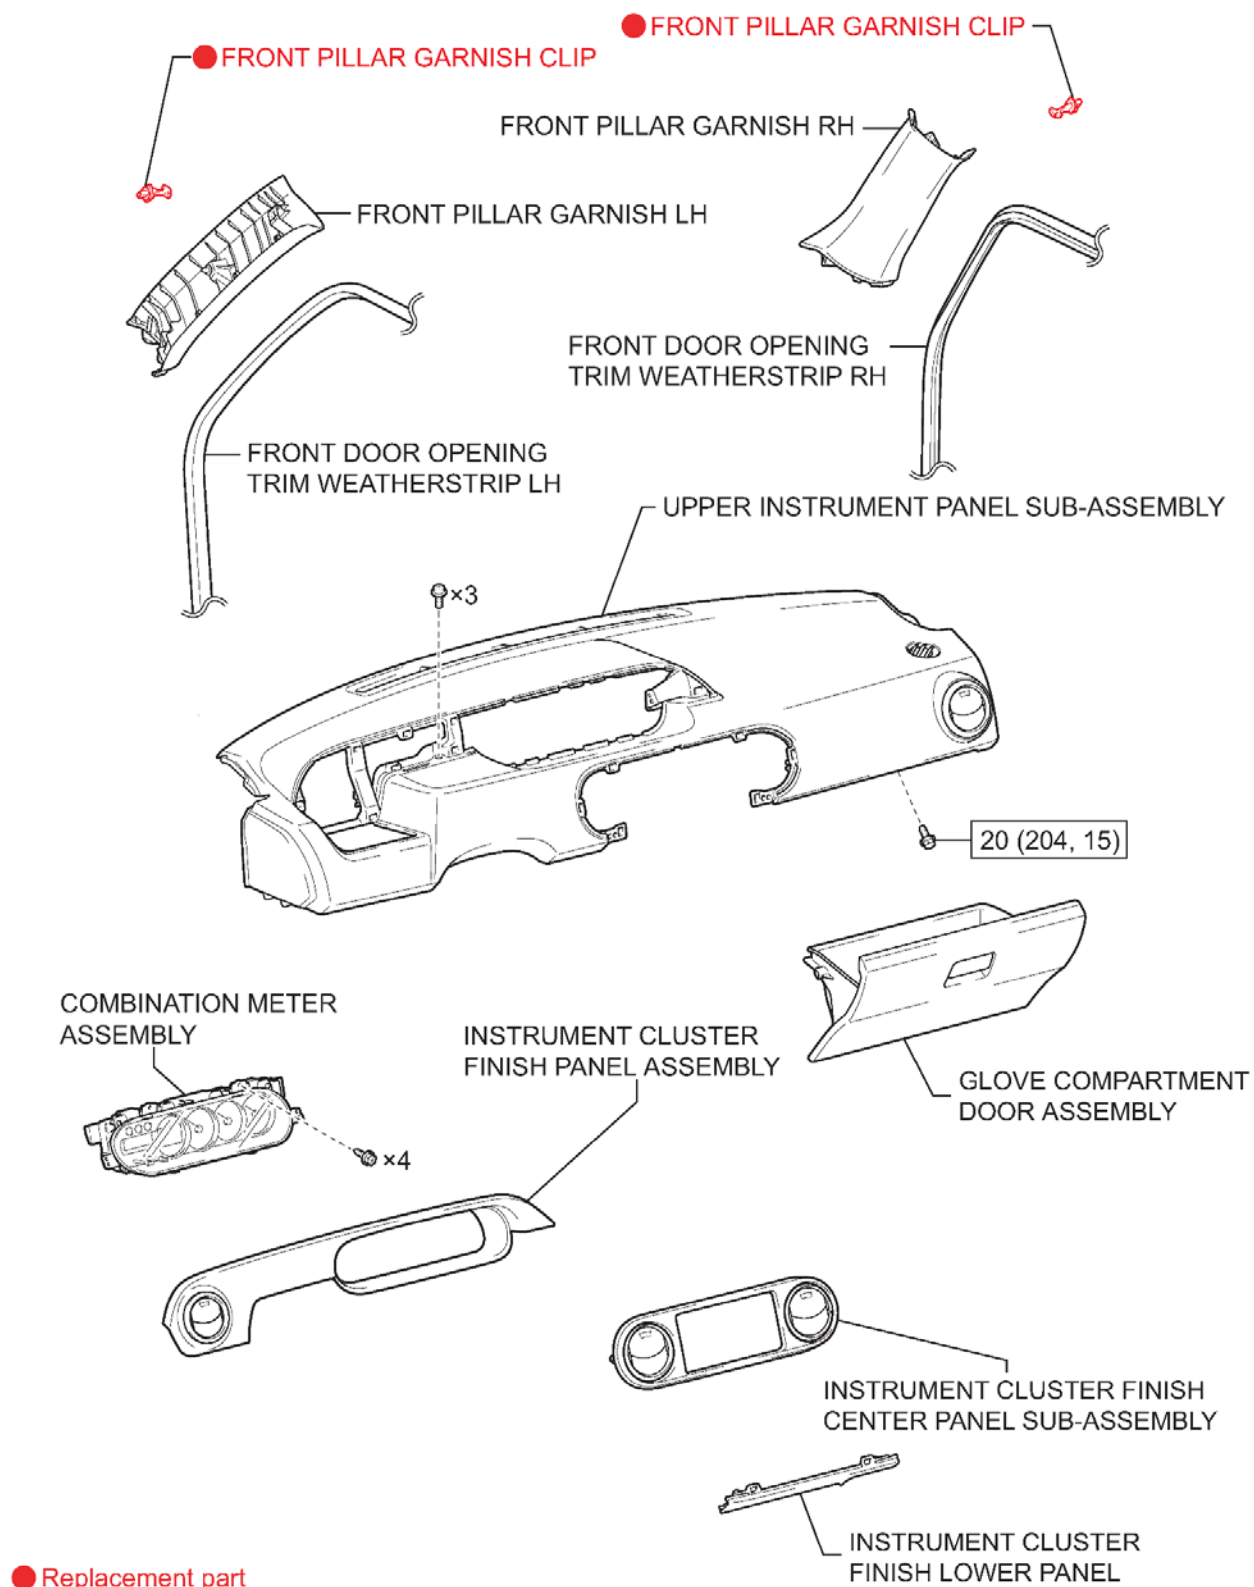
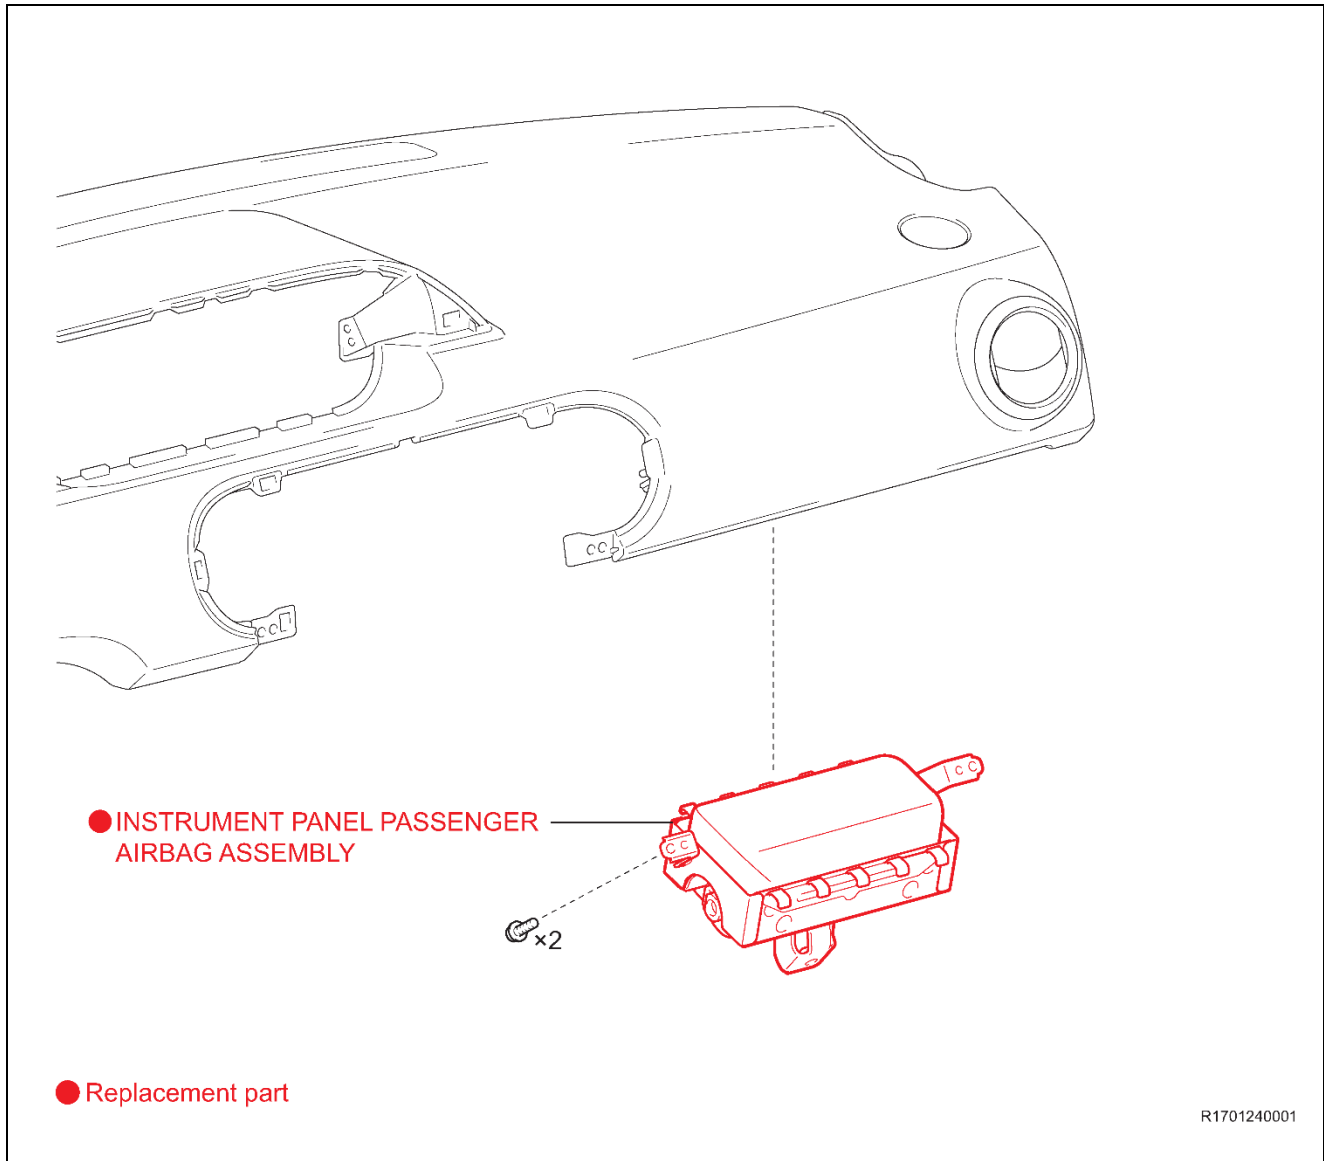
COMPONENTS

N*m (kgf*cm, ft.*lbf) : Specified torque

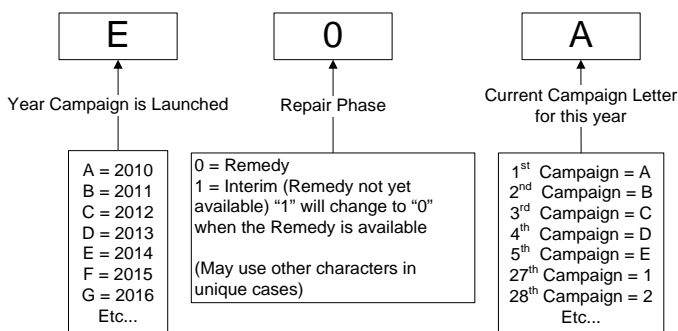
A. CAMPAIGN DESIGNATION DECODER

A0D = Launched in 2010, Remedy Phase, 4th Campaign Launched in 2010

B1E = Launched in 2011, Interim Phase, 5th Campaign Launched in 2011

C1C = Launched in 2012, Interim Phase, 3rd Campaign Launched in 2012
