## TECHNICAL INSTRUCTIONS FOR SAFETY RECALL H0A FRONT PASSENGER AIRBAG INFLATOR MODULE CERTAIN 2009 MODEL YEAR COROLLA

### UPDATE 7-17-18

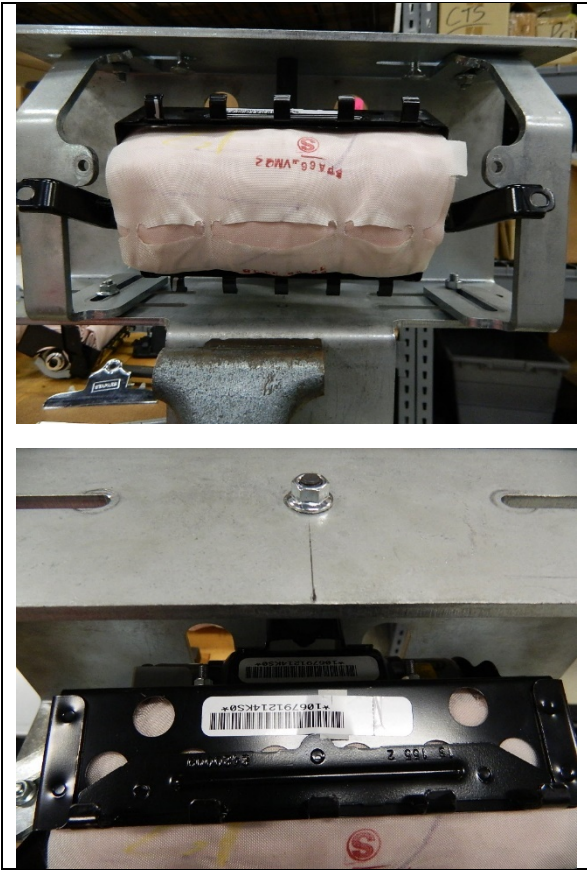
e) Use the long adaptor shown.

f) Thread the adaptor into the airbag as shown.  
**Note: Use the same mounting nut on the airbag that attaches the airbag to the vehicles cross tube.**
