**TECHNICAL INSTRUCTIONS**  
**FOR**  
**SAFETY RECALL H0A**  
**FRONT PASSENGER AIRBAG INFLATOR**  
**CERTAIN 2008 MY SCION xB**

The subject vehicles are equipped with front passenger airbag inflators produced by Takata. According to Takata, the propellant in these inflators may degrade after prolonged exposure to high absolute humidity and fluctuating high temperatures. Degraded propellant can cause inflator rupture during airbag deployment. In the event of an inflator rupture, metal fragments could pass through the airbag cushion material, striking the vehicle occupants, and result in serious injury or death.

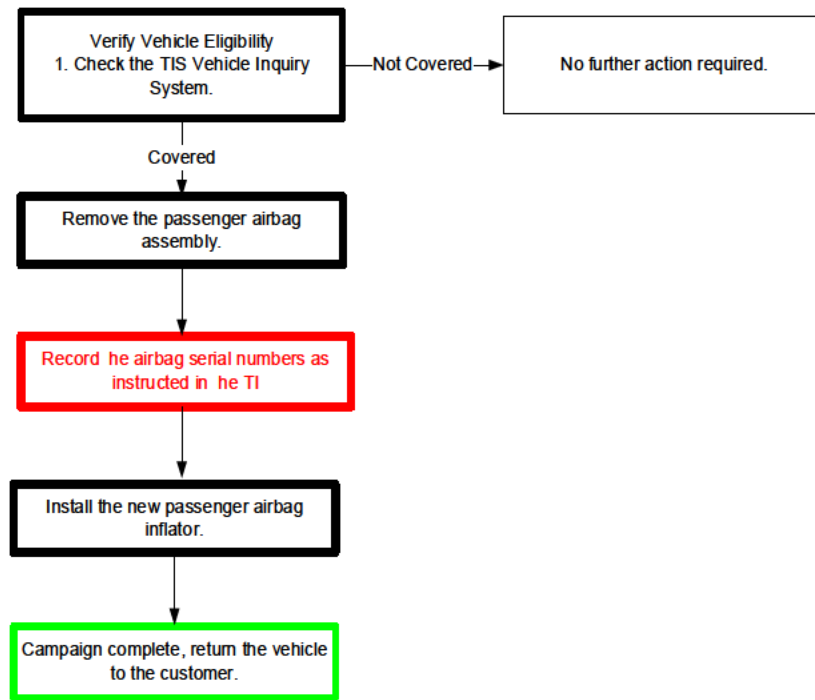
## I. OPERATION FLOW CHART

The flow chart is for reference only. **DO NOT** use it in place of the full technical instructions. Follow **ALL** steps as outlined in the full technical instructions to confirm the campaign is completed correctly.

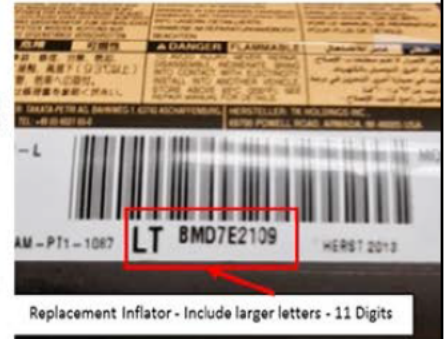
### Replacement Inflator

The first two characters of the **Replacement Inflator Serial code** will be either 'LT' or 'LR'.

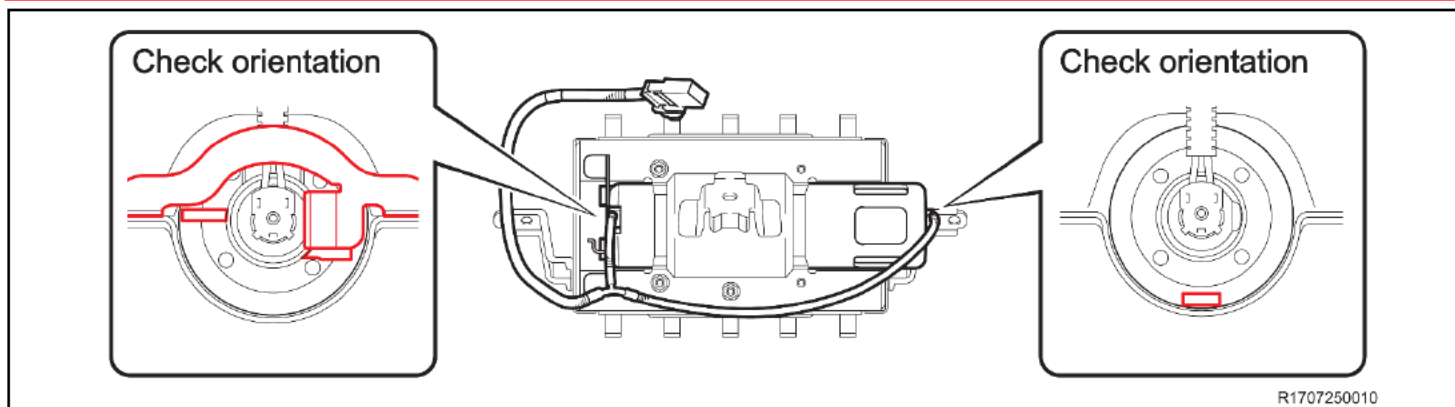
d) Insert the inflator with the correct orientation as shown in the illustration.

- Make sure that the inflator is oriented correctly as shown in the illustration, not upside down.
- If the passenger airbag inflator is upside down, it will not be able to be fully inserted.
