# IMPORTANT UPDATE

## TECHNICAL INSTRUCTIONS FOR SAFETY RECALL G0P FRONT PASSENGER AIRBAG INFLATOR CERTAIN 2008 – 2013 MY SCION xB

**Updated 4-18-2018**

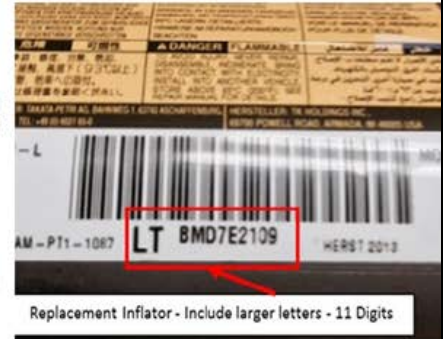
### Replacement Inflator

The first two characters of the **Replacement Inflator Serial code** will be either 'LT' or 'LR'.
