# TECHNICAL INSTRUCTIONS FOR SAFETY RECALL G0R FRONT PASSENGER AIRBAG INFLATOR MODULE CERTAIN 2009-2010 MODEL YEAR COROLLA

**Updated 4-18-18**

The subject vehicles are equipped with front passenger airbag inflators produced by Takata. The propellant in these inflators may degrade after prolonged exposure to high absolute humidity and fluctuating high temperatures. Degraded propellant can cause inflator rupture during airbag deployment. In the event of an inflator rupture, metal fragments could pass through the airbag cushion material, striking the vehicle occupants, and result in serious injury or death.

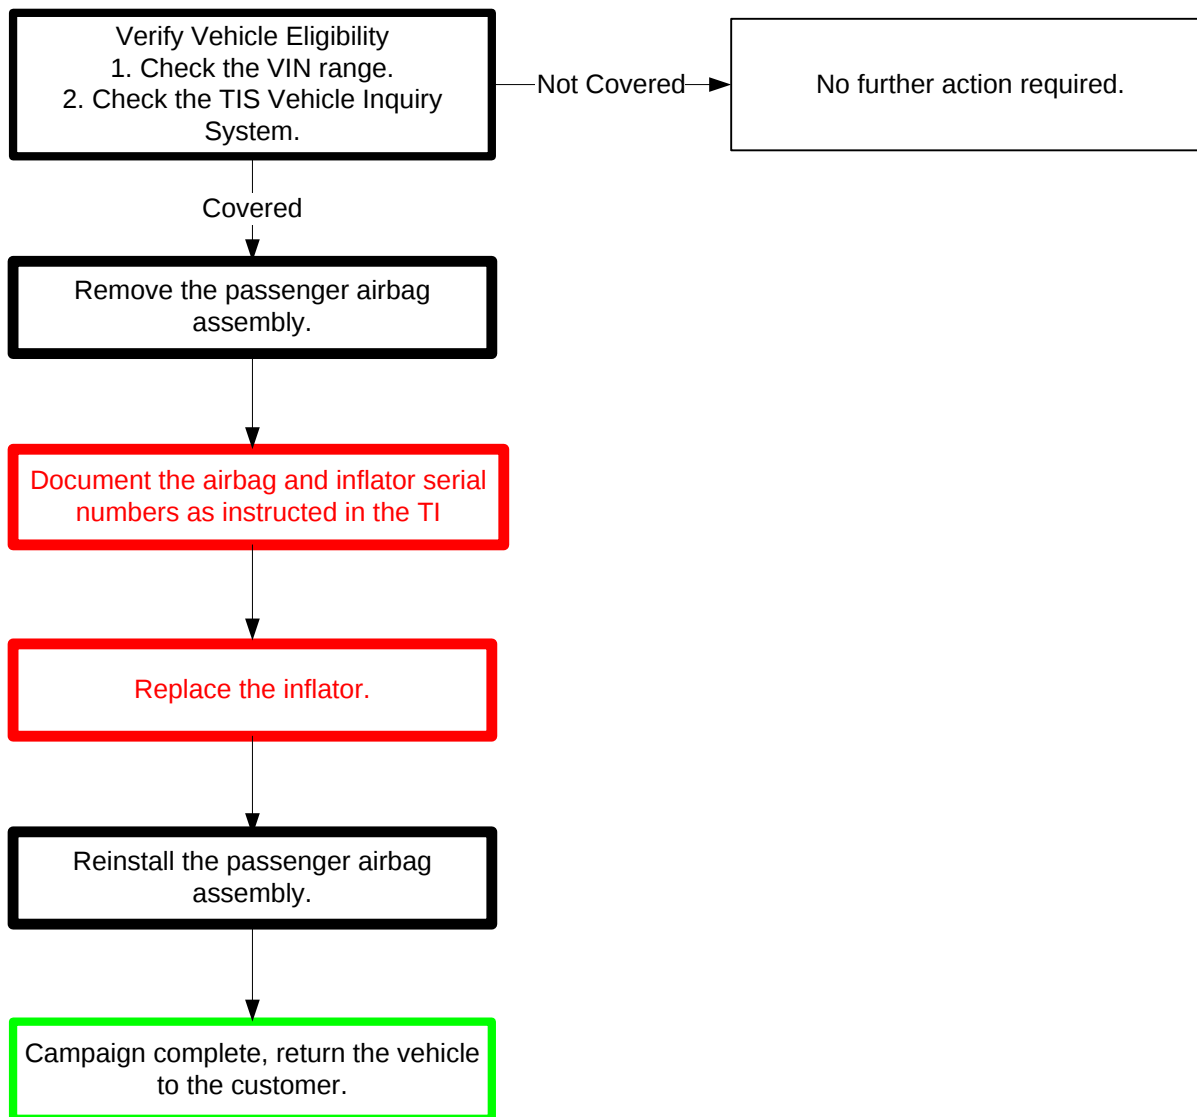
## I. OPERATION FLOW CHART

The flow chart is for reference only. **DO NOT** use it in place of the full technical instructions. Follow **ALL** steps as outlined in the full technical instructions to confirm the campaign is completed correctly.

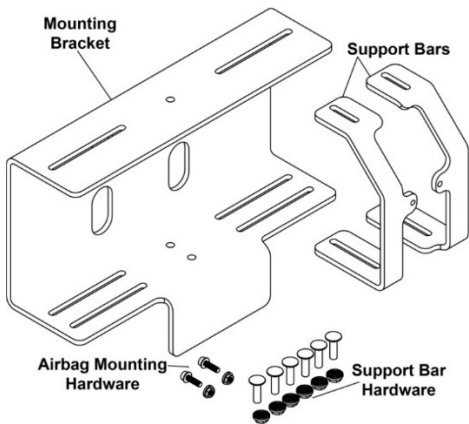
| Image | Name | Quantity |
|---|---|---|
| | Airbag Mounting Bracket & hardware | 1 |

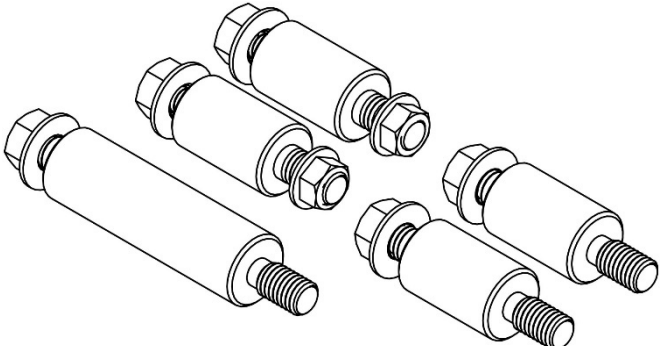
| Image | Name | Quantity |
|---|---|---|
| | Adaptor set* | 1 |

\*The adaptor set was sent to dealers at the start of this campaign.

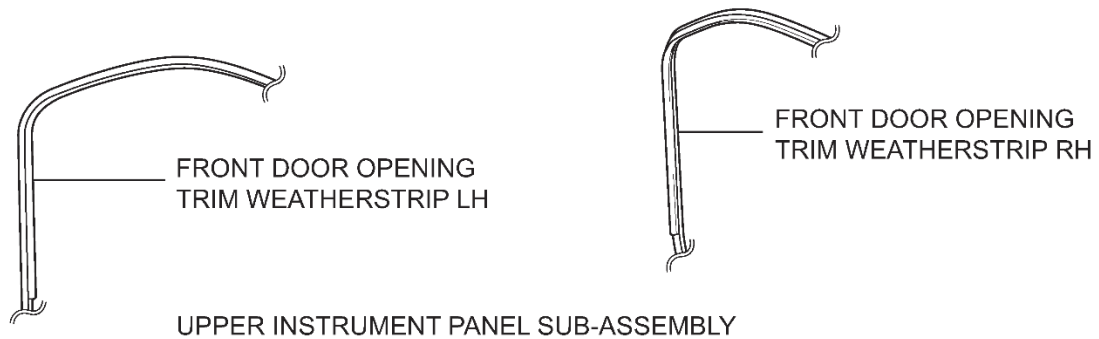
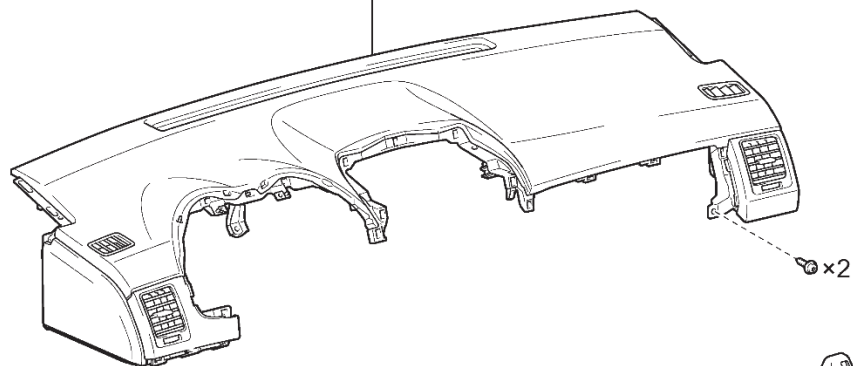
No. 1 INSTRUMENT PANEL BOX DOOR SUB-ASSEMBLY

LOWER INSTRUMENT PANEL FINISH PANEL ASSEMBLY

GLOVE COMPARTMENT DOOR ASSEMBLY

FRONT PASSENGER AIRBAG ASSEMBLY

**BE CAREFUL!**  
**DO NOT** remove the  
 No. 4 INSTRUMENT PANEL CUSHION.

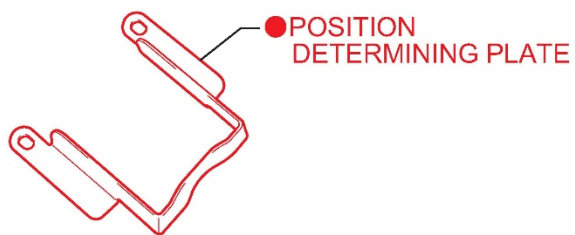
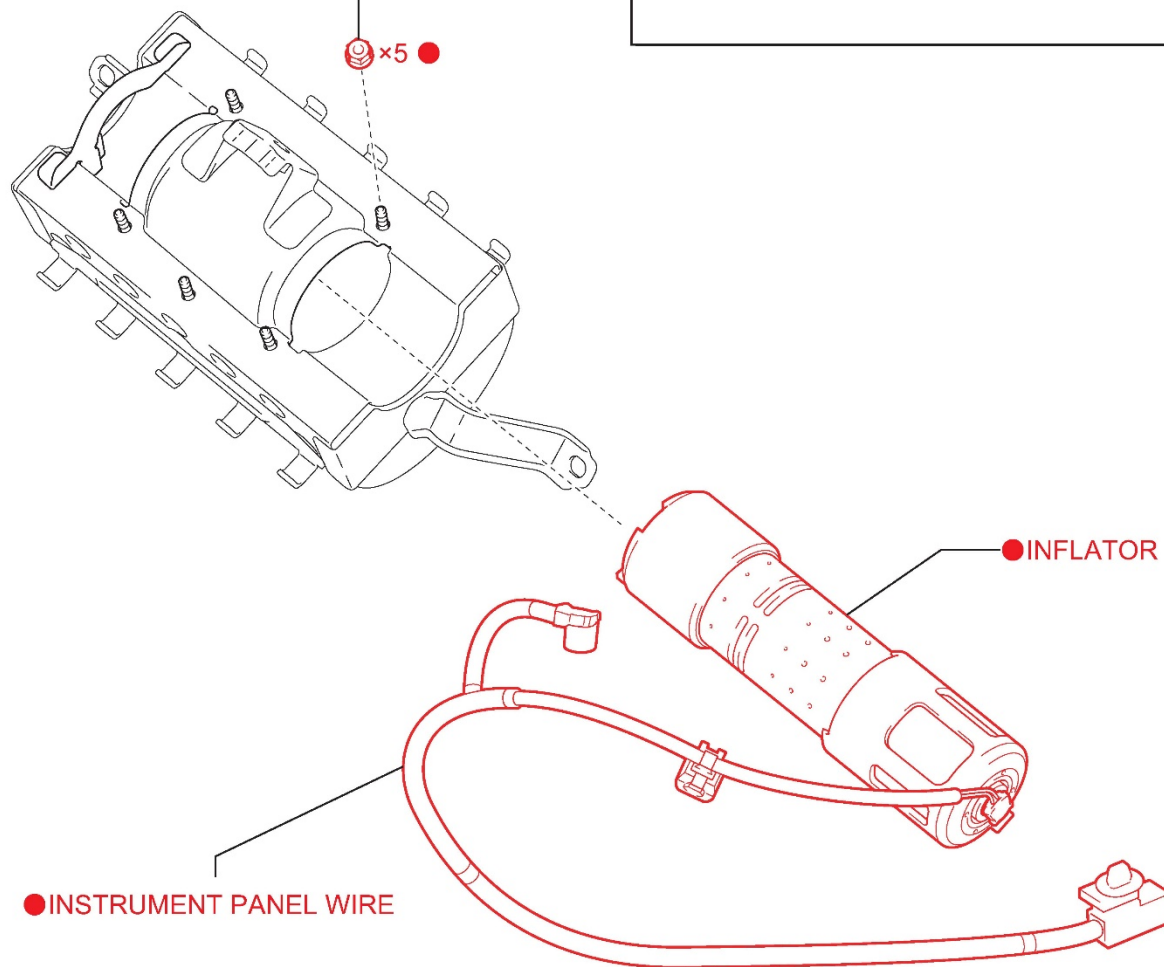
for COROLLA:

**3.9 N·m (40, 35 in.\*lbf)**  
**Be careful not to**  
**overtighten.**

● : Replacement part

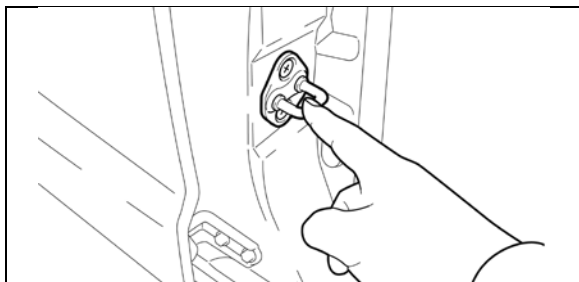
#### 1. ELIMINATE STATIC ELECTRICITY

- Before starting work and periodically while working on the vehicle, touch a metallic part of the vehicle to discharge static electricity in the body.

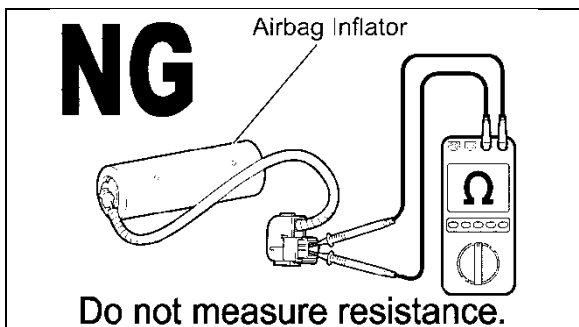
#### 2. DO NOT MEASURE RESISTANCE

- DO NOT** measure resistance of airbag components, this may cause accidental activation.

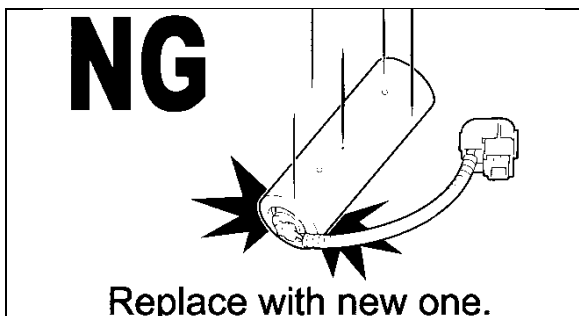
#### 3. HANDLE THE AIRBAG CAREFULLY

- If an inflator is dropped, replace it with a **NEW** inflator.

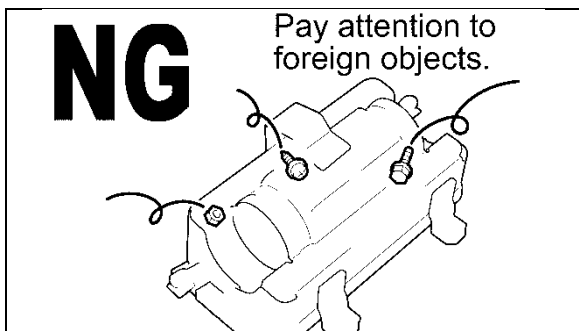
#### 4. DO NOT ALLOW FOREIGN OBJECTS NEAR AIRBAG

- Be sure to collect and account for all removed nuts/bolts to prevent them from landing in the airbag assembly.
- Any foreign objects in the airbag assembly may cause damage or injury if the airbag is activated.

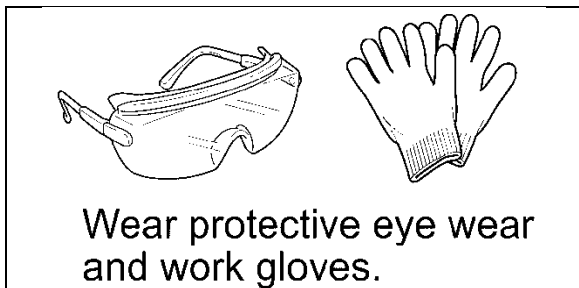
#### 5. WEAR PROTECTIVE EQUIPMENT

- Always wear appropriate protective equipment when working on the SRS.

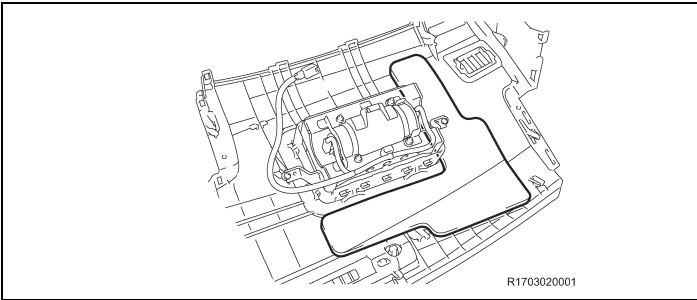
- Wait at least 90 seconds after disconnecting the cable from the negative battery terminal to prevent airbag and seat belt pre-tensioner deployment.
- Follow all precautions as outlined on TIS before servicing the SRS system.

a) Refer to TIS for instructions on airbag removal:

**NOTE:** For TMC made Corolla only (VIN starts with JT). Do not remove the No. 4 instrument panel cushion.

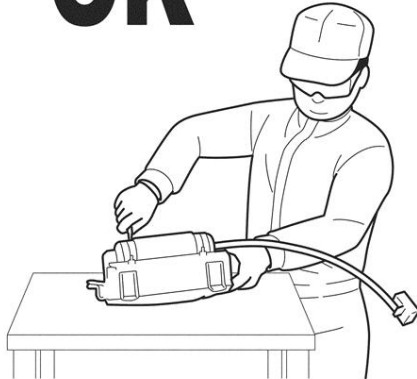
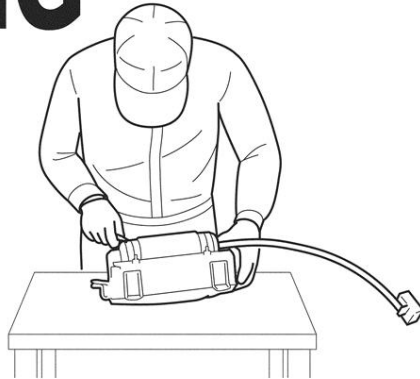
- Carefully place the airbag on the bench inflator side up.

**NOTE: Place clean sheet(s) of paper on the bench to protect the airbag.**

- Avoid standing directly over the inflator.

# OK

# NG

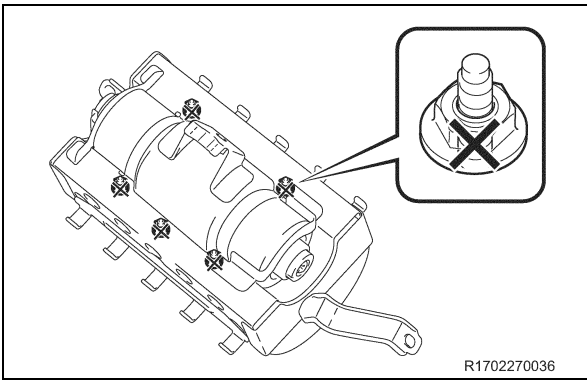
- Use a screwdriver to release the lock button.
- Disconnect the connector.
- Disconnect the wire harness clamps.

**NOTE: Disconnect the connector where the fixed stop plate is located.**

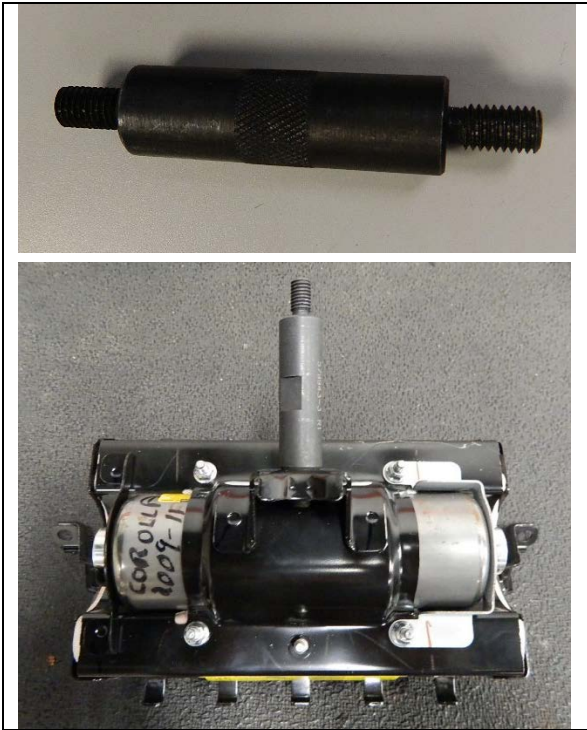
d) Mark all 5 nuts so they will not be reused.

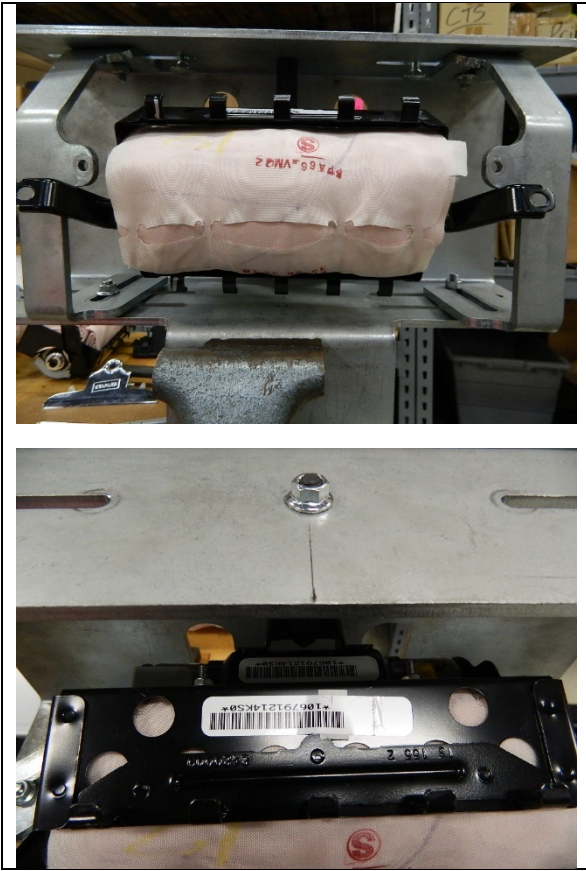
e) Use the long adaptor shown.

f) Thread the adaptor into the airbag as shown.  
**Note: Use the same mounting nut on the airbag that attaches the airbag to the vehicles cross tube.**

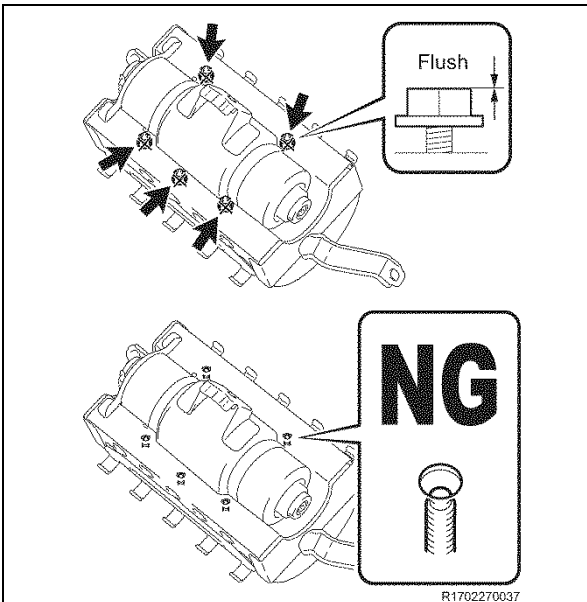
- g) Mount the airbag into the mounting bracket as shown. Pass the stud on the adaptor through the hole, on the top in the middle of the bracket, and secure with the nut.

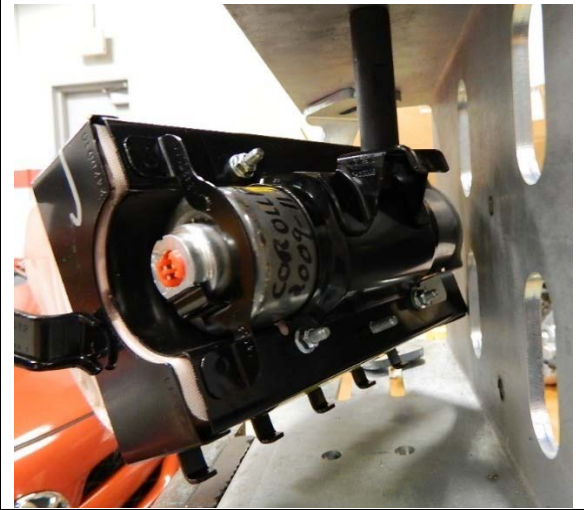
- Loosen the 5 nuts until the nuts are at the top of the studs as shown, through the openings in the mounting bracket.

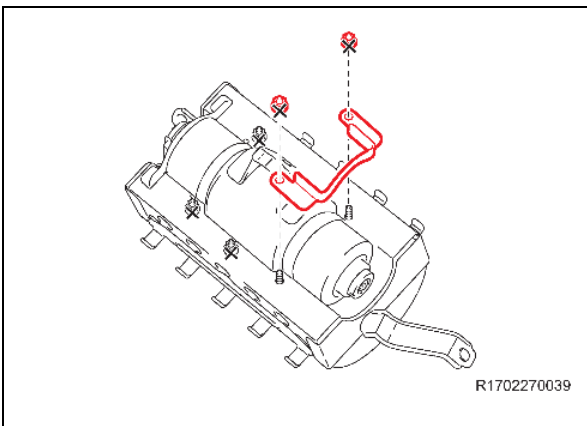
**Note:** The airbag may need to be turned to the left or right to access the center nut.

- Remove the 2 nuts on the end where the bracket is removable.
- Remove the bracket and discard.
- Reinstall the 2 nuts, until the nut is flush with the top of the stud.

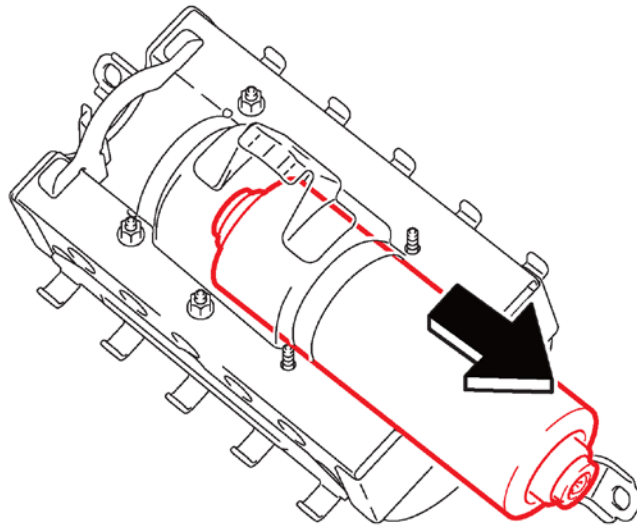
R1702270038

- a) Gently push in the studs until the nuts make contact with the housing to loosen the inflator for removal.

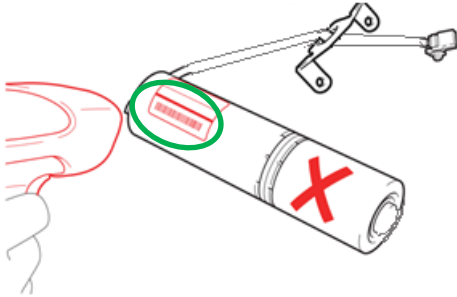
**Step a) Old Inflator (bar code)**

- Scan the **OLD** inflator bar code.
- Scan the **NEW** inflator QR code.

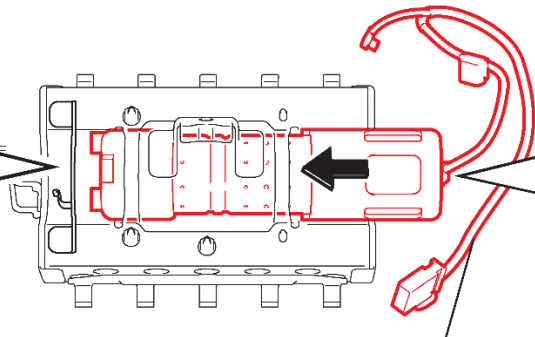
R1702270040

- a) Carefully slide the new inflator into the airbag assembly and align as shown.

- DO NOT** connect the inflator harness at this time. It is **CRITICAL** to first confirm that the inflator is installed in the correct position before connecting the harness.

**DO NOT** insert fully.

Check orientation

Upper side

Instrument panel wire

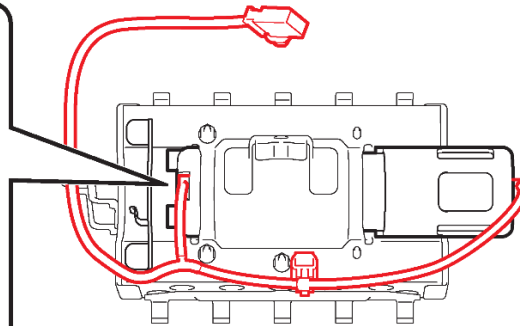
R1702270041

- b) Connect the connector to the inflator and ensure that the connector lock is fully engaged as shown.  
c) Route and secure the wire harness as shown.

**ALIGN CONNECTORS**

Wire Harness Side:

Inflator Side:

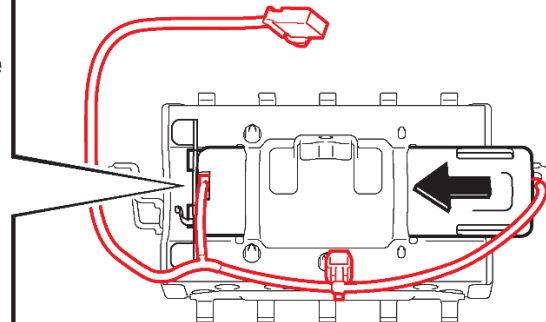
R1702270042

- d) Fully insert the inflator and ensure that the inflator is correctly oriented as shown.  
**NOTE: DO NOT** pinch the wiring between the bracket and the inflator.

**OK**

**NG**

**DO NOT**  
pinch the wire

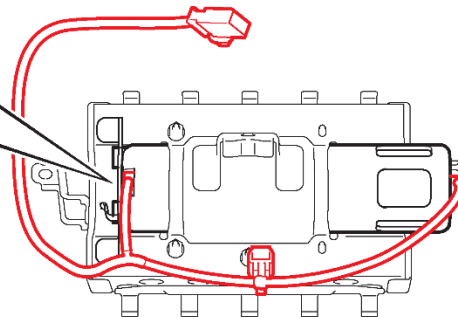
R1702270043

Check orientation

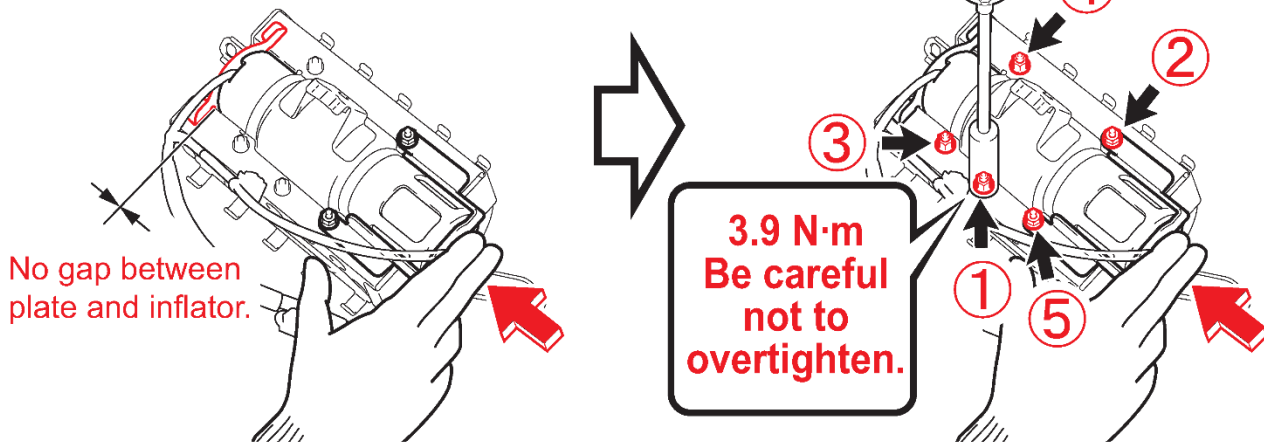
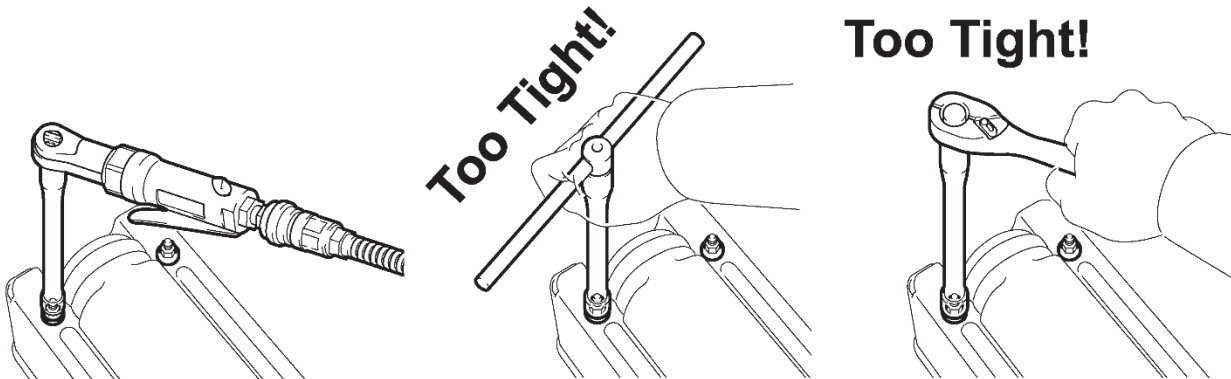
- a) Tighten the 5 nuts evenly in several increments in the sequence shown. Use a socket driver or torque wrench to tighten the nuts.

Torque: 35in. lbf (3.9N·m)

- There will be some resistance when tightening the nuts because they are self-locking, confirm the nuts are tightened correctly.
- **DO NOT** use a power tool, T-handle, or ratchet when tightening the nuts to avoid over torqueing and deforming the studs.
- You may need to turn the airbag to the left or right with in the mounting bracket to access the center nut.

# OK

# NG

## These tools cause overtightening !

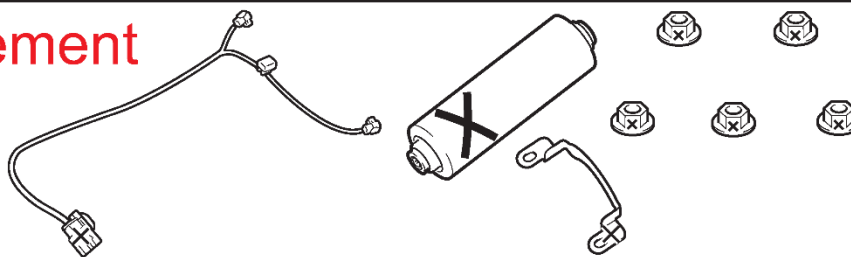
(a) Replacement of parts.

- a) Confirm the **NEW** inflator and 5 **NEW** nuts have been installed.
- b) Confirm the position of the inflator and position determining plates are correct.  
**NOTE: The flats should be aligned and no gaps between the plates and inflator.**
- c) Confirm the routing of the inflator wire harness.
