TECHNICAL INSTRUCTIONS FOR SAFETY RECALL H0A FRONT PASSENGER AIRBAG INFLATOR MODULE CERTAIN 2008 - 2009 MY SCION xB

UPDATED 1-9-2018

The subject vehicles are equipped with front passenger airbag inflators produced by Takata. According to Takata, the propellant in these inflators may degrade after prolonged exposure to high absolute humidity and fluctuating high temperatures. Degraded propellant can cause inflator rupture during airbag deployment. In the event of an inflator rupture, metal fragments could pass through the airbag cushion material, striking the vehicle occupants, and result in serious injury or death.

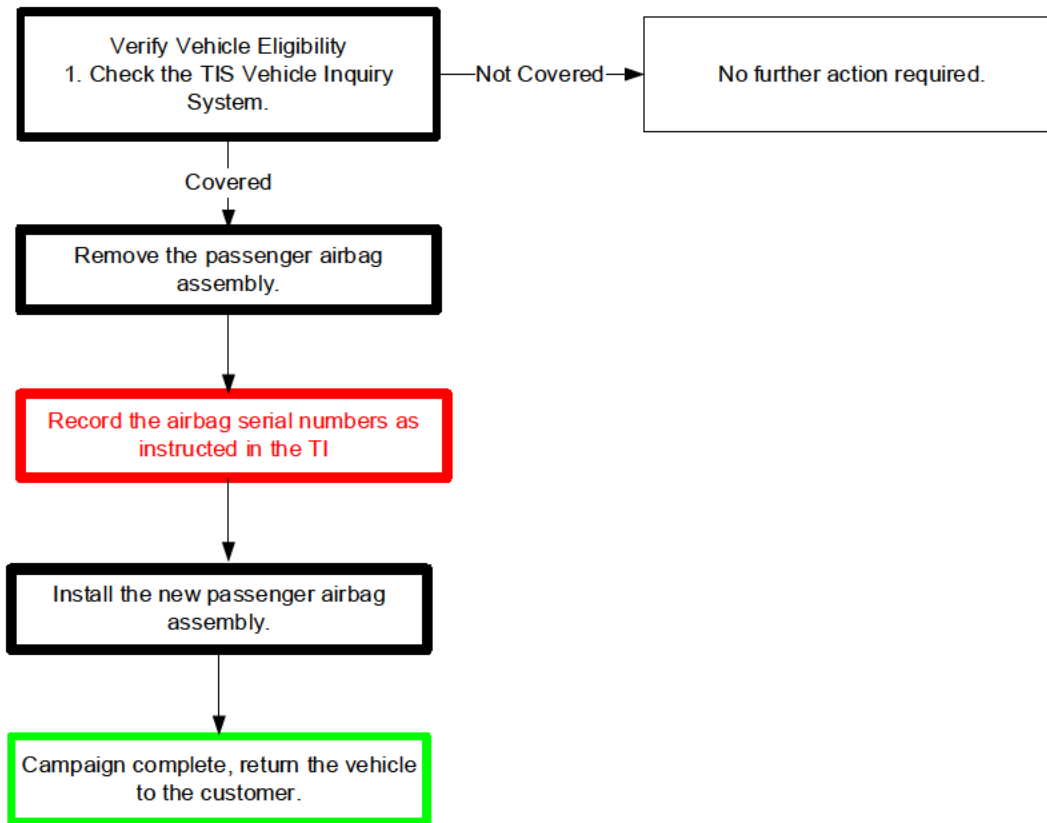
I. OPERATION FLOW CHART

The flow chart is for reference only. **DO NOT** use it in place of the full technical instructions. Follow **ALL** steps as outlined in the full technical instructions to confirm the campaign is completed correctly.

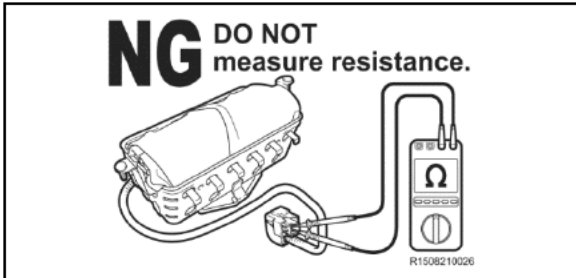
2. DO NOT MEASURE RESISTANCE

- a) **DO NOT** measure resistance of airbag components, this may cause accidental activation.

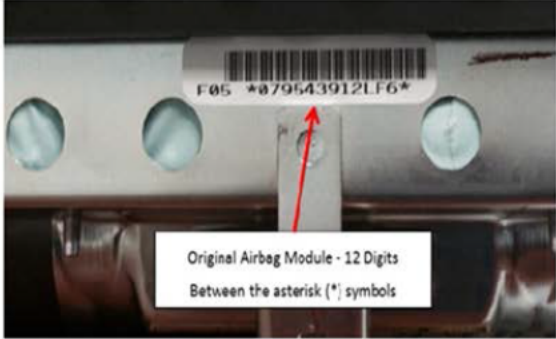
Original Airbag Module - 12 Digits
Between the asterisk (*) symbols

The Airbag module Assembly serial number is a 12 digit code. It can be found along with a bar code on opening the Airbag assembly unit. To manually enter these details into the application, the technician has to identify the 12 digit code between two Asterisks (*) inside the Airbag assembly unit. The first seven characters of this 12 digit code are numbers and the 10th digit is either 'K' or 'L' always.

Check this box if the label is damaged or missing

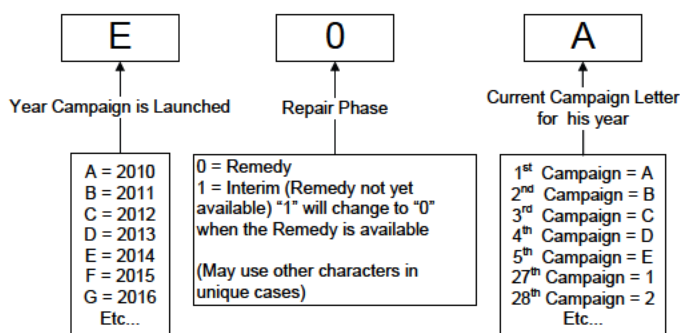
A. CAMPAIGN DESIGNATION DECODER

A0D = Launched in 2010, Remedy Phase, 4th Campaign Launched in 2010

B1E = Launched in 2011, Interim Phase, 5th Campaign Launched in 2011

C1C = Launched in 2012, Interim Phase, 3rd Campaign Launched in 2012
