**TECHNICAL INSTRUCTIONS  
FOR  
SAFETY RECALL G0P  
FRONT PASSENGER AIRBAG INFLATOR MODULE  
CERTAIN 2009 – 2012 MODEL YEAR COROLLA**

**Updated 11-2-17**

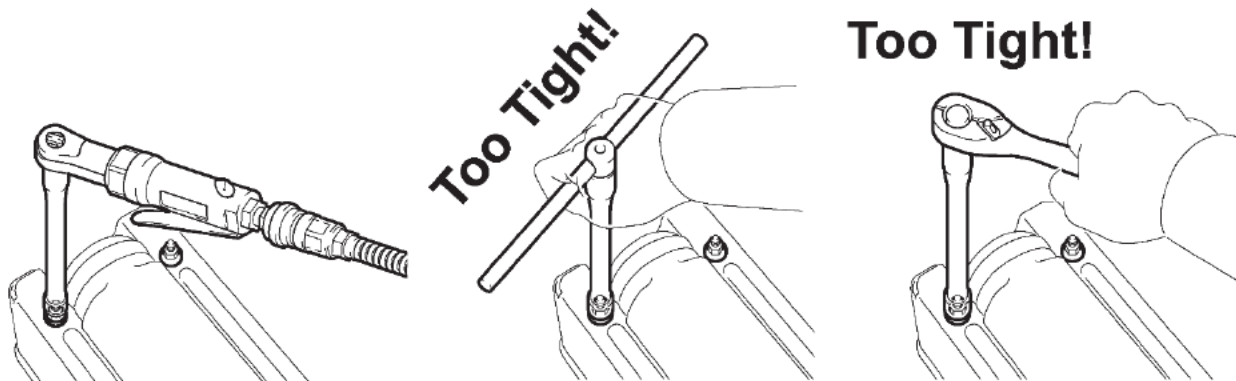
## 7. TORQUE THE PLATE NUTS

- a) Tighten the 5 nuts evenly in several increments in the sequence shown. Use a socket driver or torque wrench to tighten the nuts.

Torque: 35in. lbf (3.9N·m)

- There will be some resistance when tightening the nuts because they are self-locking, confirm the nuts are tightened correctly.
- **DO NOT** use a power tool, T-handle, or ratchet when tightening the nuts to avoid over torquing and deforming the studs.
- You may need to turn the airbag to the left or right with in the mounting bracket to access the center nut.

## These tools cause overtightening !
