**TECHNICAL INSTRUCTIONS
FOR
SAFETY RECALL G0P
FRONT PASSENGER AIRBAG INFLATOR MODULE
CERTAIN 2010-2012 MY 4Runner**

UPDATE – 11/2/17

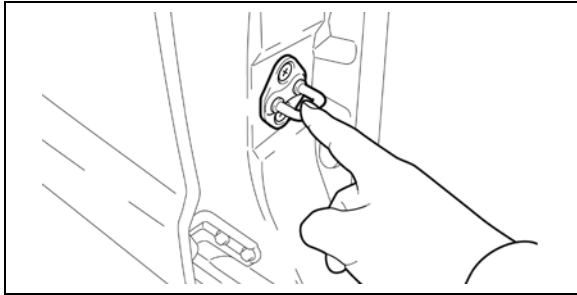
1. ELIMINATE STATIC ELECTRICITY

- Before starting work and periodically while working on the vehicle, touch a metallic part of the vehicle to discharge static electricity in the body.

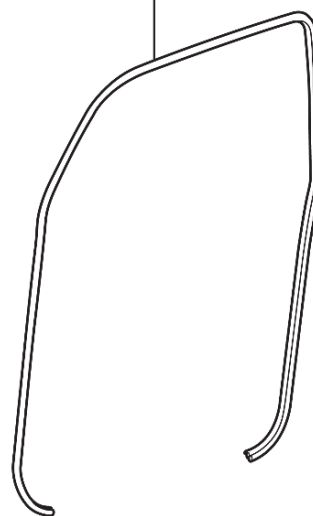
R1703160011

Part manufactured
before August 2013:

Part manufactured
after August 2013:

● FRONT PILLAR
GARNISH LH

No. 1 FRONT PILLAR
GARNISH COVER LH

FRONT PILLAR
GARNISH LH

FRONT DOOR OPENING TRIM
WEATHERSTRIP LH

COWL SIDE TRIM BOARD LH

DOOR SCUFF PLATE ASSEMBLY LH

● Replacement part

NOTE: The left front A-Pillar garnish needs to be replaced on vehicles manufactured prior to August 2013. Only one garnish is required per vehicle depending upon color code. The kit contains the garnish and the non-reusable clip. (see parts information)

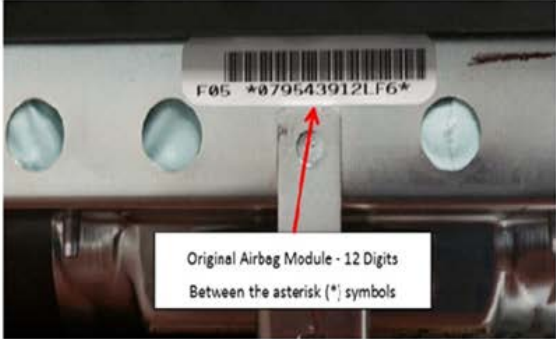
AIRBAG SERIAL NUMBER IS MISSING OR IS UNREADABLE

If the airbag serial number and barcode are not legible or are not present, check the box in the application indicating the serial number is not legible.

a) If the airbag serial number cannot be scanned or is not present check the box as shown below.

Original Airbag Module - 12 Digits
Between the asterisk (*) symbols

Check this box if the label is damaged or missing

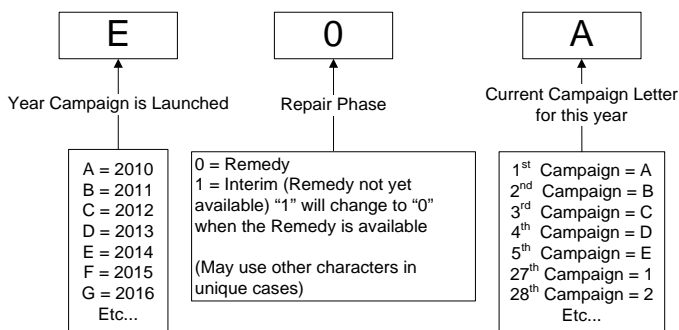
A. CAMPAIGN DESIGNATION DECODER

Examples:

A0D = Launched in 2010, Remedy Phase, 4th Campaign Launched in 2010

B1E = Launched in 2011, Interim Phase, 5th Campaign Launched in 2011

C1C = Launched in 2012, Interim Phase, 3rd Campaign Launched in 2012
