TECHNICAL INSTRUCTIONS
FOR
SAFETY RECALL G0P
FRONT PASSENGER AIRBAG INFLATOR
CERTAIN 2008 – 2012 MY SCION xB

II. BACKGROUND

VII. PASSENGER AIRBAG MODULE REPLACEMENT

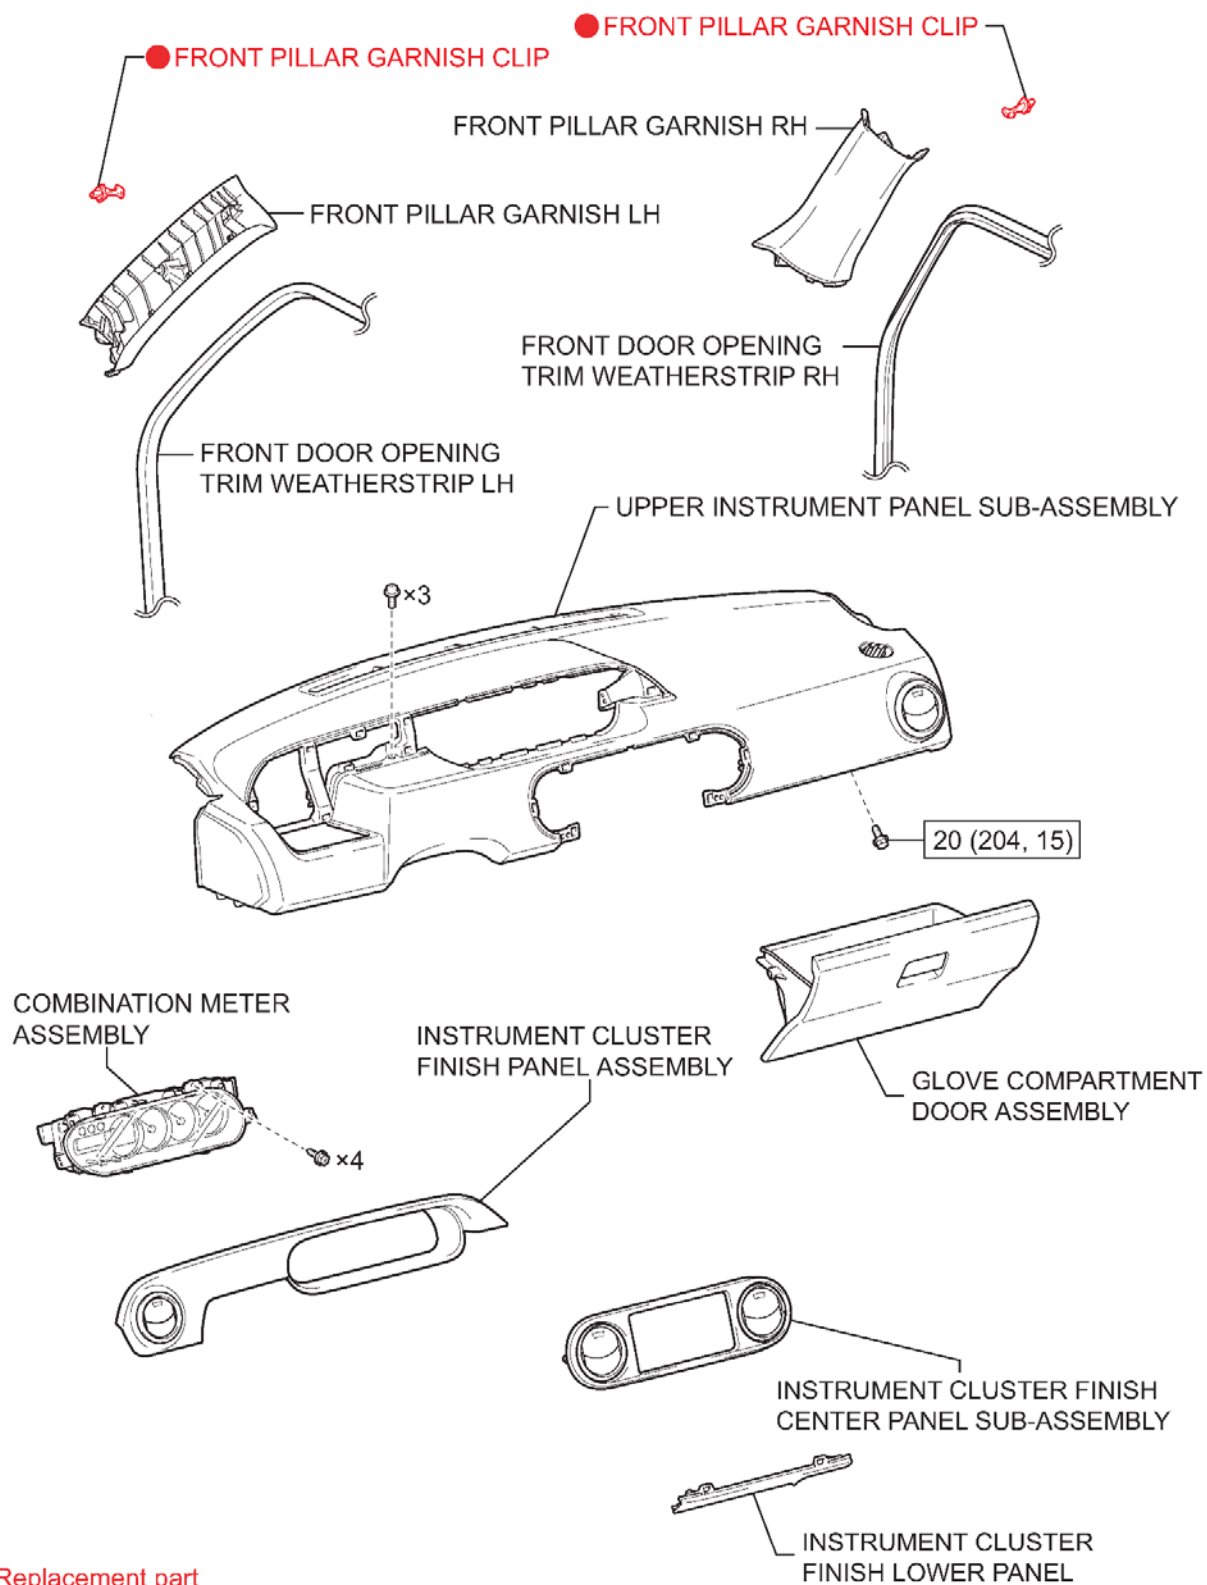
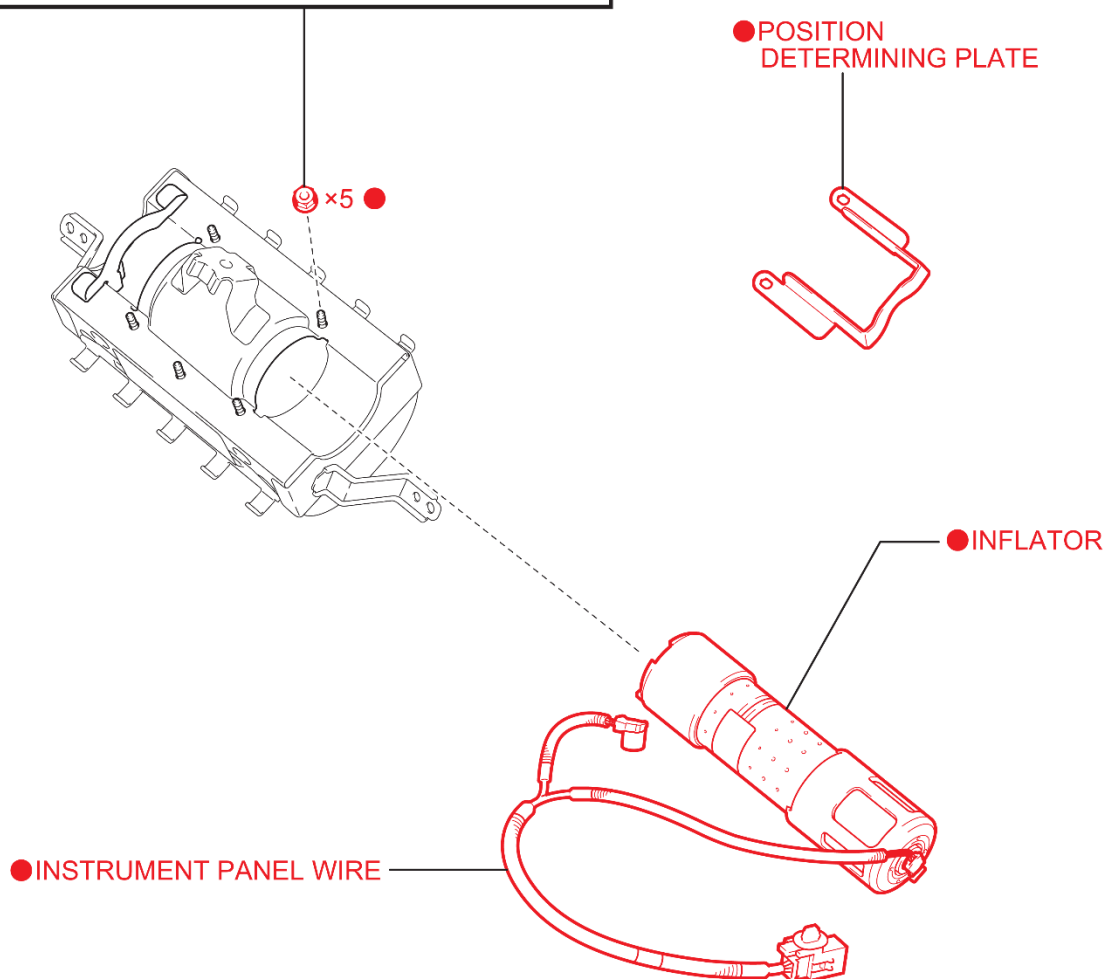
R1707250002

N*m (kgf*cm, ft.*lbf) : Specified torque

3.9 N·m (40, 35 in.*lbf)
Be careful not to
overtighten.

● : Replacement part

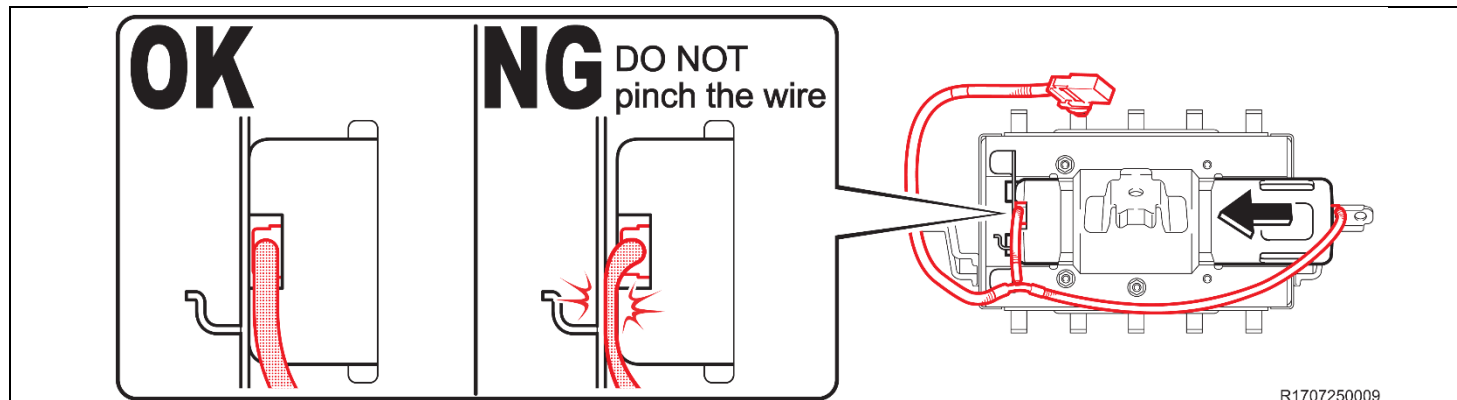
R1707250009

c) Insert the inflator fully as shown in the illustration.

DO NOT pinch instrument panel wire.

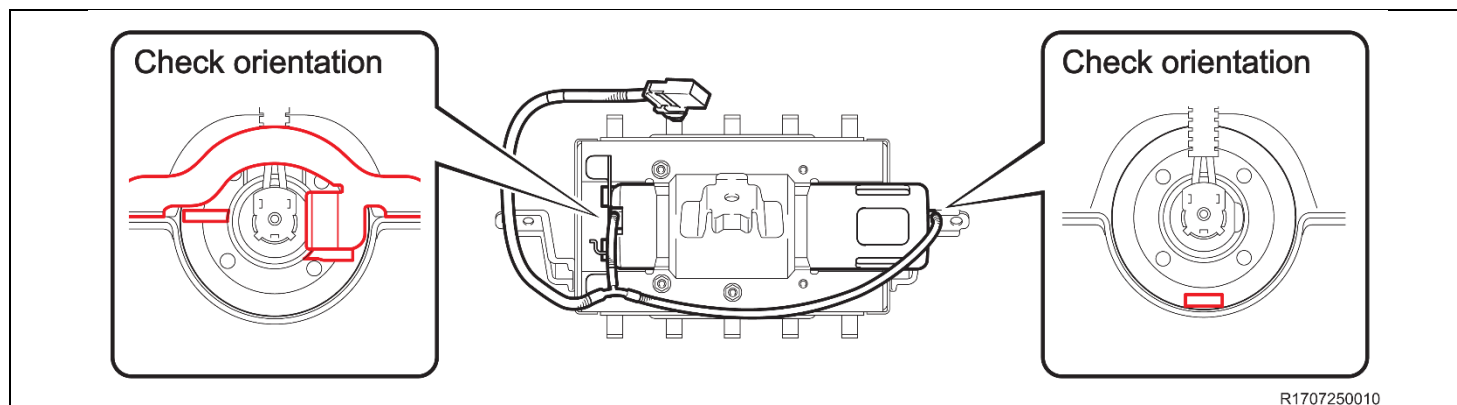
R1707250010

d) Insert the inflator with the correct orientation as shown in the illustration.

- Make sure that the inflator is oriented correctly as shown in the illustration, not upside down.
- If the passenger airbag inflator is upside down, it will not be able to be fully inserted.

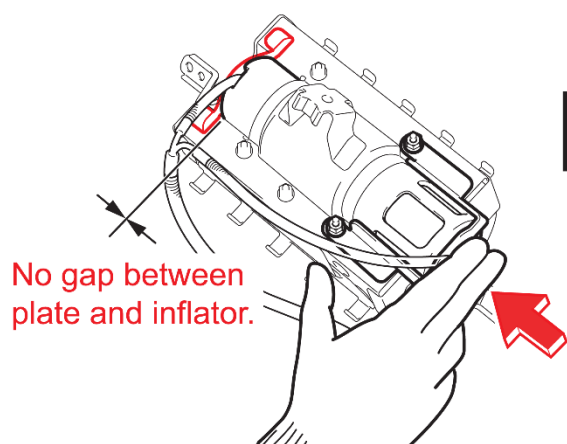
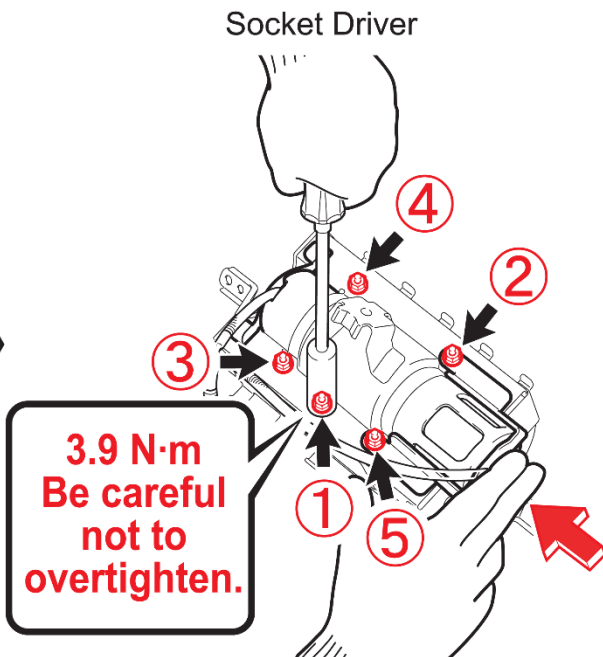
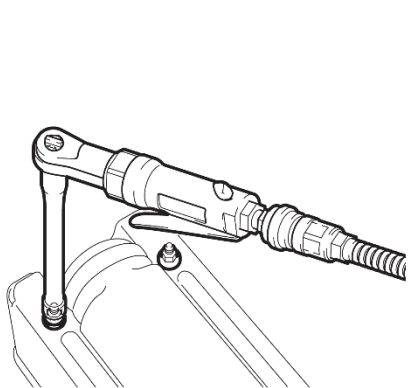
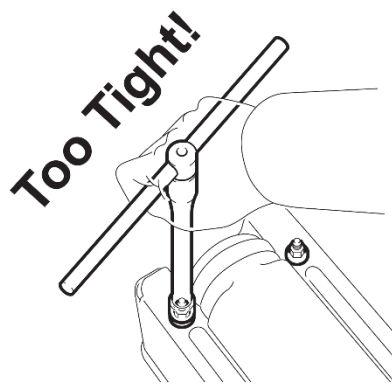
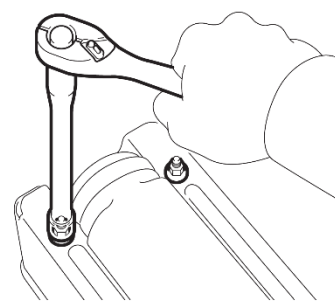
R1707250013

The tightening torque is low (3.9 N·m). Use of an air ratchet wrench or tightening strongly with a T-handle wrench or a ratchet handle may cause deformation of the stud bolt.

Too Tight!

These tools cause overtightening !
