# IMPORTANT UPDATE

## TECHNICAL INSTRUCTIONS FOR SAFETY RECALL G0R FRONT PASSENGER AIRBAG INFLATOR MODULE CERTAIN 2008 - 2010 MY SCION xB

**UPDATED 4-18-2018**

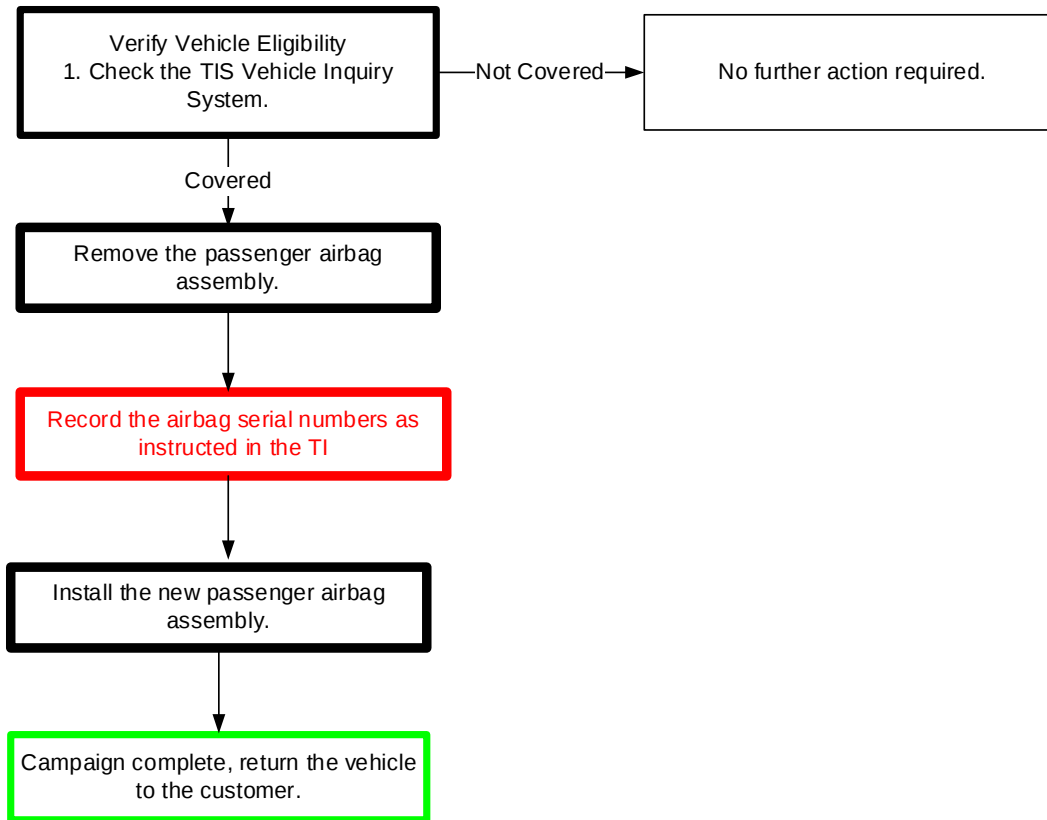
## I. OPERATION FLOW CHART

The flow chart is for reference only. **DO NOT** use it in place of the full technical instructions. Follow **ALL** steps as outlined in the full technical instructions to confirm the campaign is completed correctly.

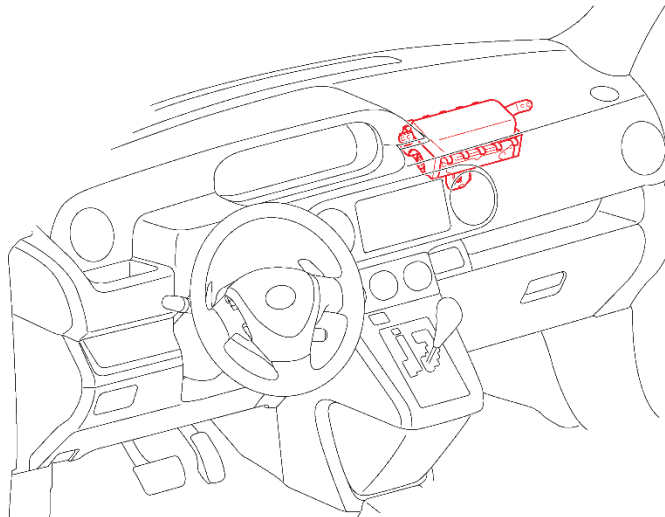
C162294

The subject vehicles are equipped with front passenger airbag inflators produced by Takata. According to Takata, the propellant in these inflators may degrade after prolonged exposure to high absolute humidity and fluctuating high temperatures. Degraded propellant can cause inflator rupture during airbag deployment. In the event of an inflator rupture, metal fragments could pass through the airbag cushion material, striking the vehicle occupants, and result in serious injury or death.

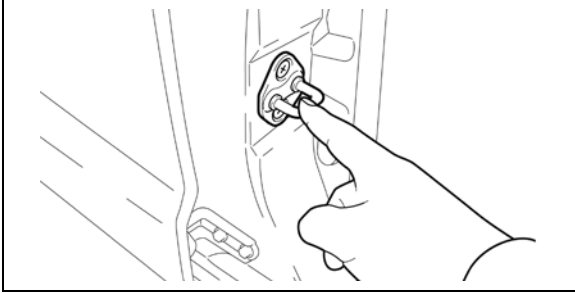
#### 1. ELIMINATE STATIC ELECTRICITY

- a) Before starting work and periodically while working on the vehicle, touch a metallic part of the vehicle to discharge static electricity in the body.

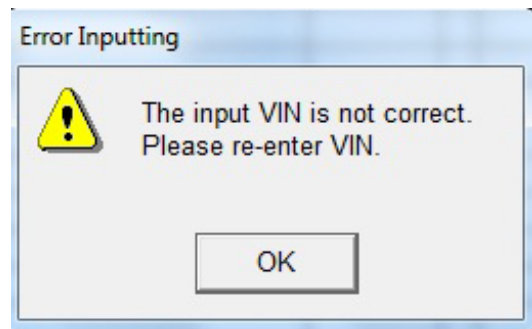
- After the health check has completed, run a diagnostic report by clicking on the link on the health check screen.

**NOTE: If the VIN was not entered in ALL CAPS when Techstream was launched, an error will be displayed and there will be a prompt to reenter the VIN**

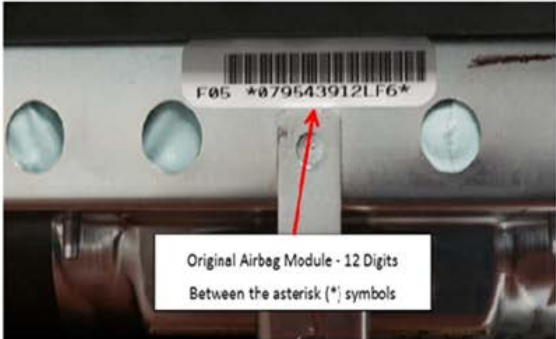
Original Airbag Module - 12 Digits  
Between the asterisk (\*) symbols

Check this box if the label is damaged or missing

a) If the airbag serial number cannot be scanned or is not present check the box as shown below.

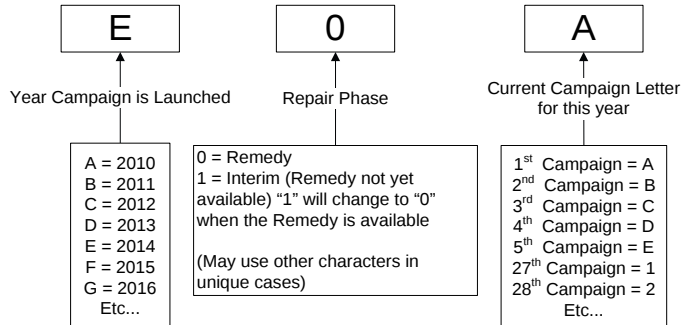
### A. CAMPAIGN DESIGNATION DECODER

Examples:

A0D = Launched in 2010, Remedy Phase, 4<sup>th</sup> Campaign Launched in 2010

B1E = Launched in 2011, Interim Phase, 5<sup>th</sup> Campaign Launched in 2011

C1C = Launched in 2012, Interim Phase, 3<sup>rd</sup> Campaign Launched in 2012
