**TECHNICAL INSTRUCTIONS  
FOR  
SAFETY RECALL G0R  
FRONT PASSENGER AIRBAG INFLATOR MODULE  
CERTAIN 2009-2010 MODEL YEAR COROLLA**

**Updated 1-9-18**

**- Added 2010 MY**

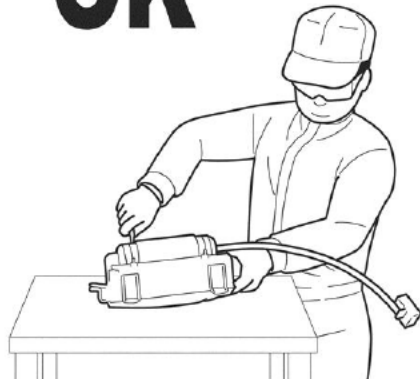
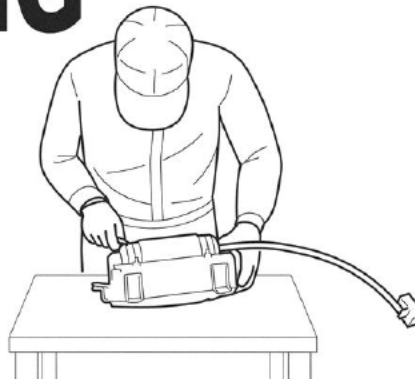
a) Carefully place the airbag on the bench inflator side up.

**NOTE: Place clean sheet(s) of paper on the bench to protect the airbag.**

b) Avoid standing directly over the inflator.
