TECHNICAL INSTRUCTIONS
FOR
SAFETY RECALL G0R
FRONT PASSENGER AIRBAG INFLATOR MODULE
CERTAIN 2008 - 2009 MY SCION xB

II. BACKGROUND

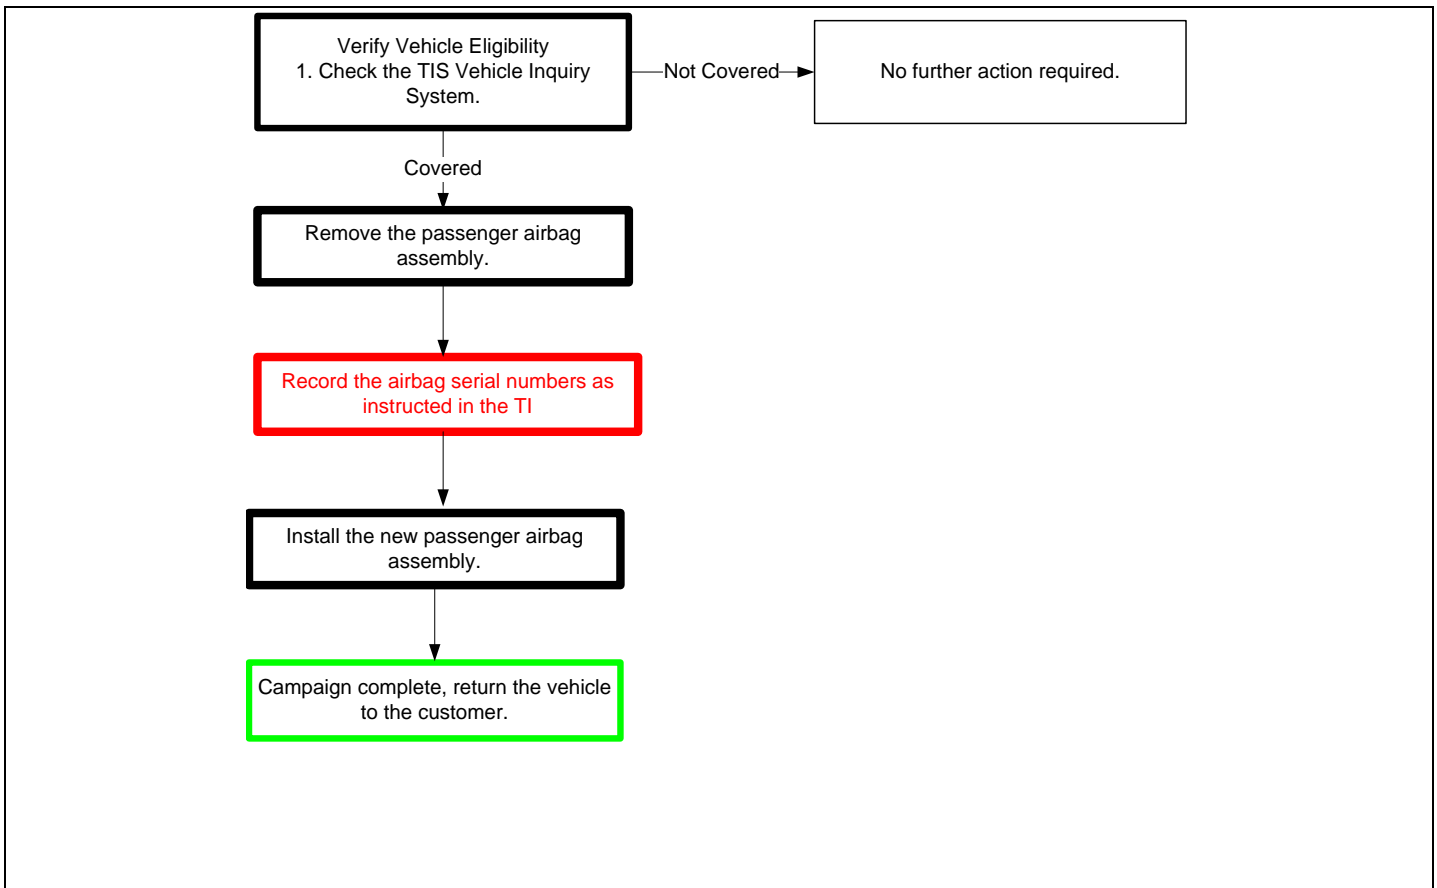
I. OPERATION FLOW CHART

The flow chart is for reference only. **DO NOT** use it in place of the full technical instructions. Follow **ALL** steps as outlined in the full technical instructions to confirm the campaign is completed correctly.

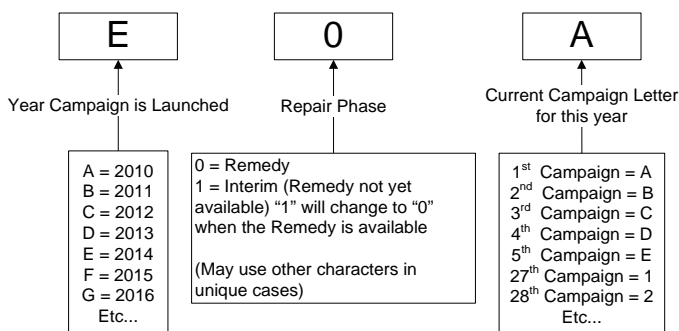
A. CAMPAIGN DESIGNATION DECODER

Examples:

A0D = Launched in 2010, Remedy Phase, 4th Campaign Launched in 2010

B1E = Launched in 2011, Interim Phase, 5th Campaign Launched in 2011

C1C = Launched in 2012, Interim Phase, 3rd Campaign Launched in 2012
