# IMPORTANT UPDATE

## TECHNICAL INSTRUCTIONS FOR SAFETY RECALL G0P FRONT PASSENGER AIRBAG INFLATOR MODULE CERTAIN 2009 –2013 MODEL YEAR MATRIX

**Updated 7-17-18**

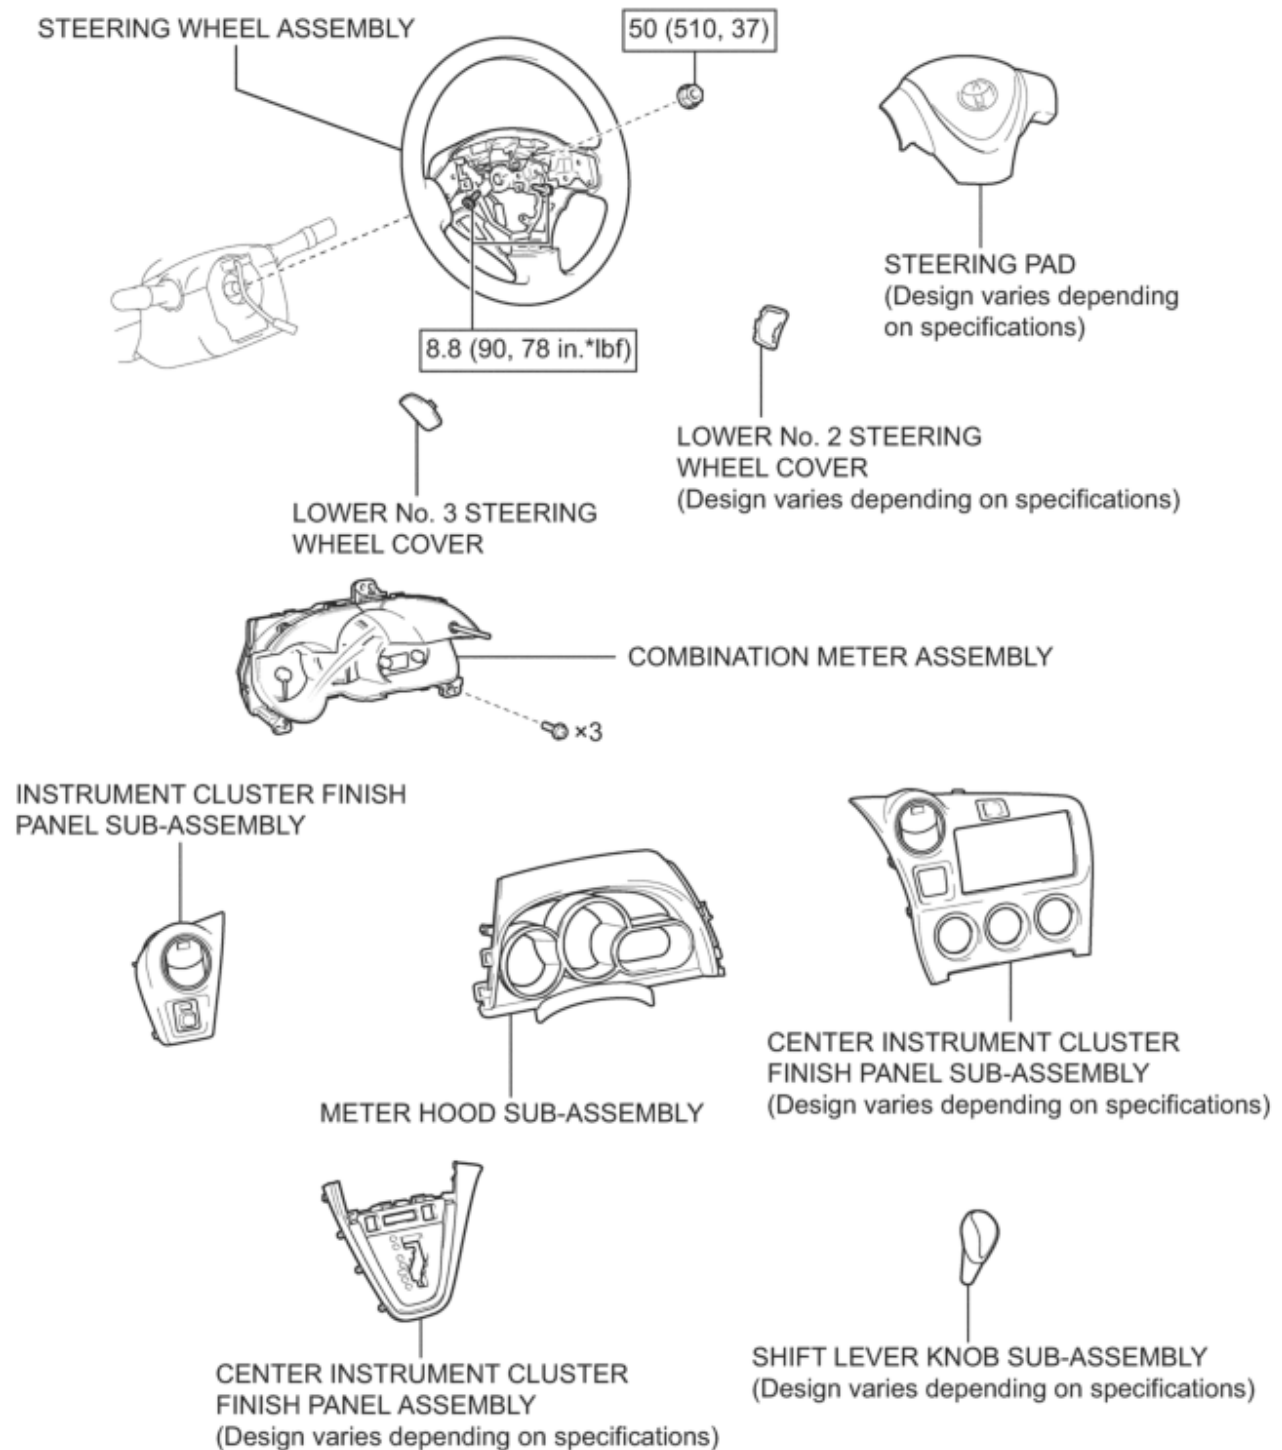
R1703010002

N\*m (kgf\*cm, ft\*lbf) : Specified torque

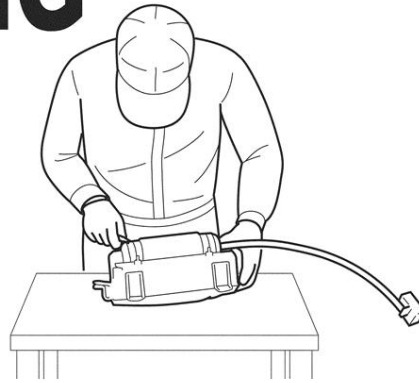
R1301230008E

- Carefully place the airbag on the bench inflator side up.

**NOTE: Place clean sheet(s) of paper on the bench to protect the airbag.**

- Avoid standing directly over the inflator.

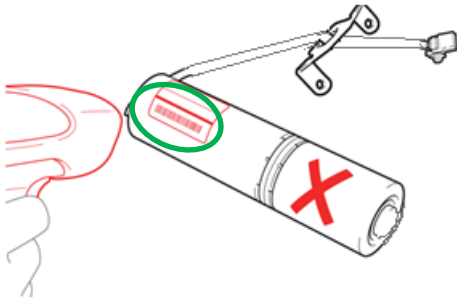
### Step a) Old Inflator (bar code)

- Scan the **OLD** inflator bar code.
- Scan the **NEW** inflator QR code.

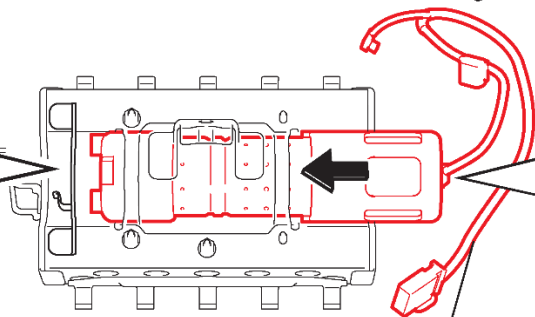
R1702270040

a) Carefully slide the new inflator into the airbag assembly and align as shown.

- DO NOT** connect the inflator harness at this time. It is **CRITICAL** to first confirm that the inflator is installed in the correct position before connecting the harness.

**DO NOT insert fully.**

Check orientation

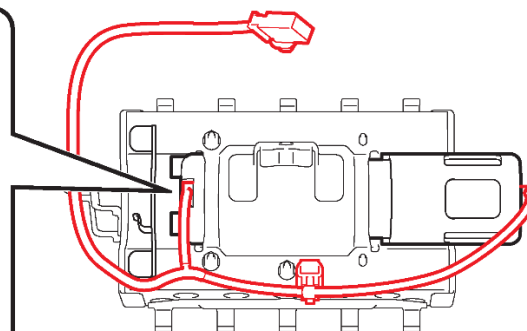
R1702270041

b) Connect the connector to the inflator and ensure that the connector lock is fully engaged as shown.

c) Route and secure the wire harness as shown.

**ALIGN CONNECTORS**

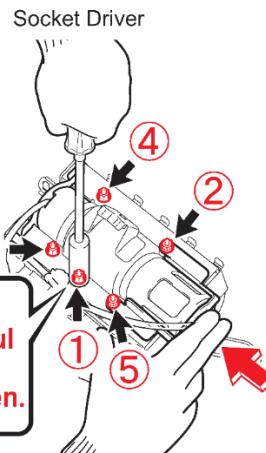
R1702270046

- a) Tighten the 5 nuts evenly in several increments in the sequence shown. Use a socket driver or torque wrench to tighten the nuts.

Torque: 35in. lbf (3.9N·m)

- There will be some resistance when tightening the nuts because they are self-locking, confirm the nuts are tightened correctly.
- **DO NOT** use a power tool, T-handle, or ratchet when tightening the nuts to avoid over torqueing and deforming the studs.
- You may need to turn the airbag to the left or right with in the mounting bracket to access the center nut.

3.9 N·m  
Be careful  
not to  
overtighten.

**These tools cause overtightening !**

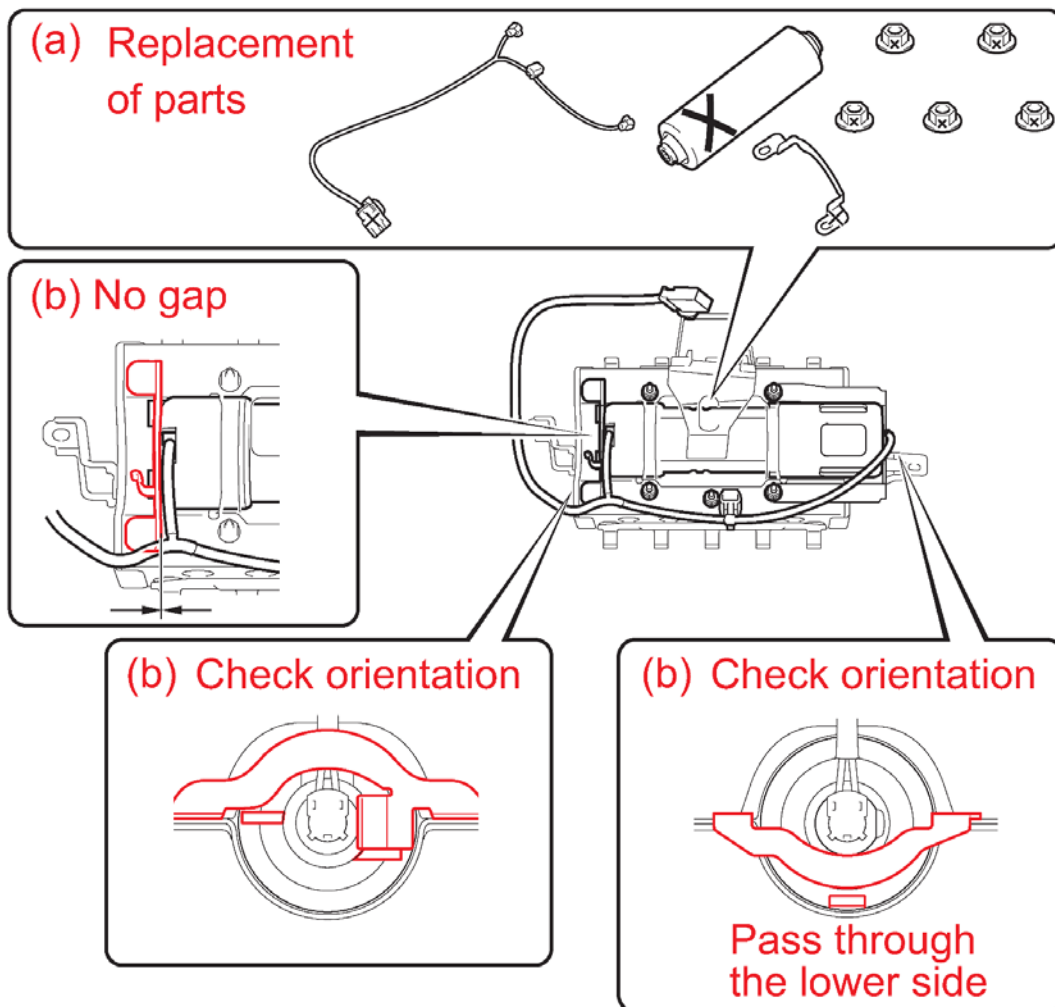
R1703080022

- a) Confirm the **NEW** inflator and 5 **NEW** nuts have been installed.
- b) Confirm the position of the inflator and position determining plates are correct.
- c) Confirm the routing of the inflator wire harness.
