TECHNICAL INSTRUCTIONS FOR SAFETY RECALL H0A FRONT PASSENGER AIRBAG INFLATOR CERTAIN 2008 - 2009 MY SCION xB

UPDATED 1-9-18

**Update 1-9-18
- Added 2009 MY**

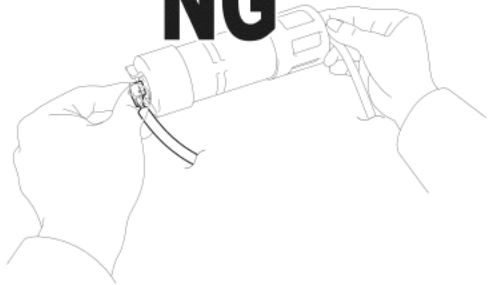
R170128000

DO NOT CONNECT PREMATURELY
CANNOT DISCONNECTED

NG

1. **IMPORTANT NOTICE WHEN CONNECTING INSTRUMENT PANEL WIRE CONNECTOR TO AIRBAG INFLATOR**
 - a) Once connected, the instrument panel wire connector cannot be disconnected from the airbag inflator. If the instrument panel wire connector is incorrectly connected to the inflator, replace the instrument panel wire and inflator with new ones.

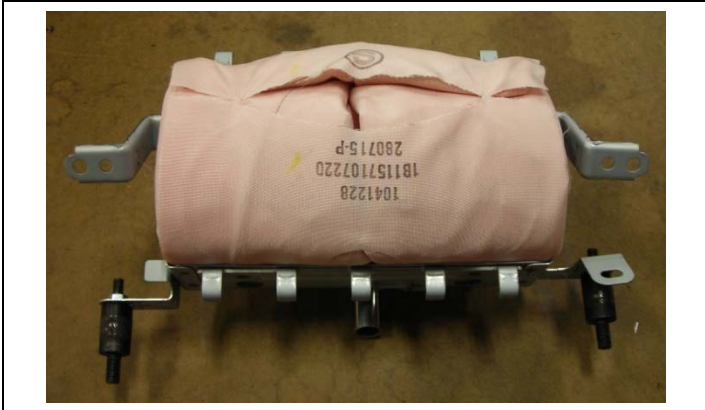
- a) Mark the 5 self locking nuts to prevent reuse.

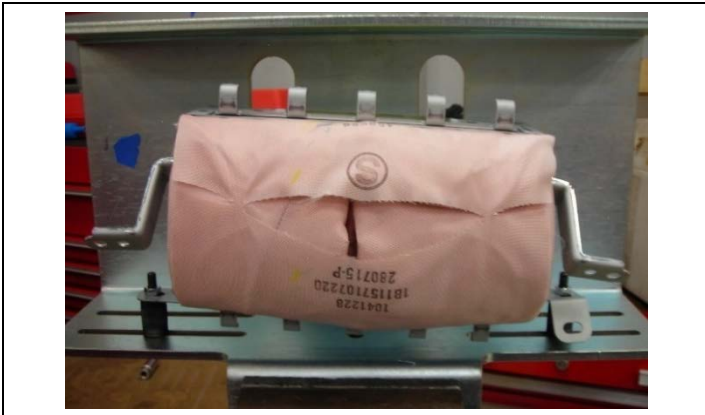
- a) Mount the adaptors (579943-3R3) to the airbag as shown.

NOTE: The 6mm stud mounts to the airbag.

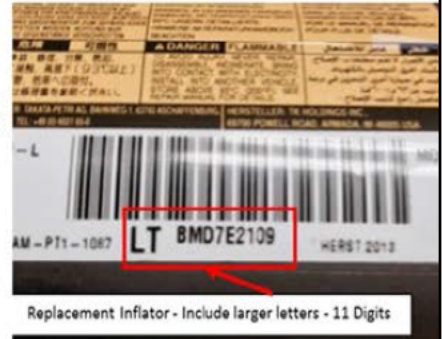
The first two characters of the Replacement Inflator Serial code will be either 'LT' or 'LR'.
