# IMPORTANT UPDATE

## TECHNICAL INSTRUCTIONS FOR SAFETY RECALL G0P FRONT PASSENGER AIRBAG INFLATOR MODULE CERTAIN 2010-2013 MY 4Runner

### UPDATE 4-18-18

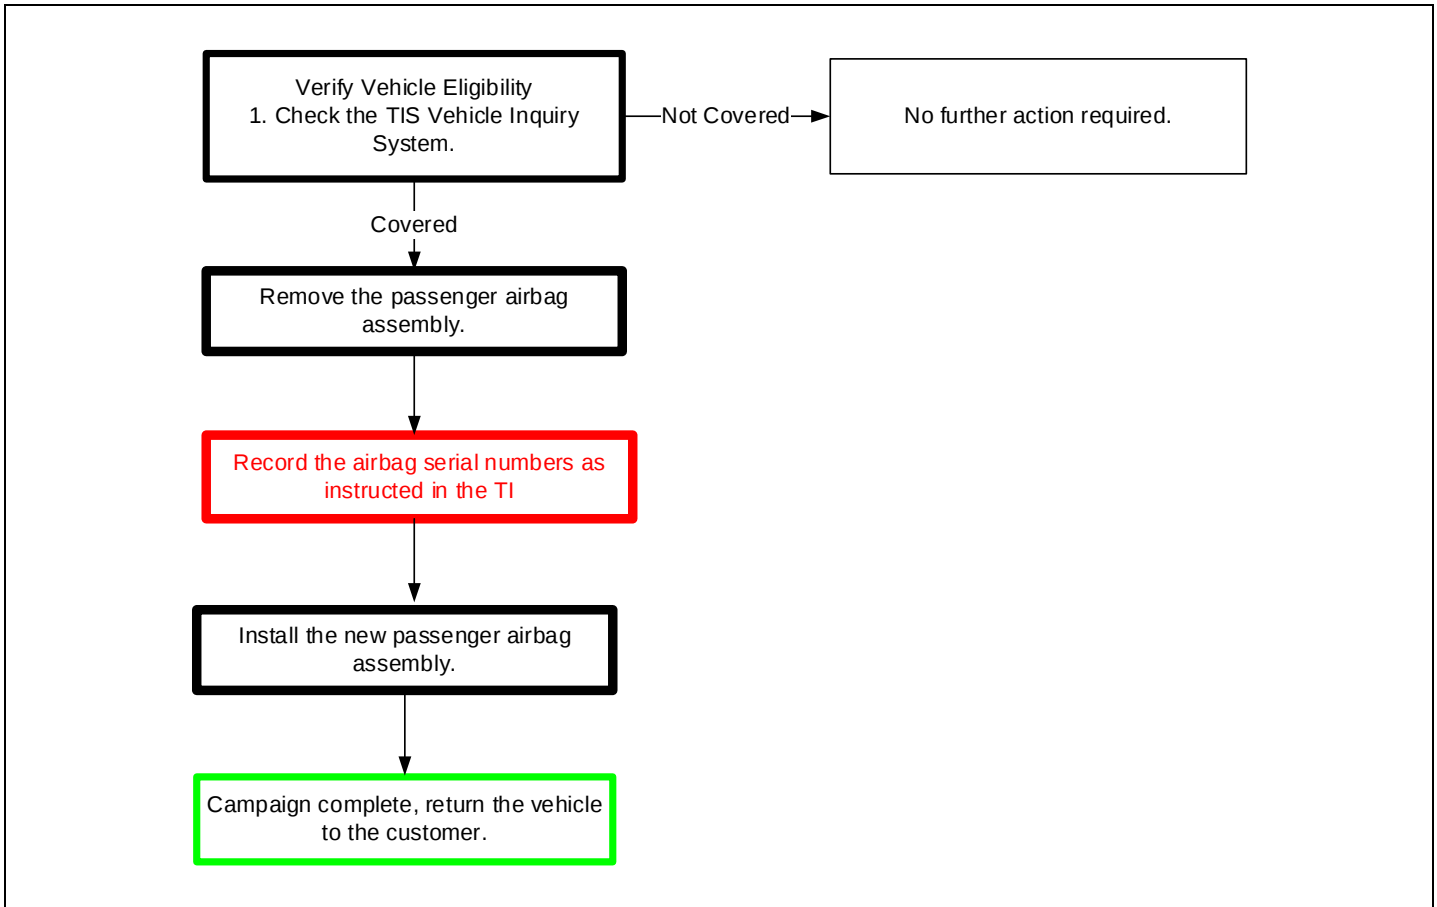
## I. OPERATION FLOW CHART

The flow chart is for reference only. **DO NOT** use it in place of the full technical instructions. Follow **ALL** steps as outlined in the full technical instructions to confirm the campaign is completed correctly.

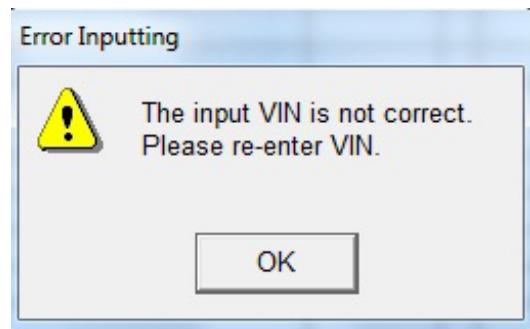
- After the health check has completed, run a diagnostic report by clicking on the link on the health check screen.

**NOTE: If the VIN was not entered in ALL CAPS when Techstream was launched, an error will be displayed and there will be a prompt to reenter the VIN**

- Enter the vehicle mileage and repair order information, then click the 'report' button.

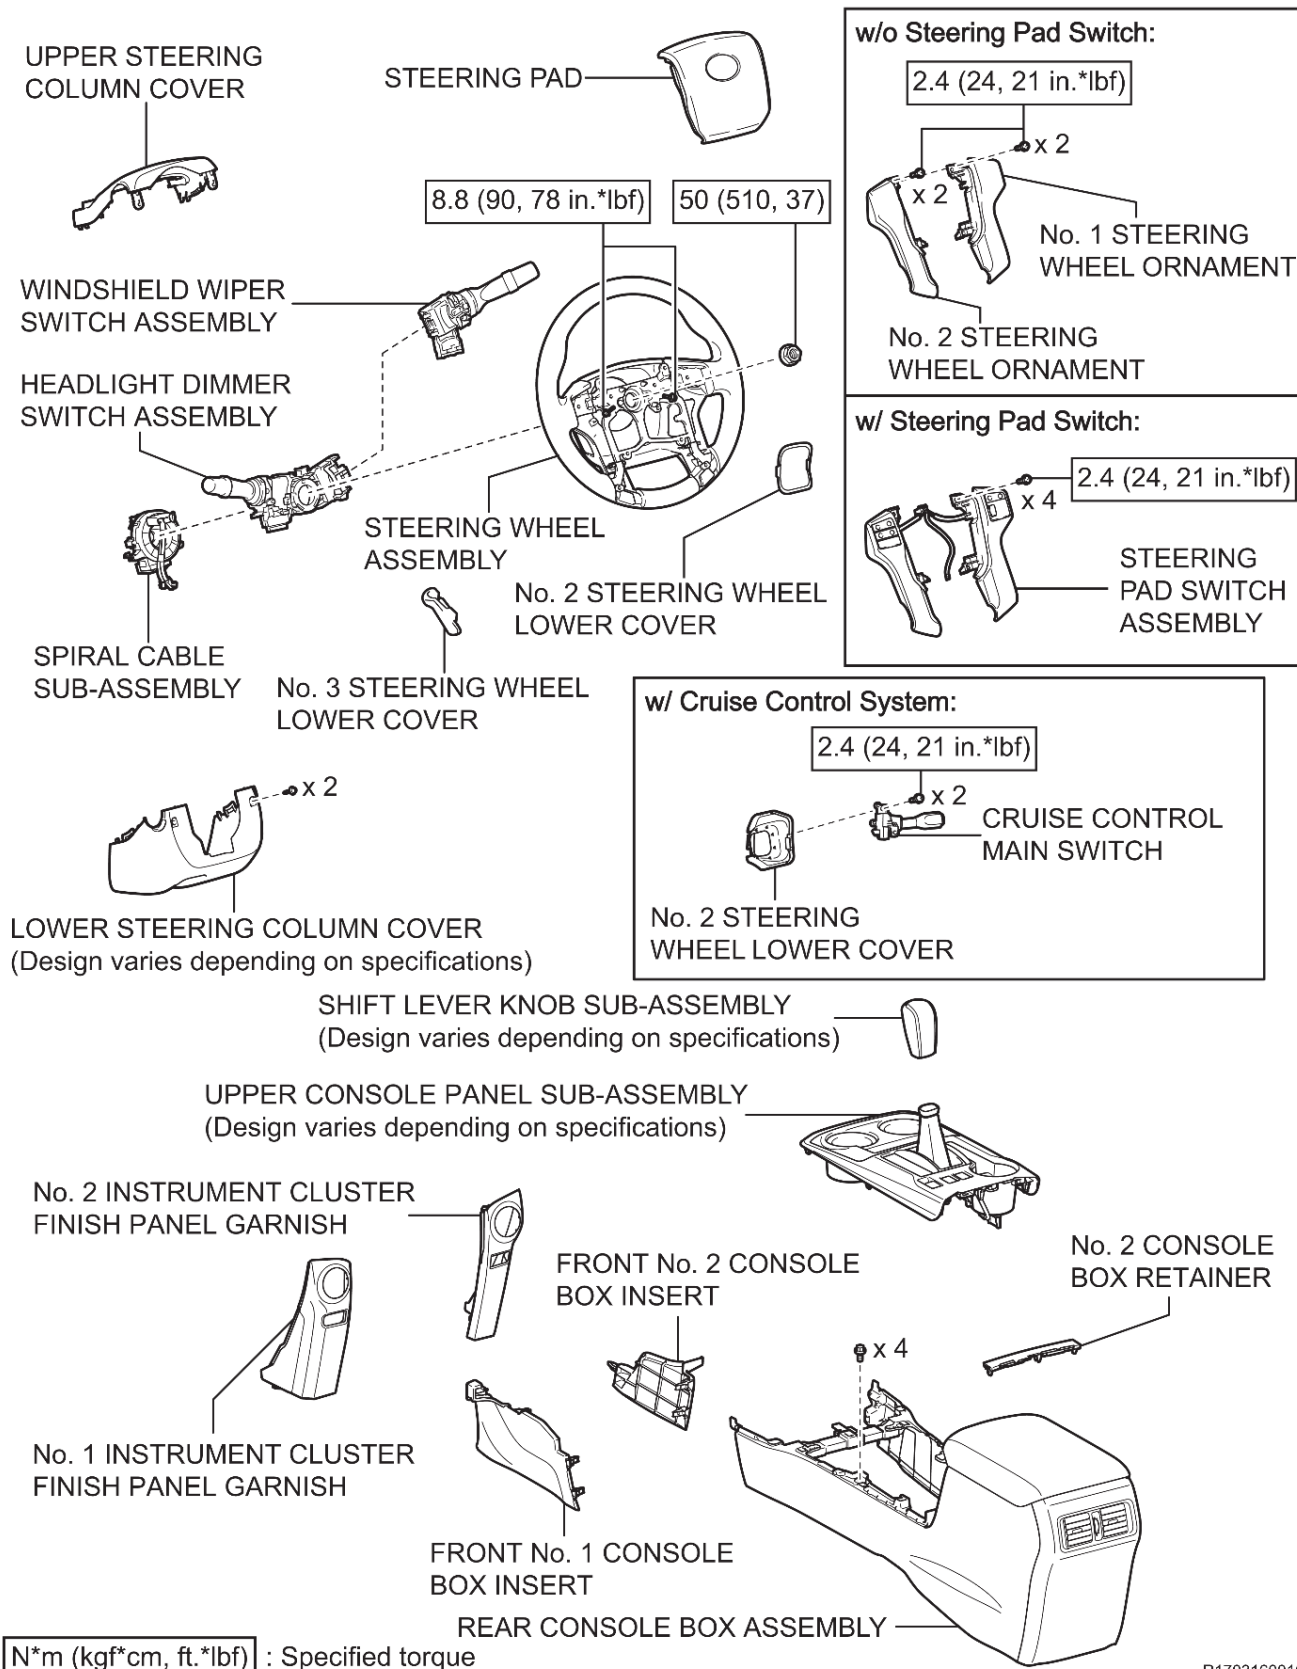
R1703160010

**CAUTION-PLASTIC RETAINING CLIPS ARE FRAGILE. REMOVE WITH CARE**

FRONT PILLAR  
GARNISH RH

FRONT DOOR OPENING TRIM  
WEATHERSTRIP RH

COWL SIDE TRIM BOARD RH

DOOR SCUFF PLATE ASSEMBLY RH

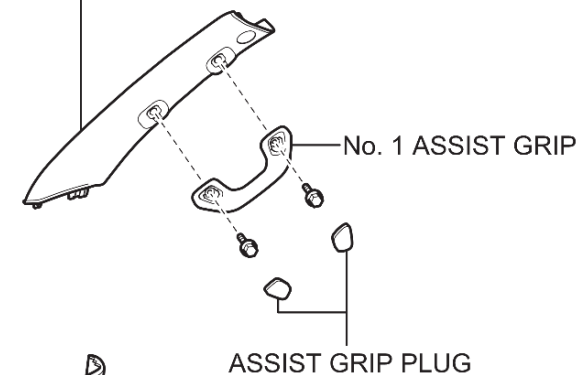
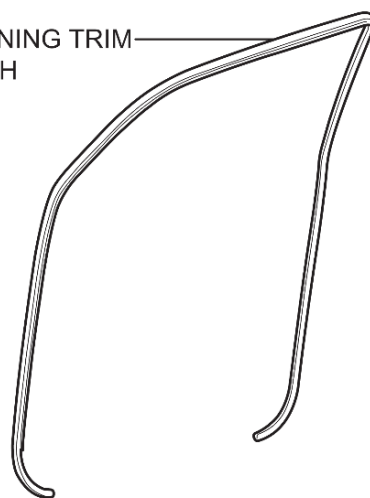
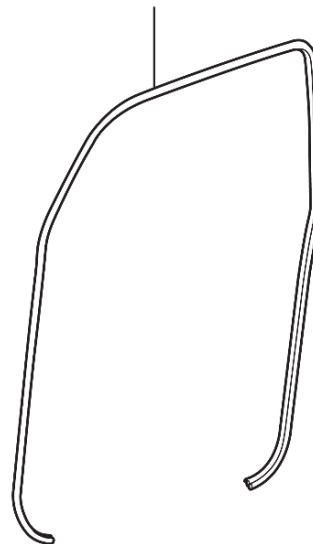
R1703160011

Part manufactured  
before August 2013:

Part manufactured  
after August 2013:

● FRONT PILLAR  
GARNISH LH

No. 1 FRONT PILLAR  
GARNISH COVER LH

FRONT PILLAR  
GARNISH LH

FRONT DOOR OPENING TRIM  
WEATHERSTRIP LH

COWL SIDE TRIM BOARD LH

DOOR SCUFF PLATE ASSEMBLY LH

● Replacement part

**NOTE:** The left front A-Pillar garnish needs to be replaced on vehicles manufactured prior to August 2013. Only one garnish is required per vehicle depending upon color code. The kit contains the garnish and the non-reusable clip. (see parts information)

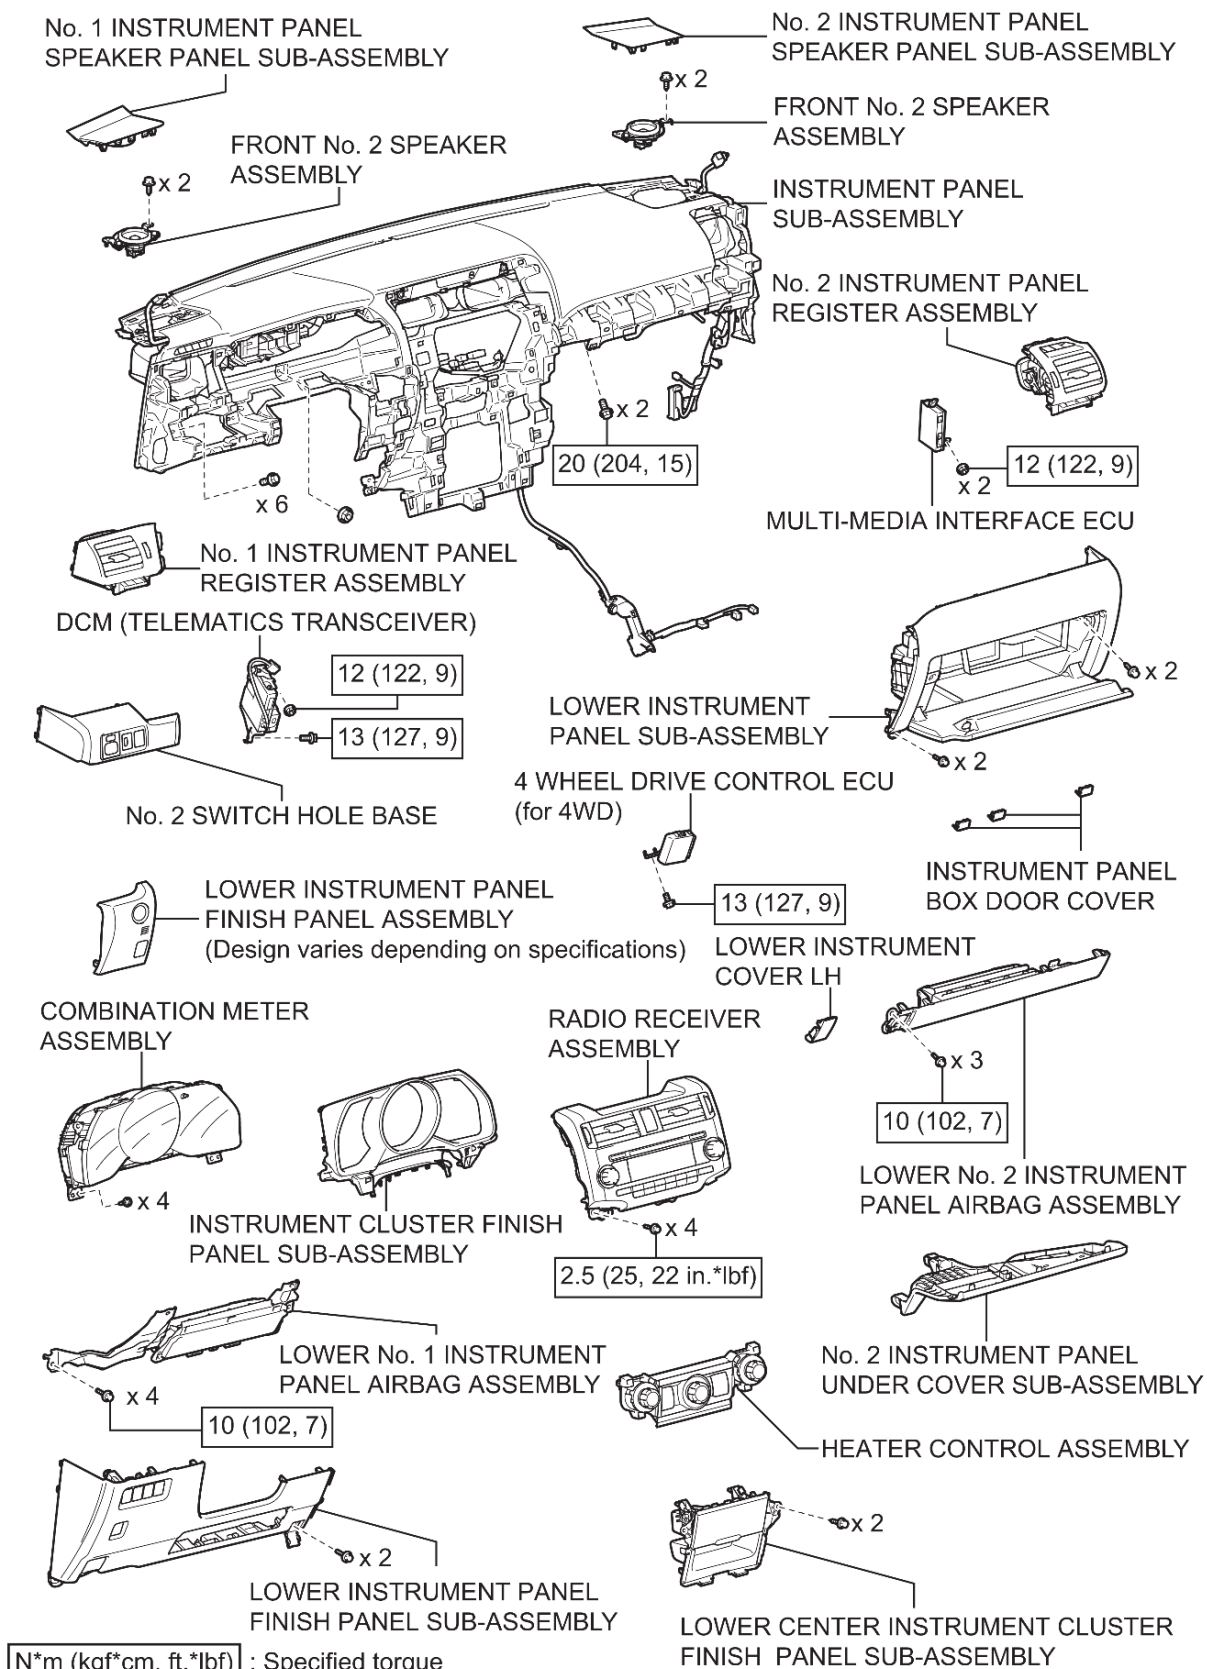
R1703160012

**CAUTION-PLASTIC RETAINING CLIPS ARE FRAGILE. REMOVE WITH CARE**

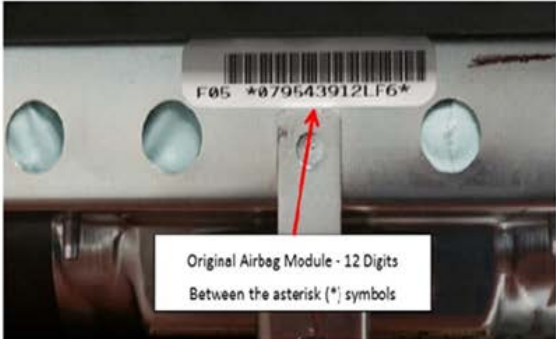
a) If the airbag serial number cannot be scanned or is not present check the box as shown below.

Check this box if the label is damaged or missing

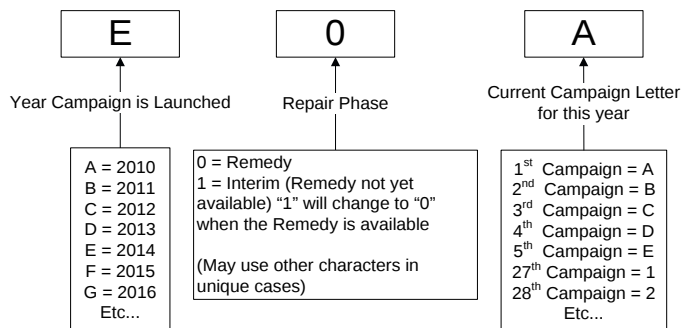
### A. CAMPAIGN DESIGNATION DECODER

Examples:

A0D = Launched in 2010, Remedy Phase, 4<sup>th</sup> Campaign Launched in 2010

B1E = Launched in 2011, Interim Phase, 5<sup>th</sup> Campaign Launched in 2011

C1C = Launched in 2012, Interim Phase, 3<sup>rd</sup> Campaign Launched in 2012
