# IMPORTANT UPDATE

## TECHNICAL INSTRUCTIONS FOR SAFETY RECALL G0R FRONT PASSENGER AIRBAG INFLATOR MODULE CERTAIN 2009-2010 MODEL YEAR MATRIX

**Updated 4-18-18**

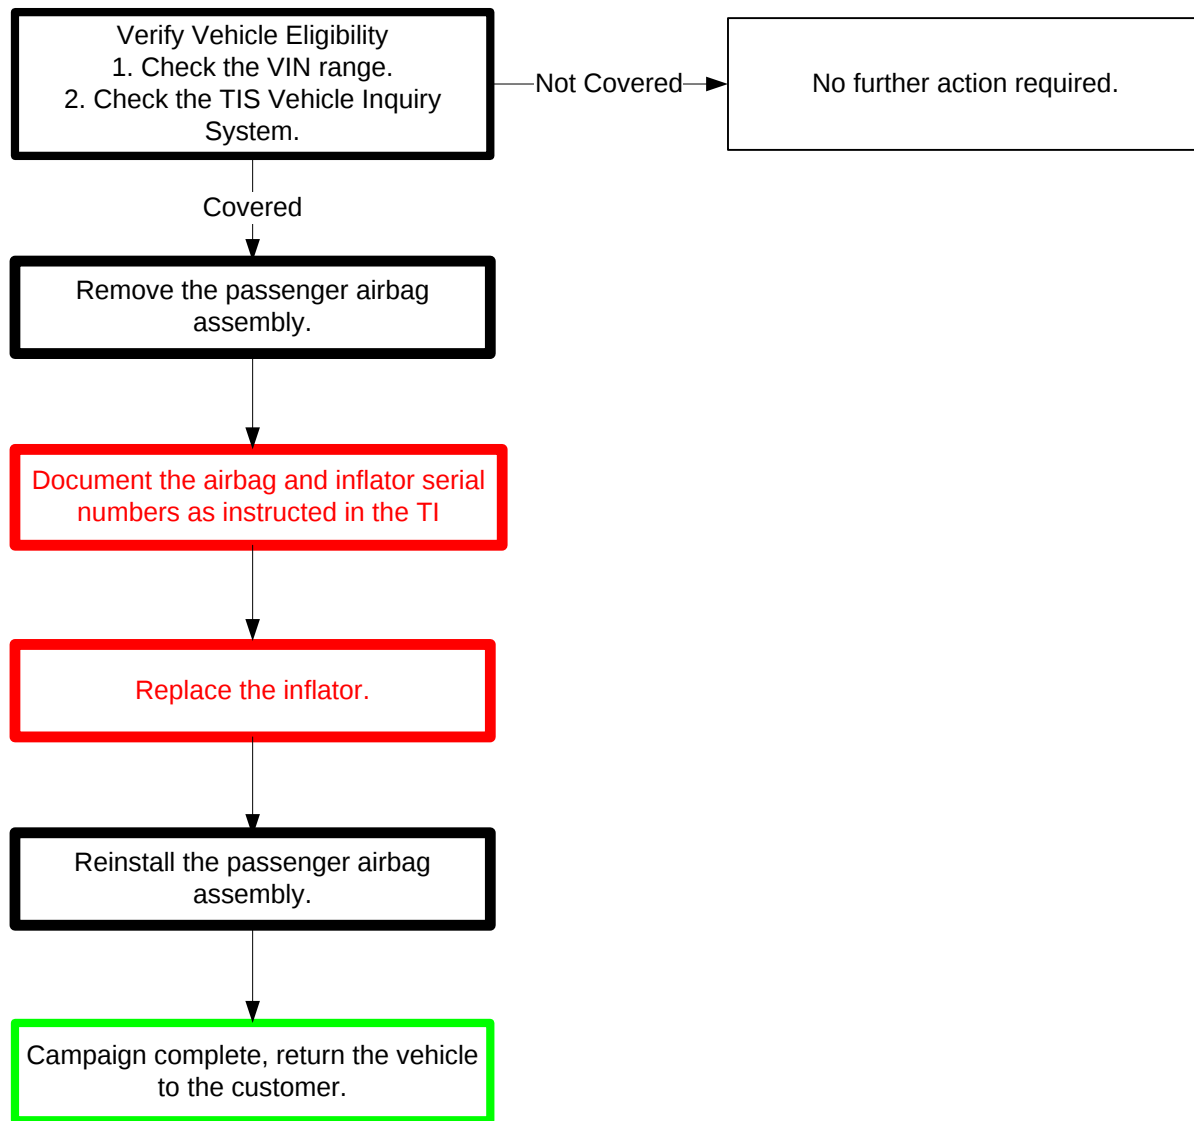
## I. OPERATION FLOW CHART

The flow chart is for reference only. **DO NOT** use it in place of the full technical instructions. Follow **ALL** steps as outlined in the full technical instructions to confirm the campaign is completed correctly.

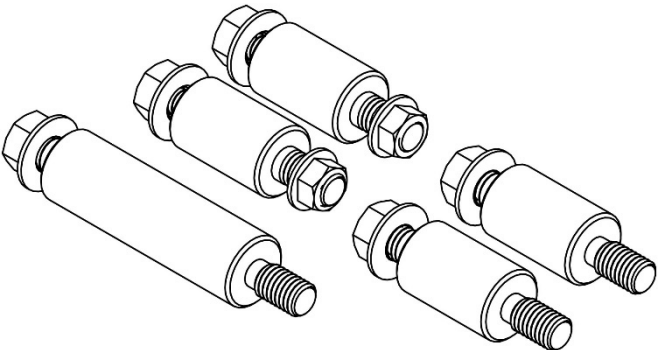
| Image | Name | Quantity |
|---|---|---|
| | Adaptor set* | 1 |

\*The adaptor set was sent to dealers at the start of this campaign.

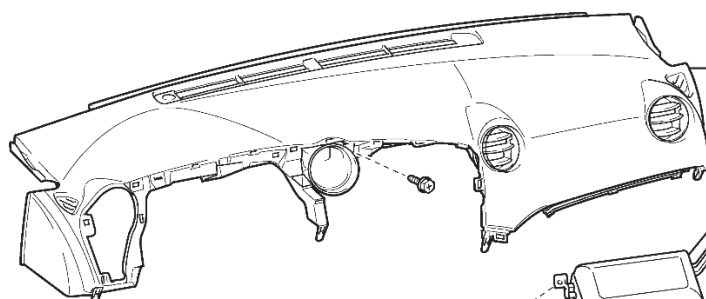
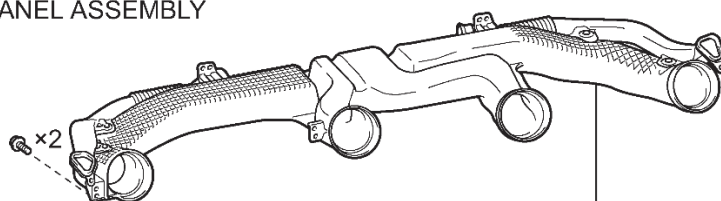
R1703010003

FRONT PILLAR GARNISH LH

FRONT PASSENGER AIRBAG ASSEMBLY

No. 1 INSTRUMENT PANEL BOX DOOR SUB-ASSEMBLY

20 (204, 15)

● : Replacement part

N\*m (kgf\*cm, ft.\*lbf) : Specified torque

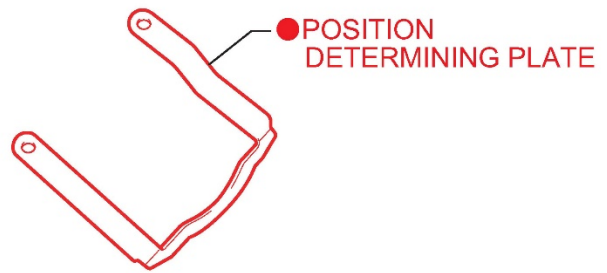
R1702270035

**3.9 N·m (40, 35 in.\*lbf)**  
**Be careful not to**  
**overtighten.**

for MATRIX:

● : Replacement part

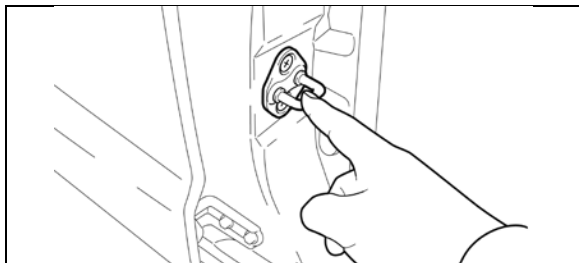
#### 1. ELIMINATE STATIC ELECTRICITY

- Before starting work and periodically while working on the vehicle, touch a metallic part of the vehicle to discharge static electricity in the body.

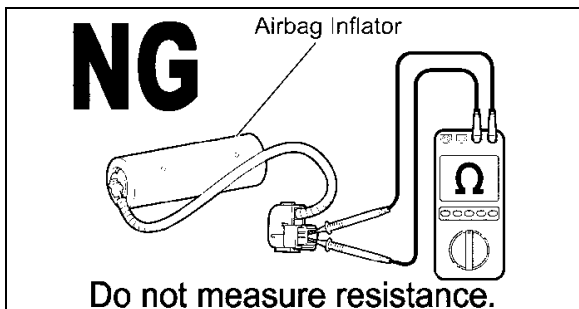
#### 2. DO NOT MEASURE RESISTANCE

- DO NOT** measure resistance of airbag components, this may cause accidental activation.

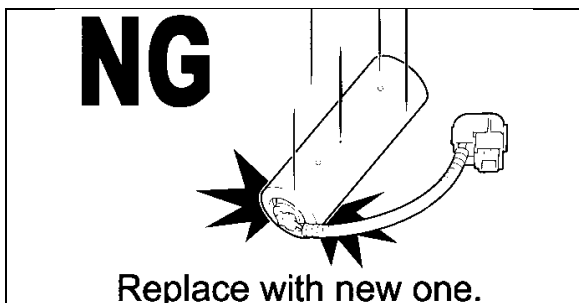
#### 3. HANDLE THE AIRBAG CAREFULLY

- If an inflator is dropped, replace it with a **NEW** inflator.

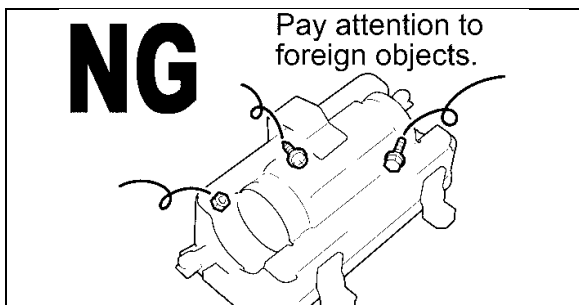
#### 4. DO NOT ALLOW FOREIGN OBJECTS NEAR AIRBAG

- Be sure to collect and account for all removed nuts/bolts to prevent them from landing in the airbag assembly.
- Any foreign objects in the airbag assembly may cause damage or injury if the airbag is activated.

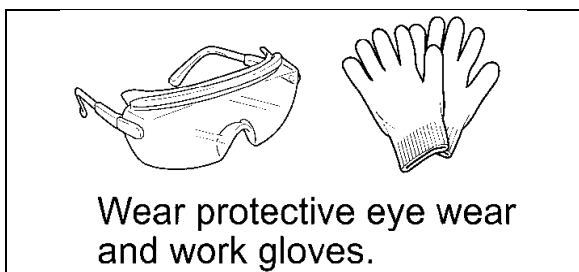
#### 5. WEAR PROTECTIVE EQUIPMENT

- Always wear appropriate protective equipment when working on the SRS.

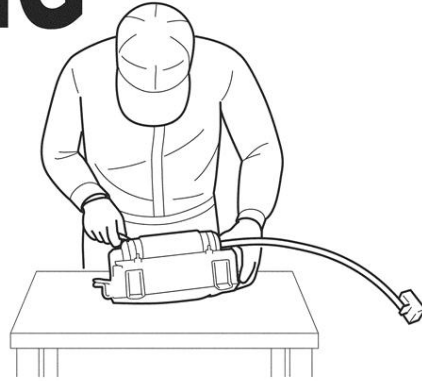
R1301230008E

- Carefully place the airbag on the bench inflator side up.

**NOTE: Place clean sheet(s) of paper on the bench to protect the airbag.**

- Avoid standing directly over the inflator.

# OK

# NG

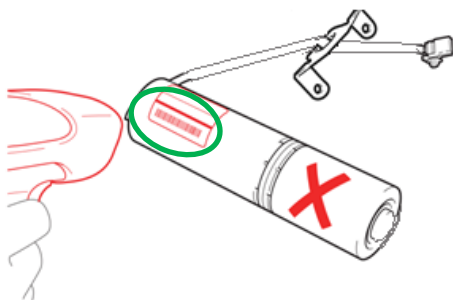
### Step a) Old Inflator (bar code)

- Scan the **OLD** inflator bar code.
- Scan the **NEW** inflator QR code.

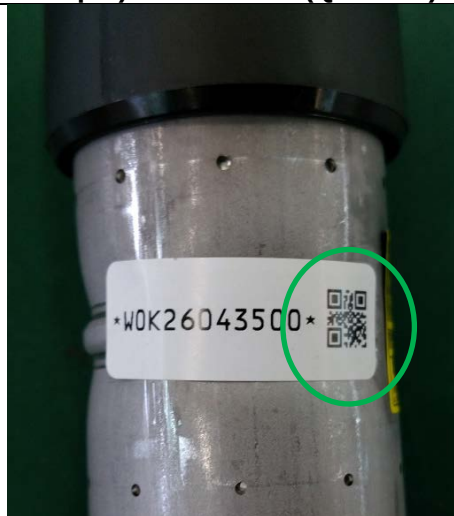
### Step b) New Inflator (QR code)

- Discard the positioning determination plate included with the new inflator. It is for Corolla only. The Matrix requires an additional bracket kit see the parts section for details

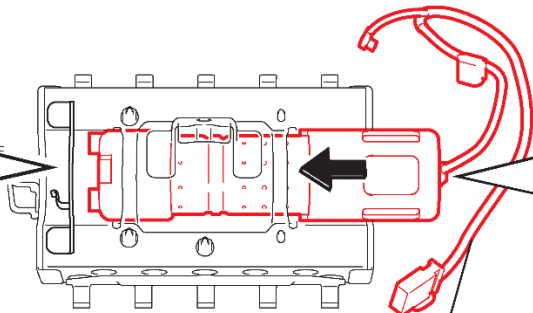
R1702270040

- a) Carefully slide the new inflator into the airbag assembly and align as shown.

- DO NOT** connect the inflator harness at this time. It is **CRITICAL** to first confirm that the inflator is installed in the correct position before connecting the harness.

**DO NOT** insert fully.

Check orientation

Upper side

Bottom

Instrument panel wire

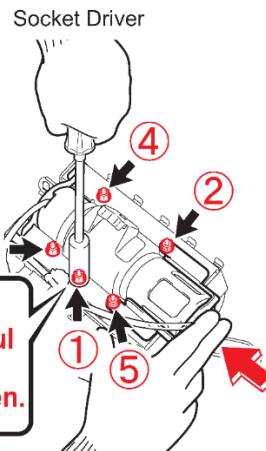
- a) Tighten the 5 nuts evenly in several increments in the sequence shown. Use a socket driver or torque wrench to tighten the nuts.

Torque: 35in. lbf (3.9N·m)

- There will be some resistance when tightening the nuts because they are self-locking, confirm the nuts are tightened correctly.
- **DO NOT** use a power tool, T-handle, or ratchet when tightening the nuts to avoid overtorqueing and deforming the studs.
- You may need to turn the airbag to the left or right with in the mounting bracket to access the center nut.

**OK**

3.9 N·m  
Be careful  
not to  
overtighten.

**NG**

**Too Tight!**

**These tools cause overtightening !**
