# TECHNICAL INSTRUCTIONS FOR SAFETY RECALL G0P FRONT PASSENGER AIRBAG INFLATOR MODULE CERTAIN 2011-2013 MODEL YEAR SIENNA

**Updated 1-9-18**

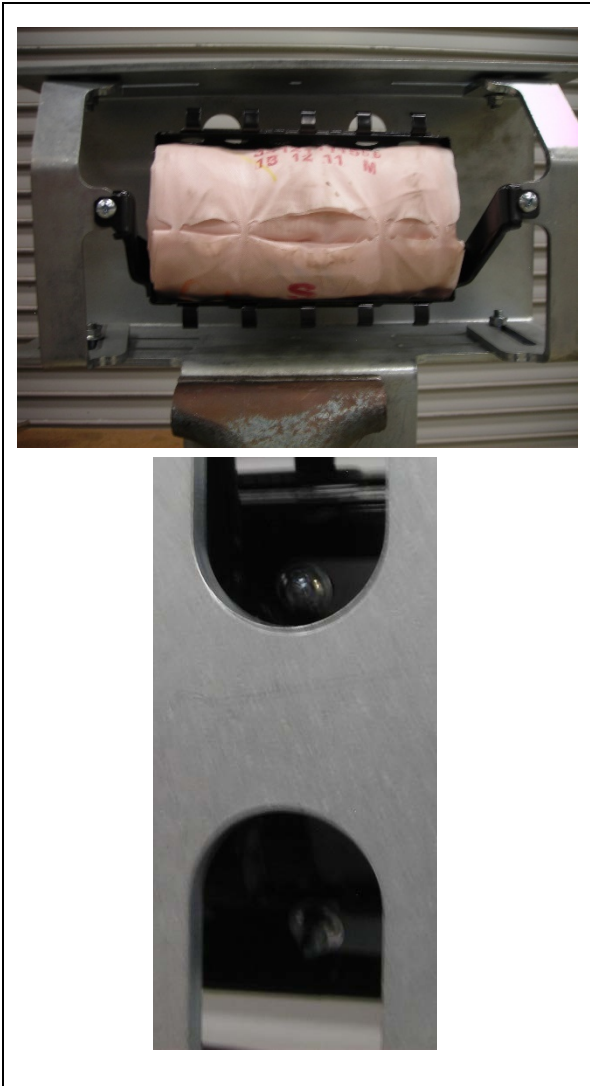
e) Mark all 5 nuts so they will not be reused.

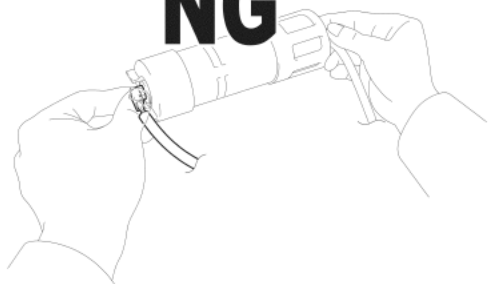
R17028000

- **DO NOT** connect the inflator harness at this time. It is **CRITICAL** to first confirm that the inflator is installed in the correct position before connecting the harness.

DO NOT CONNECT PREMATURELY  
CANNOT DISCONNECTED

**NG**

**NOTE:** Once connected the inflator harness cannot be disconnected without damaging the connector, and would require that the inflator and harness be replaced.
