## TECHNICAL INSTRUCTIONS FOR SAFETY RECALL G0P FRONT PASSENGER AIRBAG INFLATOR CERTAIN 2008 – 2013 MY SCION xB

**Updated 7-17-2018**

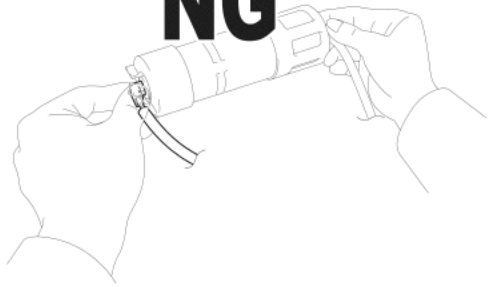
R170128000

DO NOT CONNECT PREMATURELY  
CANNOT DISCONNECTED

**NG**

1. **IMPORTANT NOTICE WHEN CONNECTING INSTRUMENT PANEL WIRE CONNECTOR TO AIRBAG INFLATOR**
  - a) Once connected, the instrument panel wire connector cannot be disconnected from the airbag inflator. If the instrument panel wire connector is incorrectly connected to the inflator, replace the instrument panel wire and inflator with new ones.

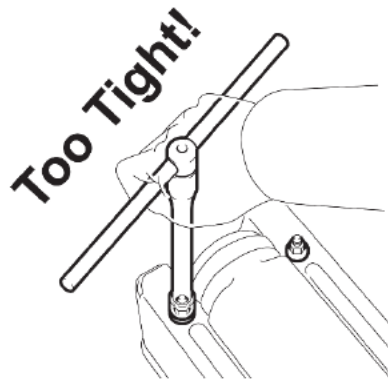
R1707250013

**The tightening torque is low (3.9 N·m). Use of an air ratchet wrench or tightening strongly with a T-handle wrench or a ratchet handle may cause deformation of the stud bolt.**

**OK**

**Too Tight!**

**These tools cause overtightening !**
