**PRODUCT CAMPAIGN BULLETIN**

**APPLICABILITY:** 2005-2006 model year Baja  
 2009-2012 model year Legacy  
 2009-2012 model year Outback  
 2009-2012 model year Forester  
 2006-2012 model year Tribeca  
 2006-2011 model year Impreza (including WRX and STI)  
 2012 model year WRX and STI

**NUMBERS:** TKA-17R  
 TKB-17R  
 TKC-17R

**SUBJECT:** Takata Front Passenger Airbag Inflator Replacement

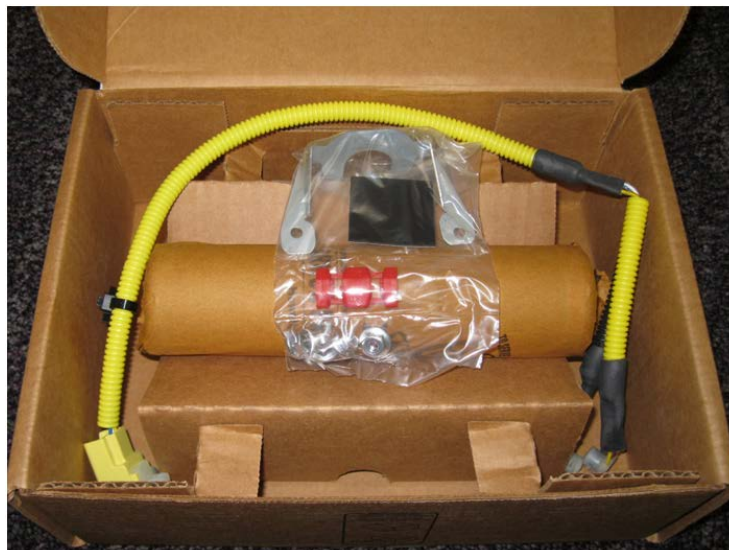
- 4 Self-Locking nuts
- New Inflator (yellow tape applied to one end to identify it as the replacement part)
- New Inflator Harness
- Electro-Tap (red shorting crimp connector)
- New Stopper Plate with D-Shaped hole
- Self-Adhesive Foam Protector
- Shipping Documentation

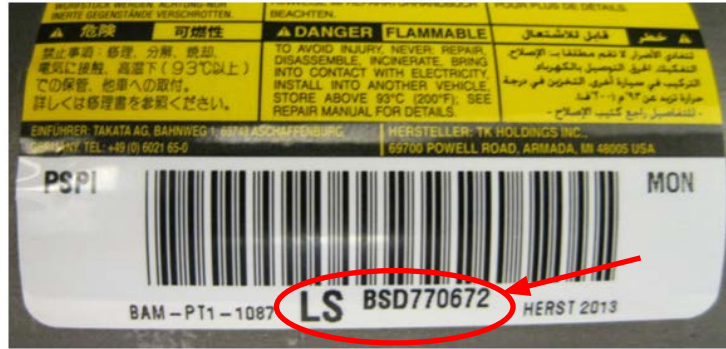
**STEP 7 - VERY IMPORTANT:** Record the **11-digit alpha-numeric serial number** for **both the new and the removed inflators** on the hard copy of the Repair Order. This information will be required for completion of the Part Return Notice which will be forwarded by the retailer to the PCC.

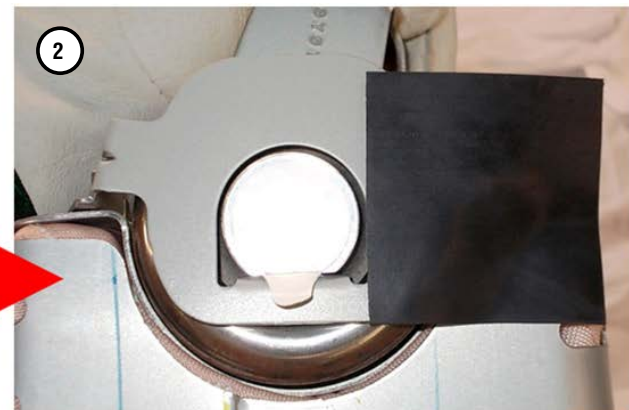
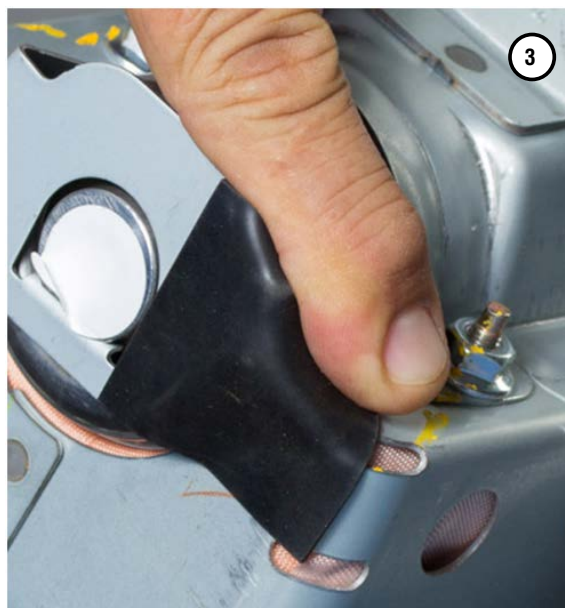
**STEP 10-** Install the black foam self-adhesive protector onto the D-Shaped stopper and mounting bracket positioned as shown in the photo sequence below. Once adhered in place on the new stopper plate, fold over the excess as shown. Always make sure the placement area for the protector is free of any grease or dirt before application.

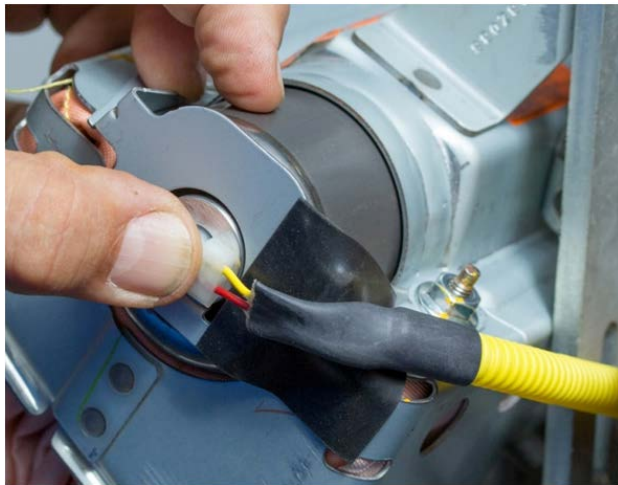
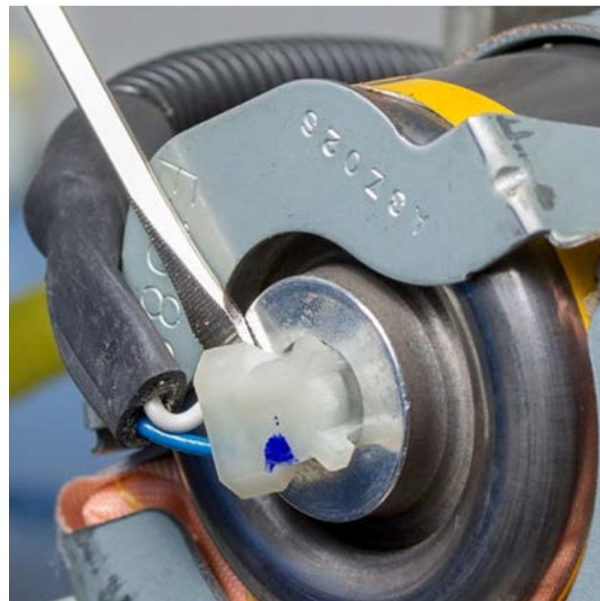
**STEP 11-** The new inflator wiring harness has 2 “sides” with round 2-pin connectors on both ends. The side with the yellow corrugated tube and red / yellow wires will connect to the end of the inflator with the D-Shaped wiring harness connector boss, new stopper plate and foam protector as shown below. Peel off the white dust cover from the D-Shaped end of the inflator **ONLY**. **IMPORTANT: NEVER PEEL BOTH THE WHITE DUST COVERS OFF AT THE SAME TIME!** CAREFULLY align the pins with the female terminals of the harness connector (red / yellow wires) as shown in the photos below. Once pin alignment is confirmed, push down firmly to engage the connector’s 3 locking tangs into the locking groove inside the connector boss. Confirm the connector is locked by prying up **LIGHTLY** with a small flat-blade screwdriver. Repeat the procedure on the opposite end with the blue / white wires.

**VERY IMPORTANT: When connecting the new harness to the inflator, both sides of the harness MUST be routed toward the module’s mounting brackets as shown in the photos below.**

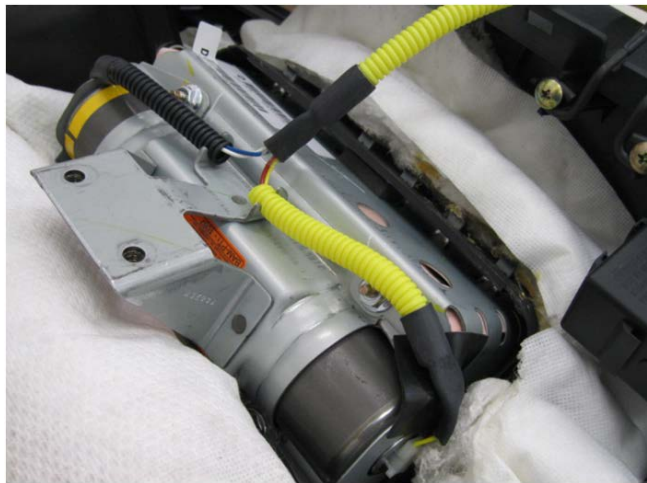
**STEP 13- CAREFULLY** reinstall the airbag module assembly into the instrument panel as shown below.

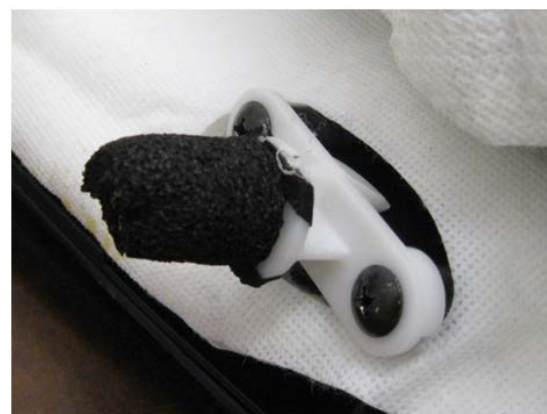
**STEP 14-** To eliminate a possible source of a rattling sound from the dash, wrap the 2 hooks and locator pin with non-woven material, p.n. SOA963W110 (or an equivalent self-adhesive foam) as shown below.

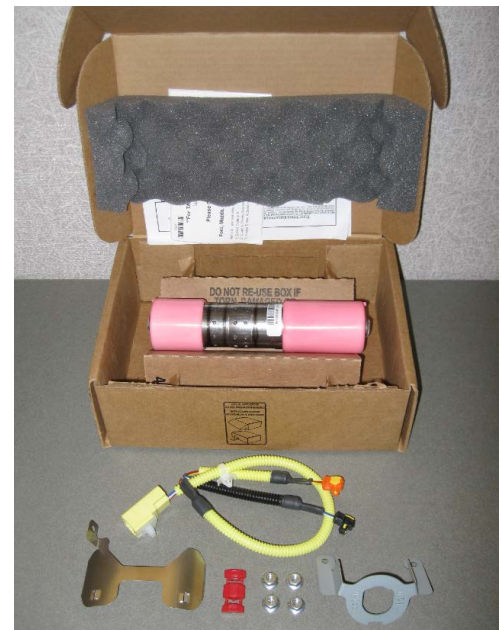
- 4 Self-Locking nuts
- New **Type 2** Inflator (pink collars on each end identify it as the replacement part)
- New Inflator Harness
- 1 new Stopper Plate (A)
- Heat Insulating Plate
- Electro-Tap (red shorting crimp connector)
- Shipping Documentation

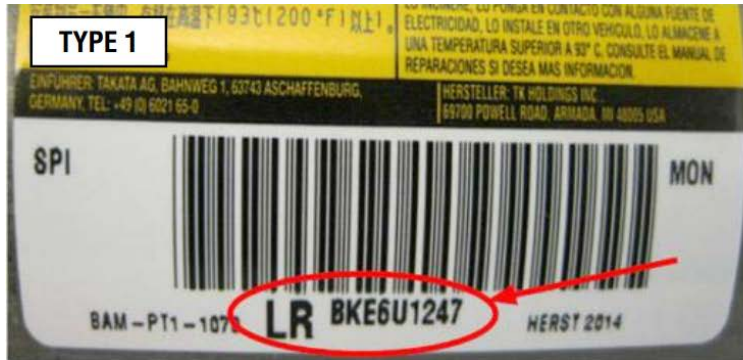
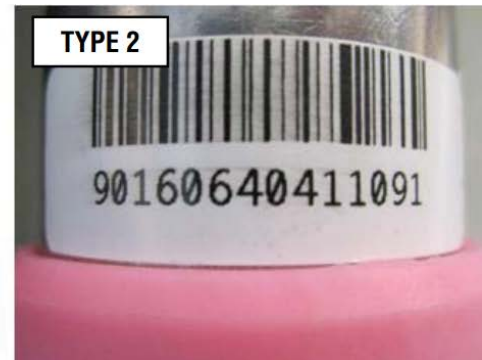
**STEP 9 - VERY IMPORTANT:** Record the **11-digit alpha-numeric serial number for both the new Type 2 and the original Type 1 inflators** on the hard copy of the Repair Order. This information will be required for completion of the Part Return Notice which will be forwarded by the retailer to the PCC.

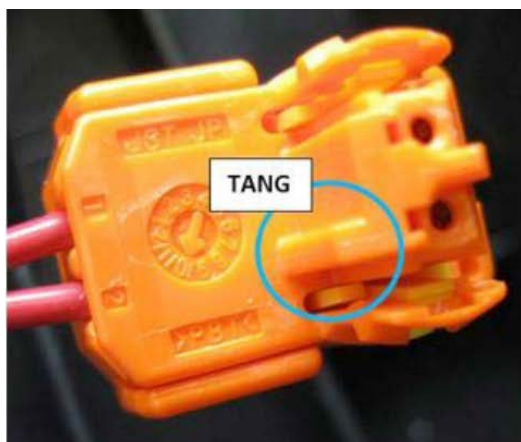
**STEP 17-** Peel off **one** white dust cover and **CAREFULLY** align the tang of the new harness connector with the receiving slot in the inflator connector. This assures proper routing of the harness in relation to the airbag assembly mounting bracket.

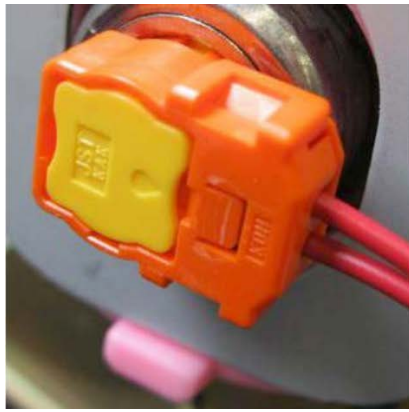
**IMPORTANT: NEVER PEEL BOTH THE WHITE DUST COVERS OFF AT THE SAME TIME!**

Once alignment is confirmed, push down firmly to engage the connector. When fully seated, press down on the yellow tab locking the connector to the inflator.

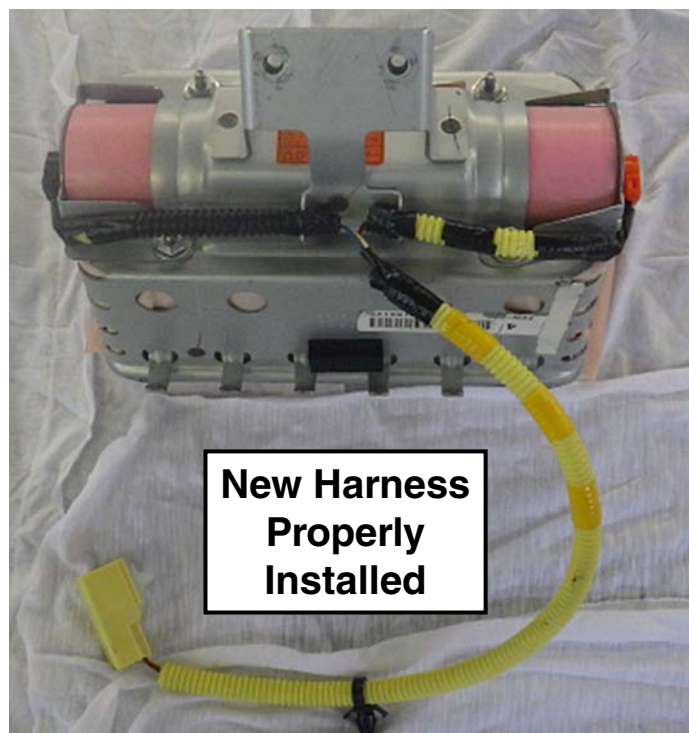
**New Harness  
Properly  
Installed**

**VERY IMPORTANT:** After connecting the new harness to the inflator, **both sides MUST be routed as shown** in the “New Harness Properly Installed” photo below.

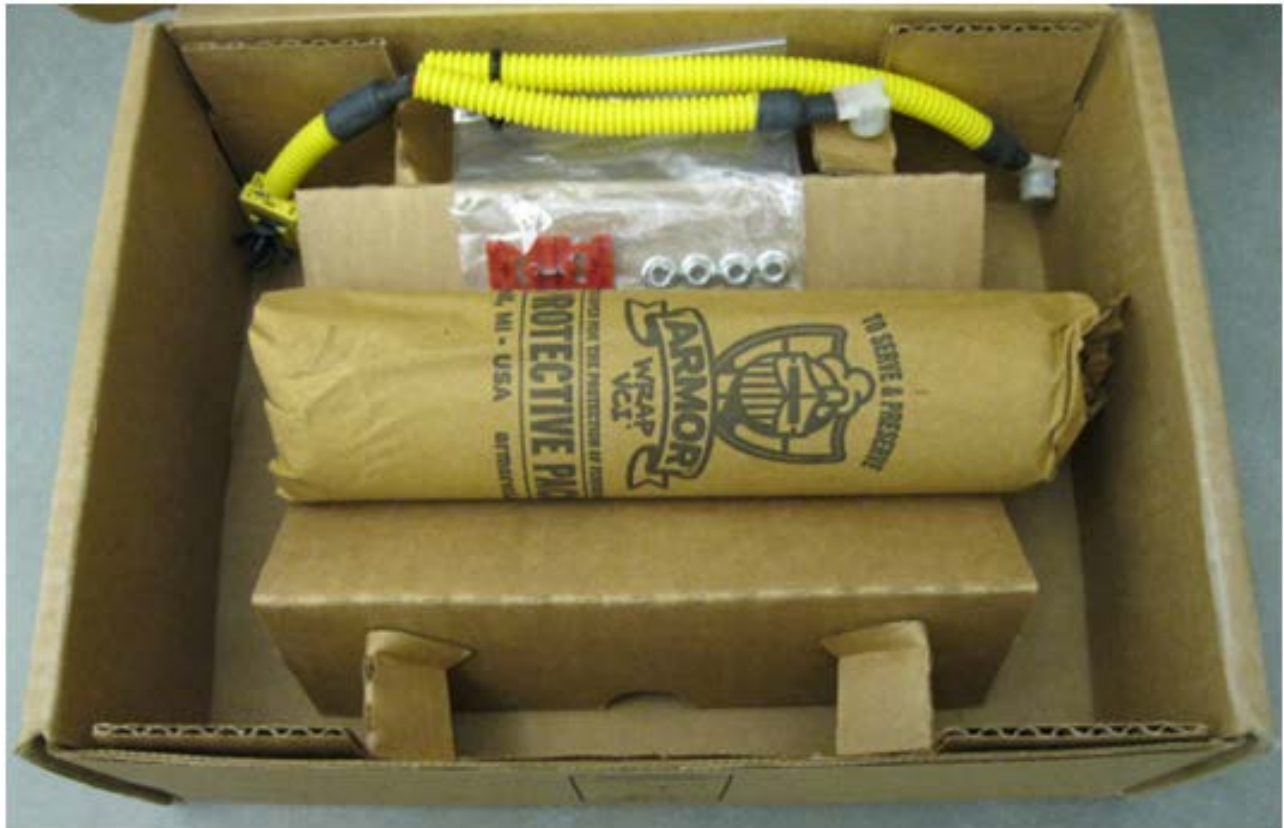
- Open the Kit Box and confirm all the necessary components are included:
  - 4 Self-Locking nuts
  - New Inflator (yellow tape applied to one end to identify it as the replacement part)
  - New Inflator Harness
  - Electro-Tap (red shorting crimp connector)
  - Shipping Documentation and Instructions

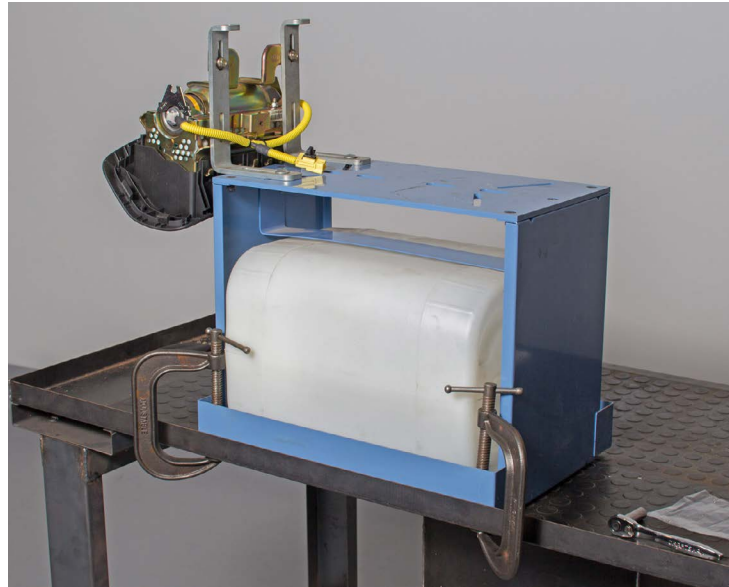
- **IMPORTANT: The removed airbag module must be mounted to the Airbag Deployment Fixture (part number J-39401-B) as shown in the photo below to better secure it during the inflator and wiring harness component replacement procedures.**

When mounting the module to the fixture, pay close attention to the harness routing as shown in the photo below. Always perform this work in an area away from others to reduce chances of inadvertent injury should any deployment occur. Take your surroundings into account to avoid possible hazards should inadvertent deployment occur or sources of static or other electricity that could potentially induce such a deployment.

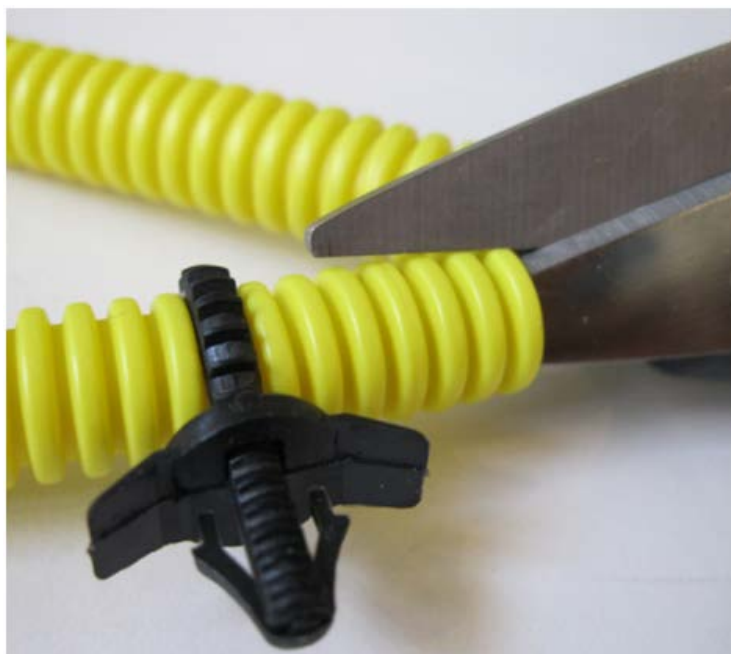
**STEP 3- CAREFULLY** cut the yellow harness cover (approximately 1 1/2 inches) enough to expose the 2 yellow wires inside and provide enough room to install the Electro-Tap (shorting) connector using a scissor or wire cutter. **TAKE YOUR TIME AND BE CAREFUL TO NOT CUT THE 2 YELLOW WIRES!**

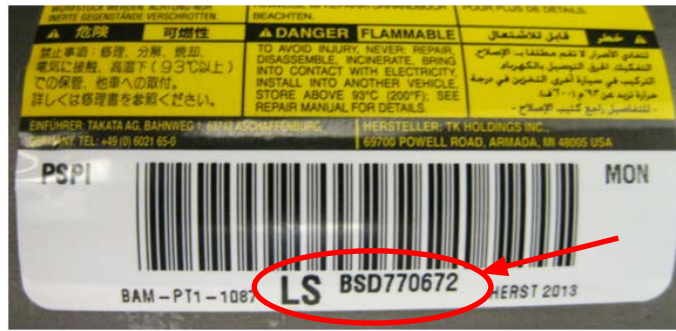
**STEP 8- VERY IMPORTANT:** Record the **11-digit alpha-numeric serial number** for both the **new and the removed inflators** on the hard copy of the Repair Order. This information will be required for completion of the Part Return Notice which will be forwarded by the retailer to the PCC.

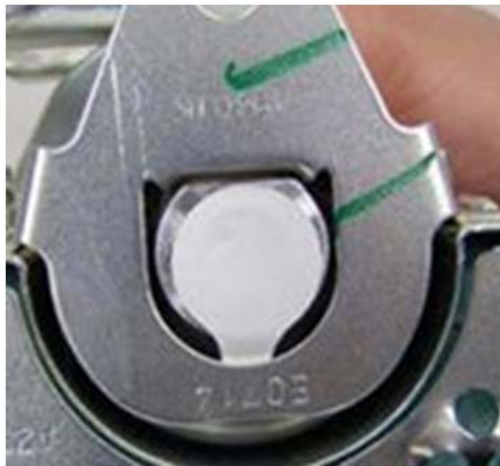
**STEP 9-** Install the new inflator into the mounting bracket so the yellow taped end aligns with the removed stopper plate. Make sure the “D-shaped” portion of the inflator harness connector boss aligns with the “D-shaped” portion of the hole in the end of the mounting bracket as shown below. When properly installed, the end of the inflator will be seated tight against the mounting bracket. Do not peel the white harness connection dust cover at this time.

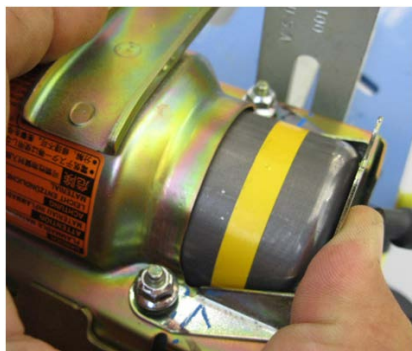
**STEP 10-** As shown below, install but **do not fully tighten** 2 of the NEW self-locking nuts while holding the stopper plate tight against the inflator. Remove the nuts still installed on the mounting bracket and replace them with 2 NEW self-locking nuts. Once all 4 NEW nuts are in place, **torque to 31 - 38 inch pounds in the sequence shown below**. Use a marker to mark the nuts after torquing to indicate they have been fully tightened.

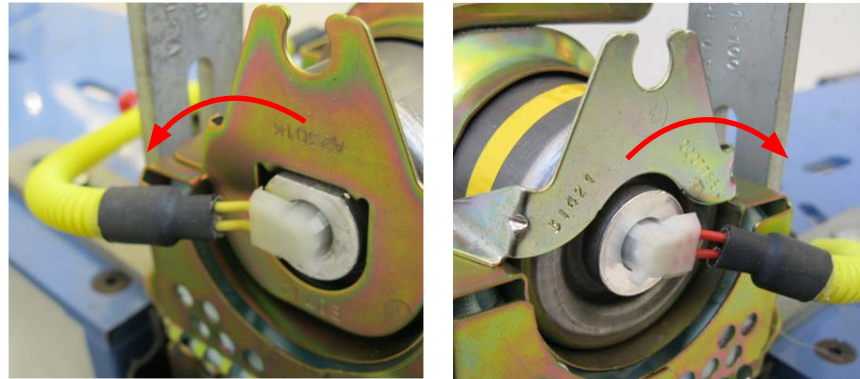
**STEP 11-** The new inflator wiring harness has a “long side” and a “short side” with round 2-pin connectors on both ends. The short side with red wires will connect to the end of the inflator with the round wiring harness connector boss, yellow tape and removable stopper plate. **VERY IMPORTANT: When connecting the new harness to the inflator, both sides of the harness MUST be routed toward the module’s mounting brackets as shown in the photos below.**

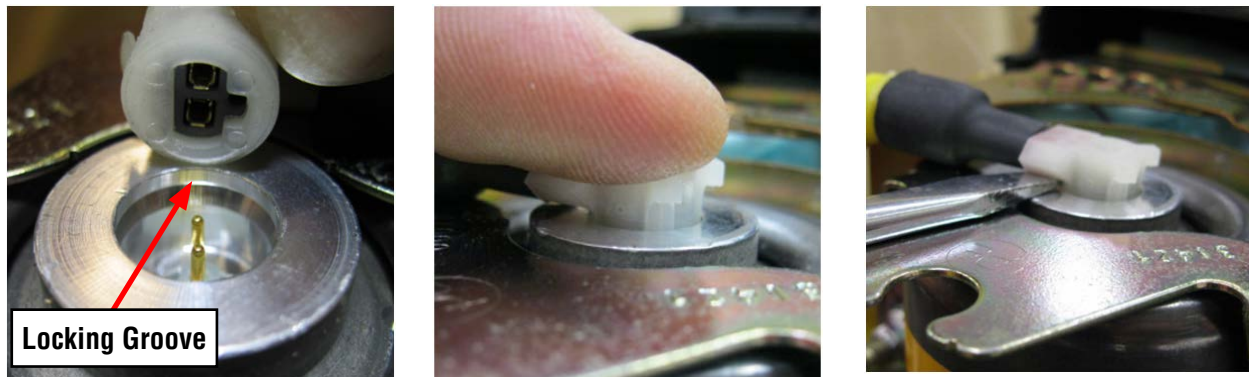
Peel off the white dust cover from the round connector boss end of the inflator **ONLY**. **CAREFULLY** align the pins with the female terminals of the harness connector (2 red wires) as shown in the sequence below. **IMPORTANT: NEVER PEEL BOTH THE WHITE DUST COVERS OFF AT THE SAME TIME!** Once pin alignment is confirmed, push down firmly to engage the connector’s 3 locking tangs into the locking groove inside the connector boss. Confirm the connector is locked by prying up **LIGHTLY** with a small flat-blade screwdriver. Repeat the procedure on the D-shaped connector boss end (2 yellow wires). Reinstall the black wiring harness retaining clip into the mounting bracket to complete the airbag reassembly.

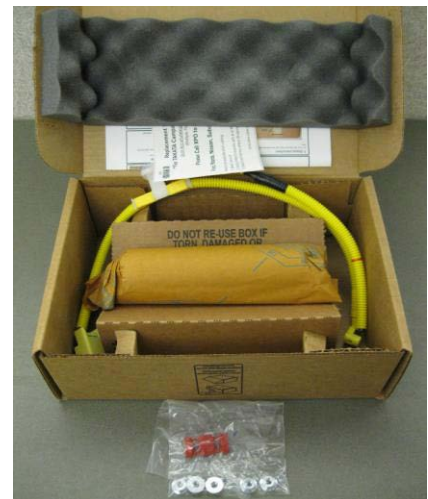
- 5 Self-Locking nuts
- New Inflator (yellow tape applied to one end to identify it as the replacement part)
- New Inflator Harness
- Electro-Tap (red shorting crimp connector)
- Shipping Documentation

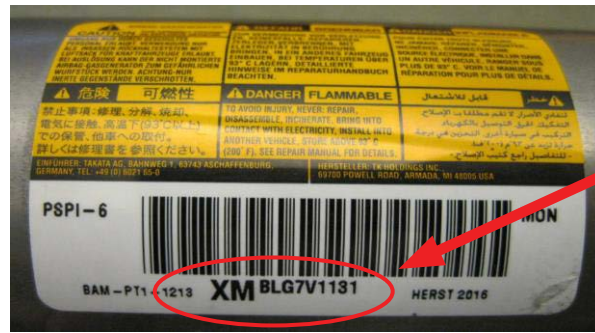
**STEP 9 - VERY IMPORTANT:** Record the **11-digit alpha-numeric serial number** for both the **new and the removed inflators** on the hard copy of the Repair Order. This information will be required for completion of the Part Return Notice which will be forwarded by the retailer to the PCC.

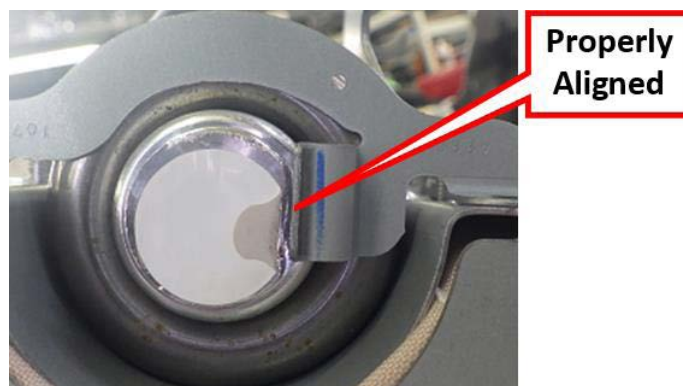
Make sure the “D-shaped” portion of the inflator harness connector boss aligns with the “D-shaped” portion of the original stopper plate as shown below. **Do not peel the white harness connection dust cover at this time.**

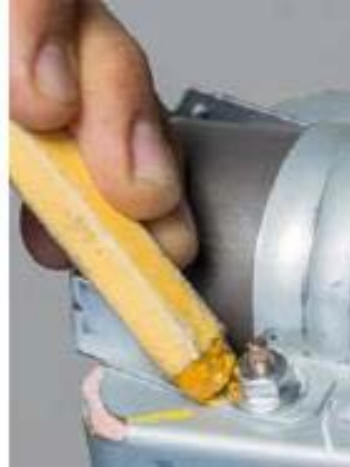
**STEP 11-** Reinstall the original stopper plate and the 5 **NEW** self-locking nuts. **SLOWLY** tighten (to prevent over-tightening) then torque the nuts to 31-38 inch-pounds. When complete, use a marker to indicate they have been fully tightened.

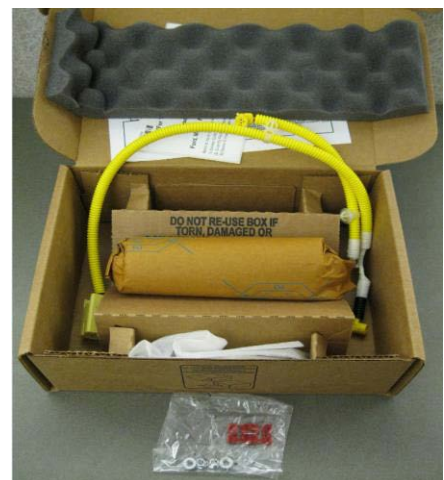
- 4 Self-Locking nuts
- New Inflator (yellow tape applied to one end to identify it as the replacement part)
- New Inflator Harness
- Electro-Tap (red shorting crimp connector)
- Shipping Documentation

**NOTE:** The contents of both kit part numbers are virtually identical except for the vinyl tape color (black / white).

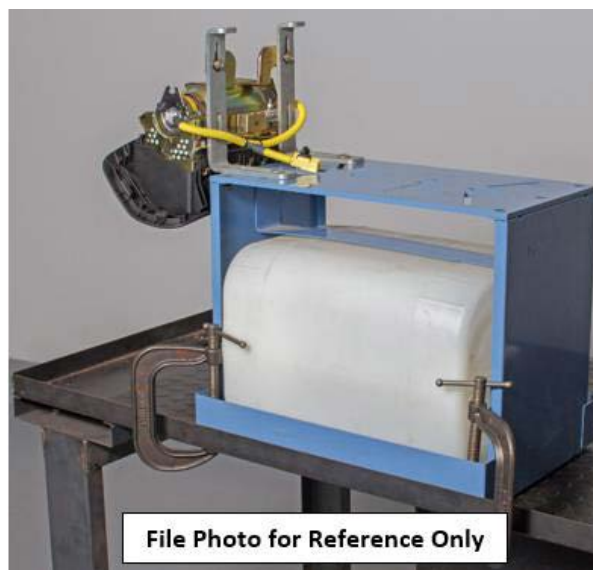
**REMINDER:** It is **STRONGLY RECOMMENDED** the removed airbag module **ALWAYS** be mounted to the Airbag Deployment Fixture (part number J-39401-B and file photo shown below) to better secure it during the inflator replacement procedure. When mounting the module to the fixture, pay close attention to the harness routing. Always perform this work in an area away from others to reduce chances of inadvertent injury should any deployment occur. Take your surroundings into account to avoid possible hazards should an inadvertent deployment occur or sources of static or other electricity that could potentially induce such a deployment.

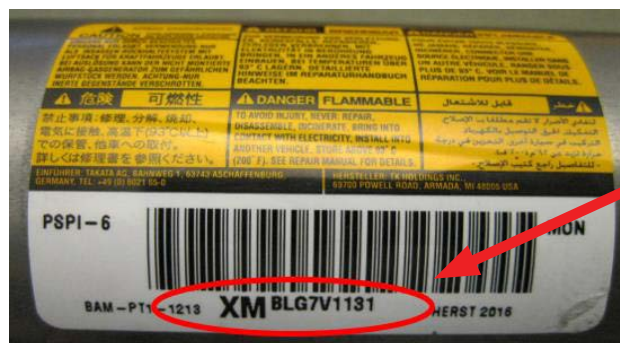
**STEP 9 - VERY IMPORTANT:** Record the **11-digit alpha-numeric serial number for both the new and the removed inflators** on the hard copy of the Repair Order. This information will be required for completion of the Part Return Notice which will be forwarded by the retailer to the PCC.

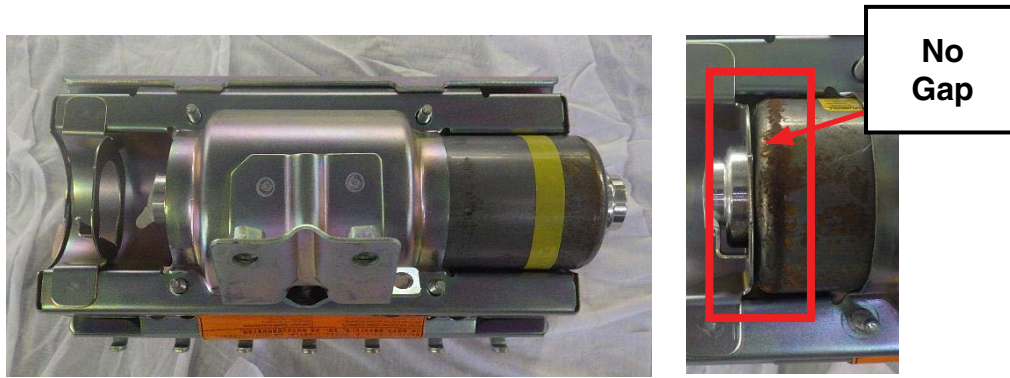
**STEP 10-** Install the new inflator into the mounting bracket so the yellow taped end will align with

the stopper plate when reinstalled on the mounting bracket. When properly installed, both ends of the inflator will be seated tight against the stopper plates with no gaps.

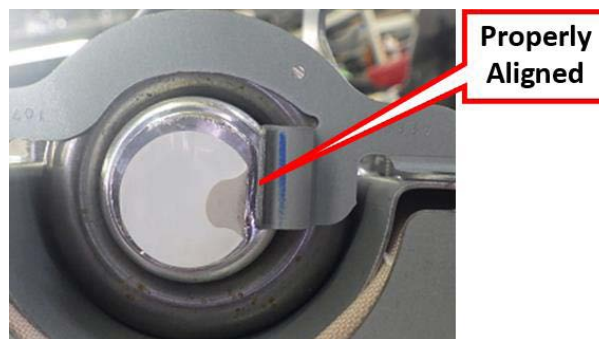
Make sure the “D-shaped” portion of the inflator harness connector boss aligns with the “D-shaped” portion of the original stopper plate as shown below. Do not peel the white harness connection dust cover at this time.

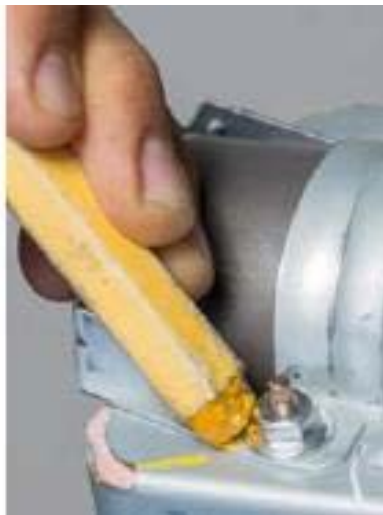
**STEP 11-** Reinstall the original stopper plate and the 4 **NEW** self-locking nuts. **SLOWLY** tighten (to prevent over-tightening) then torque the nuts to 31-38 inch-pounds. When complete, use a marker to indicate they have been fully tightened.

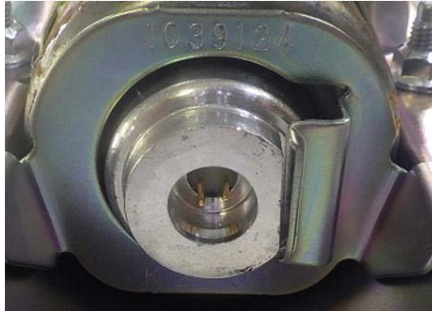
**STEP 12-** Peel the white dust cover from the d-shaped end of the new inflator. The new inflator wiring harness has 2 “sides” with round 2-pin connectors on both ends. The “long” side with the yellow / red wires will connect to the end of the inflator with the D-Shaped wiring harness connector boss as shown below. Peel the white dust cover from the D-Shaped end of the inflator **ONLY**.

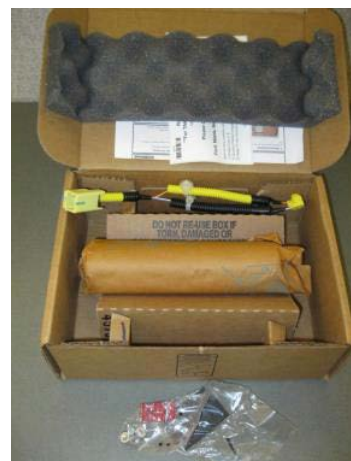
Open the Kit Box and confirm all the necessary components are included:

- 4 Self-Locking nuts
- 1 ½” X 2 ¼” piece of self-adhesive sponge tape
- New Inflator (yellow tape applied to one end to identify it as the replacement part)
- New Inflator Harness
- Electro-Tap (red shorting crimp connector)
- Shipping Documentation

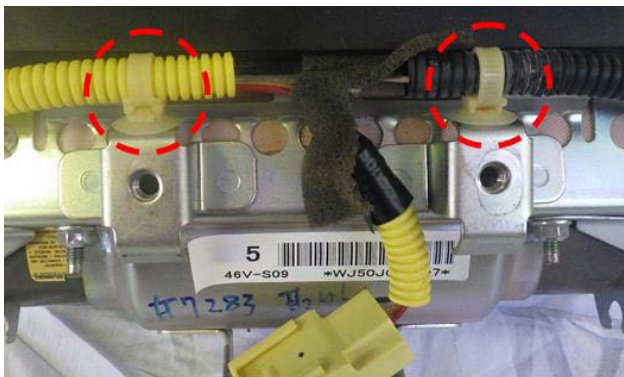
**STEP 2-** Peel the sponge tape and remove the harness clips from the retainer bracket by pushing the tangs inward with a flat-blade screwdriver as shown below. Always remove any sponge tape adhesive residue from the airbag mounting bracket using mild solvent on a clean shop cloth.

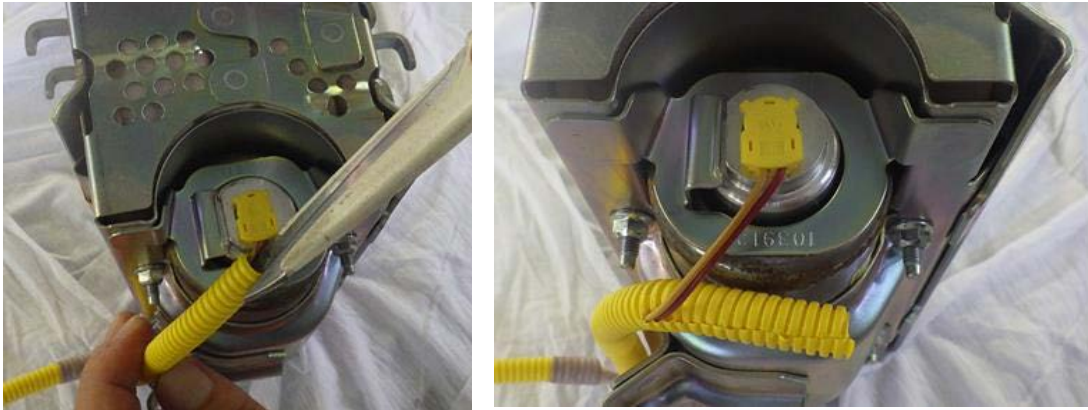
**STEP 3-** Using a scissor or wire cutter (no knives or razors) **CAREFULLY** cut the yellow harness cover tube (approximately 1 1/2 inches) enough to expose the red and yellow wires inside and provide enough room to install the Electro-Tap (shorting) connector.

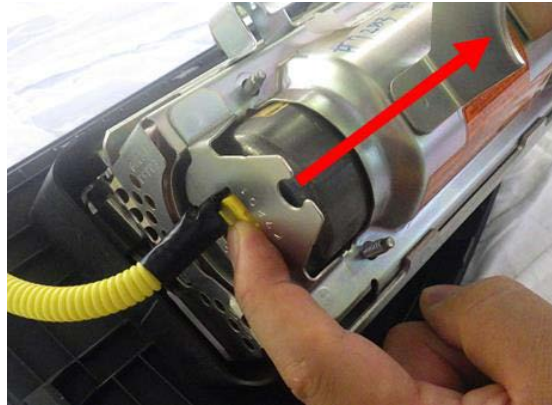
**STEP 7-** With the self-locking nuts and stopper plate removed, slide the original inflator out of the mounting bracket while feeding the cut off portion of the wiring harness under the remaining stopper plate. Place the removed original air bag inflator back into the “cradle” of the Kit Box insert.

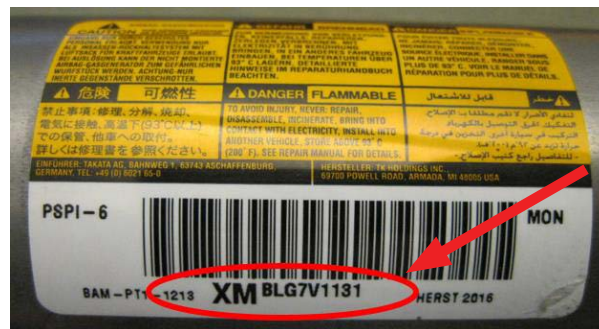
**STEP 8 - VERY IMPORTANT:** Record the **11-digit alpha-numeric serial number** for both the **new and the removed inflators** on the hard copy of the Repair Order. This information will be required for completion of the Part Return Notice which will be forwarded by the retailer to the PCC.

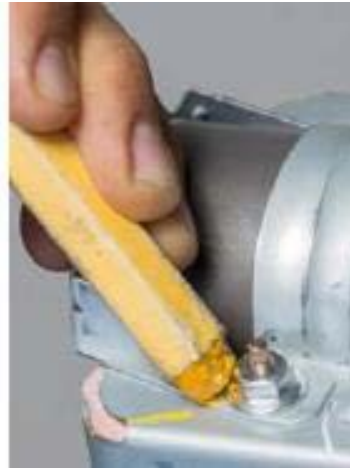
**STEP 10-** Reinstall the original stopper plate and the 4 **NEW** self-locking nuts. **SLOWLY** tighten (to prevent over-tightening) then torque the nuts to 31-38 inch-pounds. When complete, use a marker to indicate they have been fully tightened.

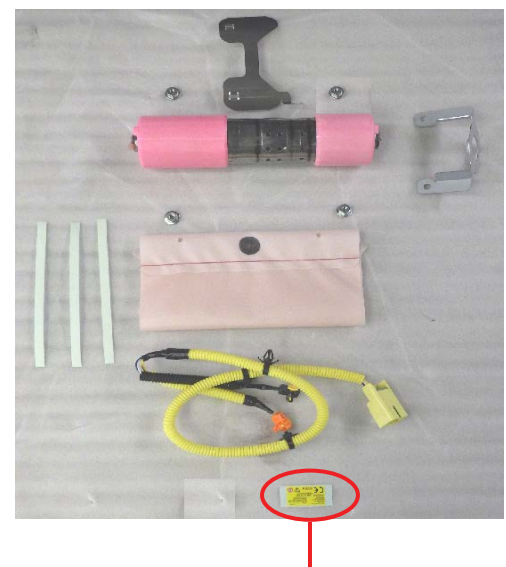
- New Self-Locking nuts (4)
- New Inflator (pink caps on both ends identify it as the replacement part)
- New Inflator Harness
- Electro-Tap (red shorting crimp connector, not shown)
- Black Thermal Insulator
- Stopper Plate
- Protective Sheet
- Anti-Wrinkling Tapes (3)
- Shipping Documentation

**NOTE: Discard this CE label as it is not applicable to the US market.**

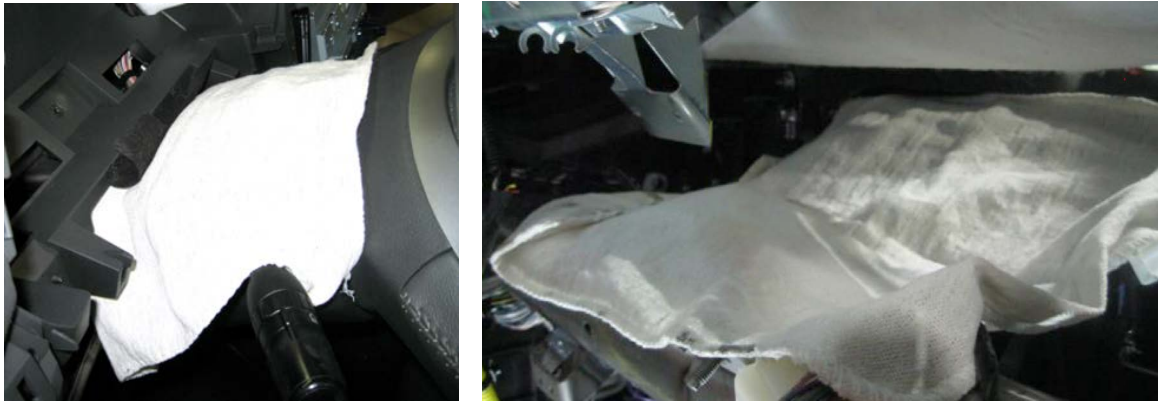
- **IMPORTANT:** Always cover the steering column cover to protect it along with the top of the HVAC blower case to keep out any removed hardware (e.g. airbag module retaining bolts) with clean shop cloth.

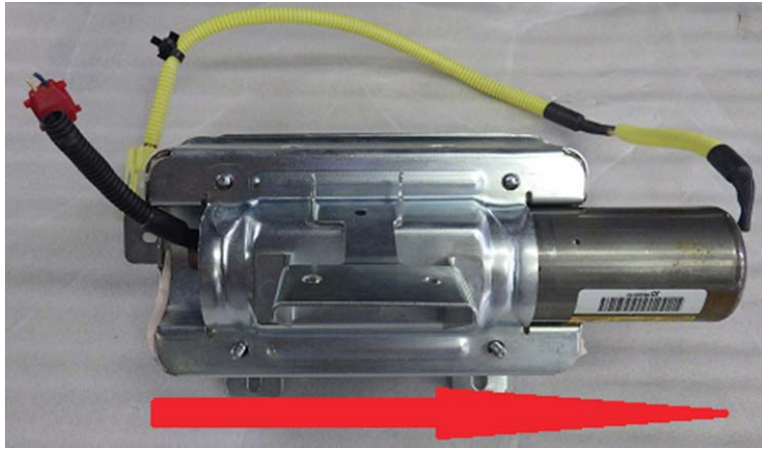
**STEP 8-** With the self-locking nuts and stopper plate removed, slide the original inflator out of the mounting bracket. Place the removed original air bag inflator back into the “cradle” of the Kit Box.

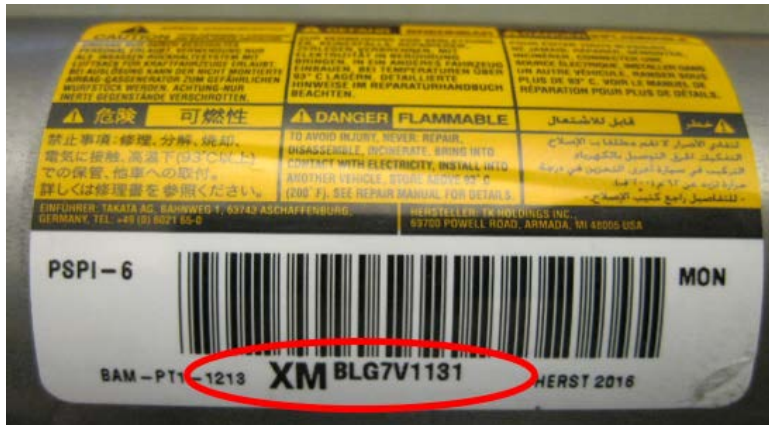
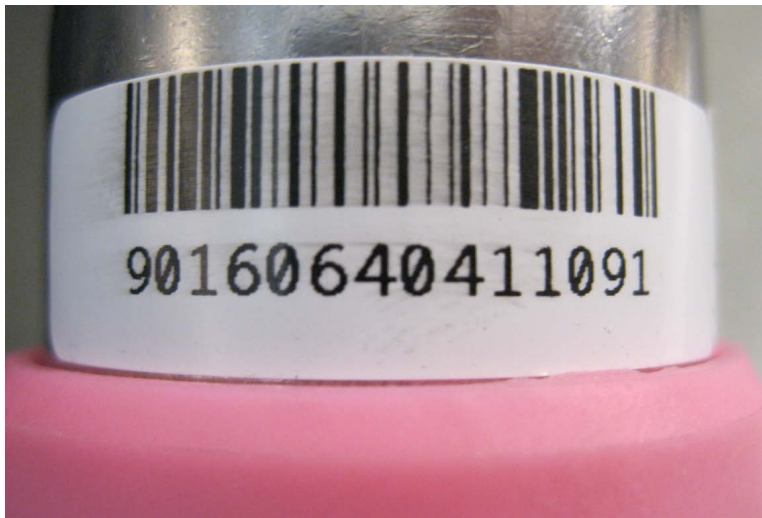
**STEP 9- VERY IMPORTANT:** Record the serial number for **both the new and the removed inflators** on the hard copy of the Repair Order. This information will be required for completion of the Part Return Notice which will be forwarded by the retailer to the PCC. Place the removed inflator in the kit box for return.

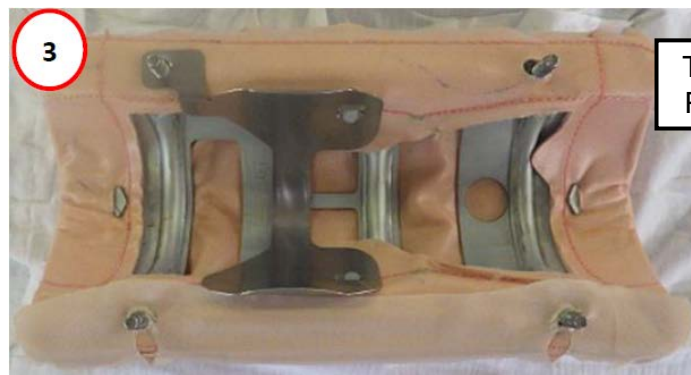
Thermal Insulator Properly Installed

**STEP 11-** CAREFULLY install the black thermal insulator into the back (inflator) side of the airbag as shown in photo 1 below. **CAUTION:** Gloves are recommended when doing this as edges of the thermal insulator can be very sharp. **TAKE YOUR TIME** and do not bend or twist the insulator any more than necessary to make it fit. The insulator can only be installed in one direction as shown in photo 3 otherwise, the airbag will not fit back into the module frame properly. Confirm both retaining claws come through the corresponding insulator holes like the example shown in photo 2.
