RECALL CAMPAIGN BULLETIN

NTB17-037a

VOLUNTARY SAFETY RECALL CAMPAIGN 2007-2012 VERSA; FRONT PASSENGER AIR BAG INFLATOR

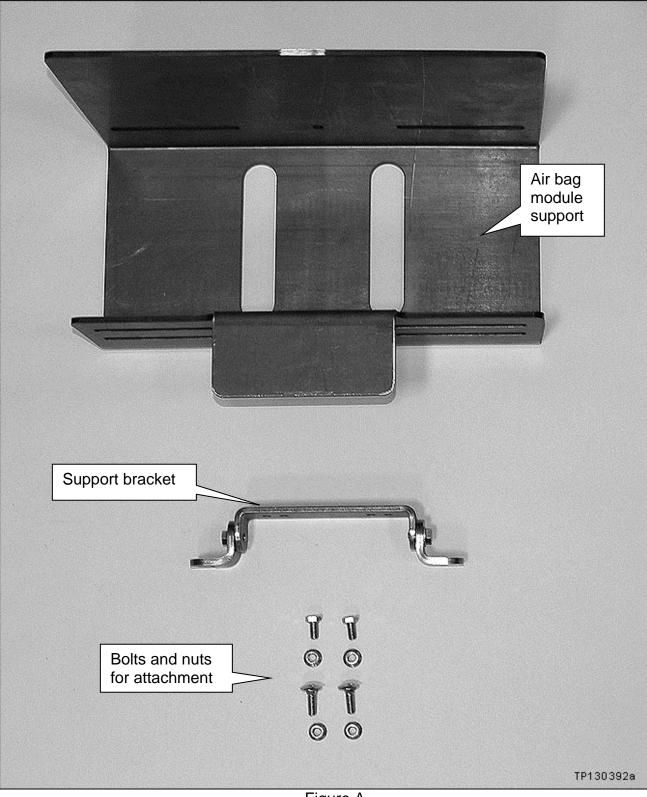
Figure A

Air Bag Module Support (J-51315)

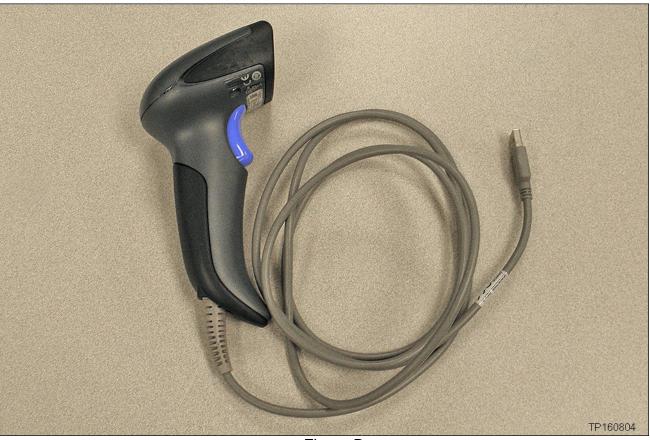
Figure B

Quick Scan Tool (J-52352)

- Each dealer has been shipped one Quick Scan Tool (J-52352).
- Additional tools can be obtained from Tech•Mate at 1-800-662-2001.

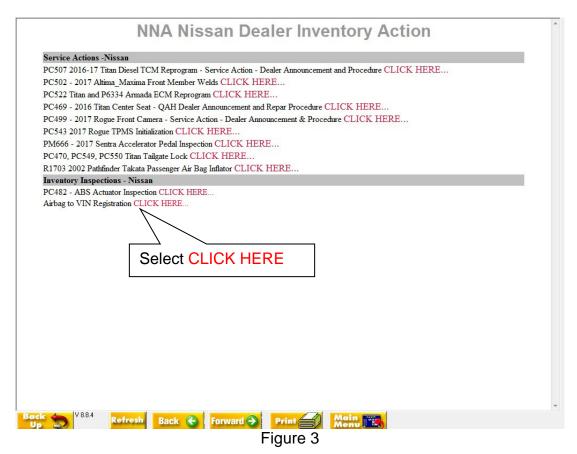
4. Select CLICK HERE (Airbag to VIN Registration).

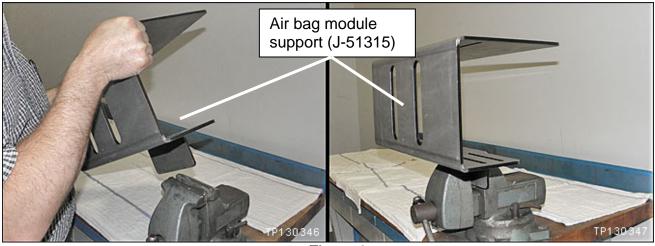
12. Securely mount the air bag module support (support) in a vice (see Figure 8).

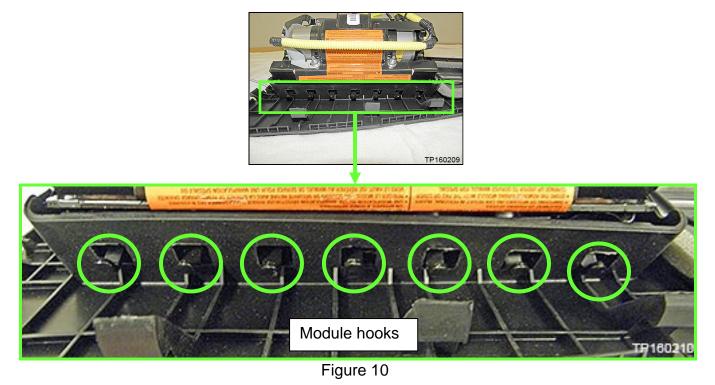
- 16. Remove the instrument panel finisher from the module assembly.
 - a. Detach the module hooks (Figure 10) one at a time, starting at one end and then working towards the opposite end (seven hooks).
 - Detach the hooks from the side of the instrument panel finisher that is facing up when it is installed in the vehicle.

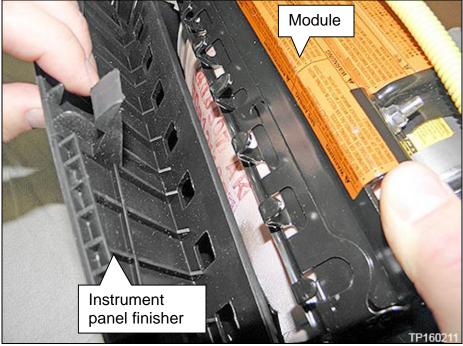
Figure 11

b. Swing the module away from the instrument panel finisher and then detach the hooks on the opposite side to remove.

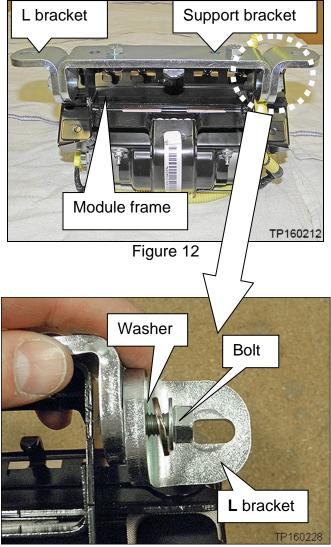
Figure 13

- 17. Attach the support bracket to the module frame.
 - Tighten the bolts holding the bracket to the module frame.

- Put a washer between the bolt and L bracket (on the right side as viewed in Figure 13).
 - Leave the L brackets on each end slightly loose to allow for positioning of the module in the support.

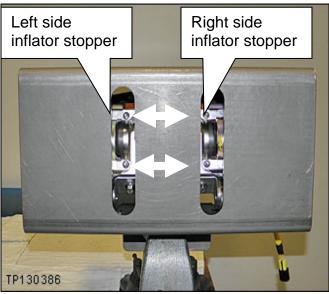
Figure 21

- 25. Remove the 4 nuts from the module that hold the inflator in place (see Figures 20 and 21).
 - Use a ratchet and extension.

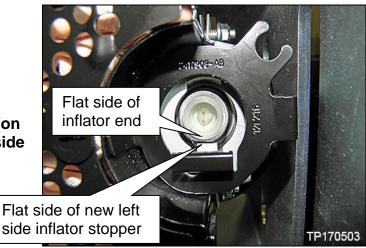
Figure 27

- 33. Make sure the inflator is positioned / oriented correctly as shown.
 - The flat side of the inflator end (on the left side) must face the flat side of the inflator stopper.

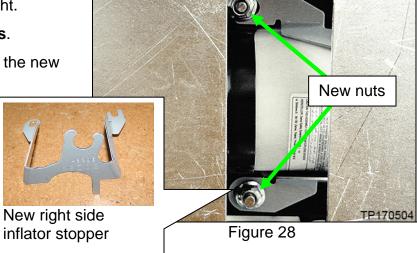
35. Make sure the inflator is pushed all the way into its housing and up to the left side inflator stopper- no gap on the left side (see Figure 29).

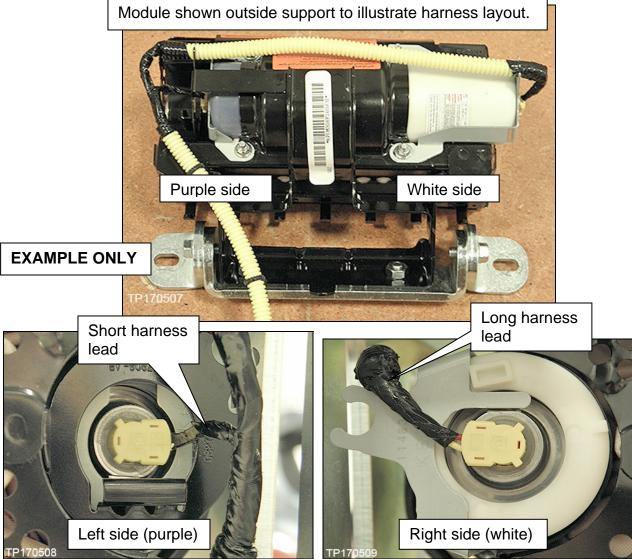
Figure 31

38. Attach the new harness to the inflator.

- Make sure to attach the harness correctly refer to Figures 31, 32 and 33.
- The short lead of the harness will be attached to the purple end of the inflator.
- The long lead of the harness will be attached to the white end of the inflator.

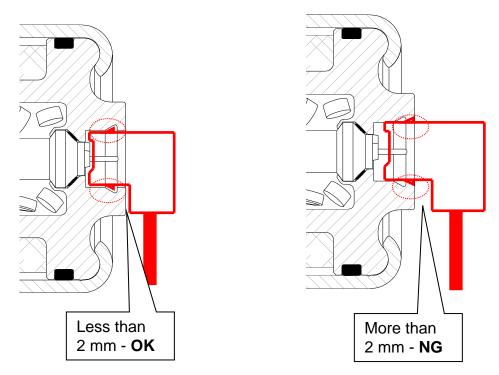
Figure 33

• Make sure the inflator connectors are fully engaged / seated (see Figure 33).

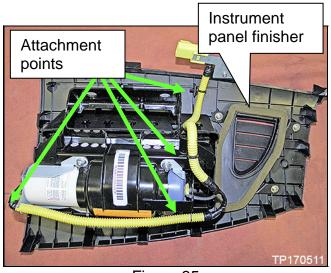
Figure 35

- 41. Reinstall the instrument panel finisher to the module assembly.
- 42. Route and attach the harness to the harness guides, and attach harness clips as shown.
