September 4, 2019

Version 4

## Safety Recall: Front Passenger's Airbag Inflator Can Be Over-Pressurized (Phase 2)

Supersedes 17-001, Dated December 7, 2018 to revise the information highlighted in **yellow**.

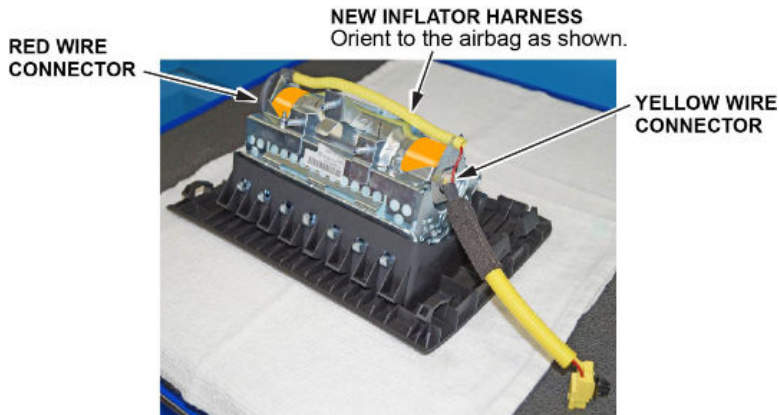
17.1. Make sure the airbag and harness are aligned as shown.

- **Make sure you have the orientation correct as shown below.** If you connect the harness incorrectly, the harness cannot be removed, and you will not be able to reinstall the airbag because the harness will be too short.
- Connect the red wire connector to the connector with the red dot.

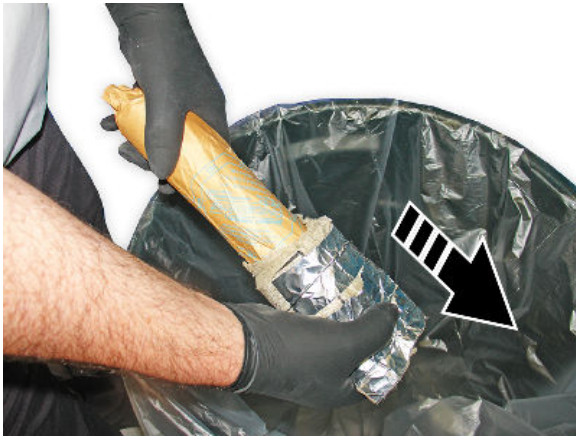
2. Hold the paper wrapping the inflator with one hand and slide the insulation off into the trash.

The insulation is securely wrapped around the inflator. You may have to use some force to slide the insulation off. Do not cut the insulation and be careful that you do not move the white or orange plastic ends.
