December 7, 2018

Version 3

Safety Recall: Front Passenger's Airbag Inflator Can Be Over-Pressurized (Phase 2)

Supersedes 17-001, Dated February 1, 2017 to revise the information highlighted in **yellow**.

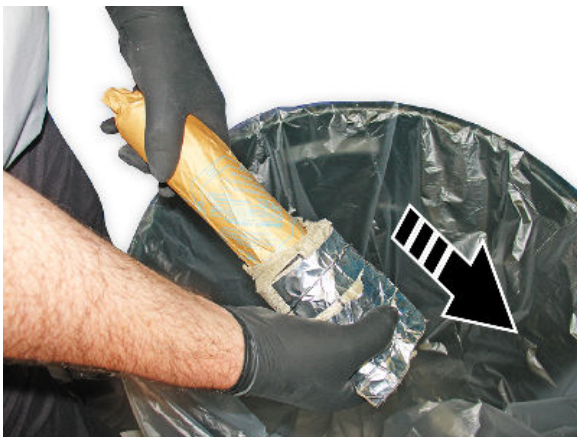
2. Hold the paper wrapping the inflator with one hand and slide the insulation off into the trash.

The insulation is securely wrapped around the inflator. You may have to use some force to slide the insulation off. Do not cut the insulation and be careful that you do not move the white or orange plastic ends.
