## Recall Campaign

NHTSA#: 17V-037  
TC#: 2017-106

Replace Outside Range Gas Valve Handle and Inspect drawer  
Adjust Drawer when inspection confirms too low

### Replace Gas Valve Handle on Exterior Range

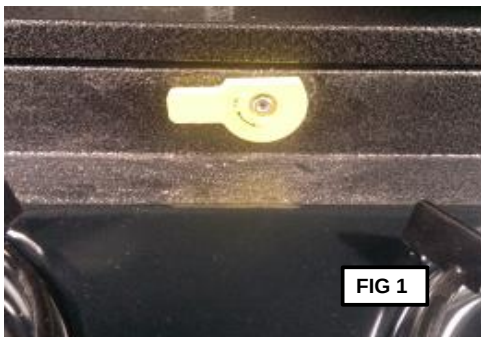
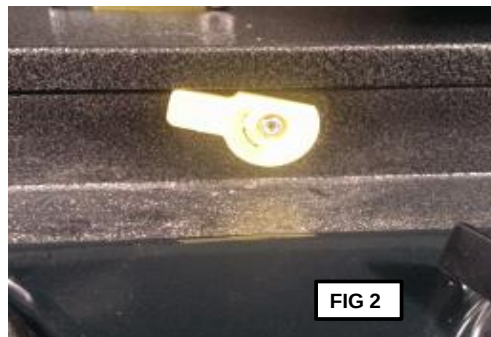
**FIG 1&2:** Old style gas valve handle allowed the drawer to close with the gas valve still in the open position

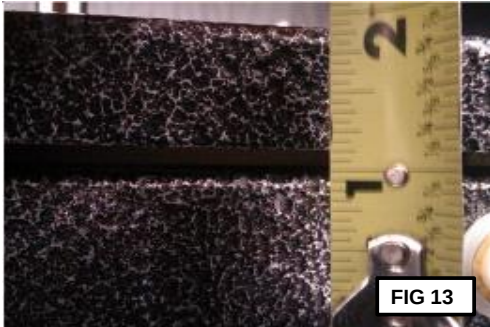
FIG 13

**Important:** the measurements of the drawer must be as noted below to ensure the drawer can not be closed with the gas valve handle in the open position.

**FIG 13:** Measure back splash of drawer in relation to front counter fascia. Drawer opening should be 1/8" +/- 1/16".
