Thor Motor Coach Recall Repair Instructions

Recall # 17V-096

Description/Title: **2014-2016 Diesel Motorhome Windshield wipers**

Affected Product Line(s): **Certain Model Year 2014, 2015, & 2016 Tuscany and Palazzo Motorhomes**

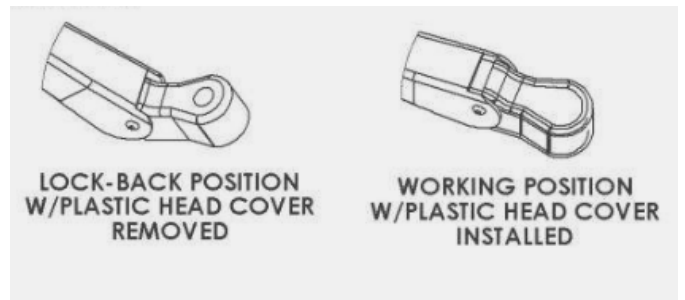
Put the wiper arm in lock-back position.

Gently remove the plastic head cover. Make sure the cover is not damaged during the removal process.

Tighten the nut to 30-35ft lbs of torque.

Reinstall cover.

Return arm to normal in-use position.

Repeat for other wiper arm

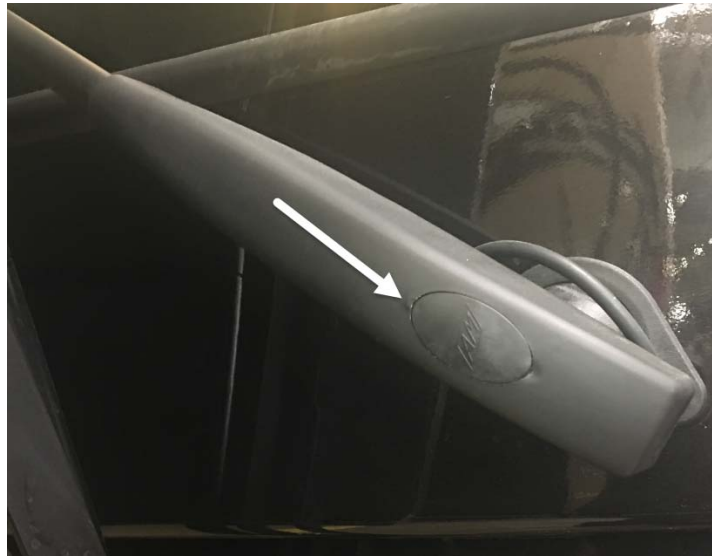
Carefully remove the plastic access cover with a small flat head screwdriver. Make sure the cover is not damaged during the process of removal.

Put the wiper arm in lock-back position

Push the wiper hose out of the way.

Tighten the screw to 12ft-lb of torque.

Reinstall the cover.

Return arm to normal in-use position.

Repeat for other wiper arm
