Volvo Car Customer Service

QB Instruction VCC-501267-2

Title	Inflatable curtain	Page	1 (17)
Action	Bolt replacements	Operation number:	97184-2

Model year	Model
2017	S90 (17-)

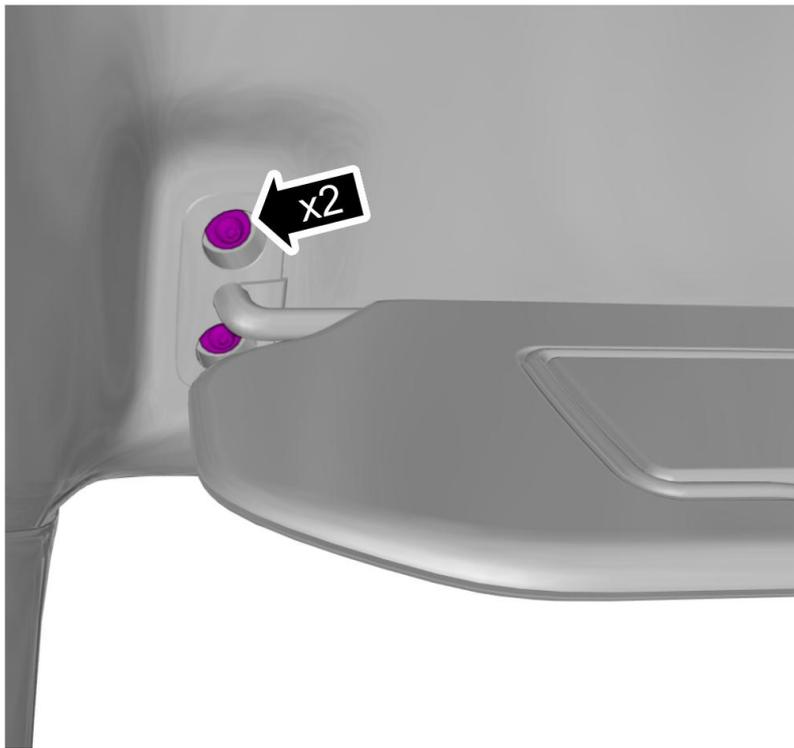
Remove the screws.
On both sides.

Torque:
M5 , 5 Nm

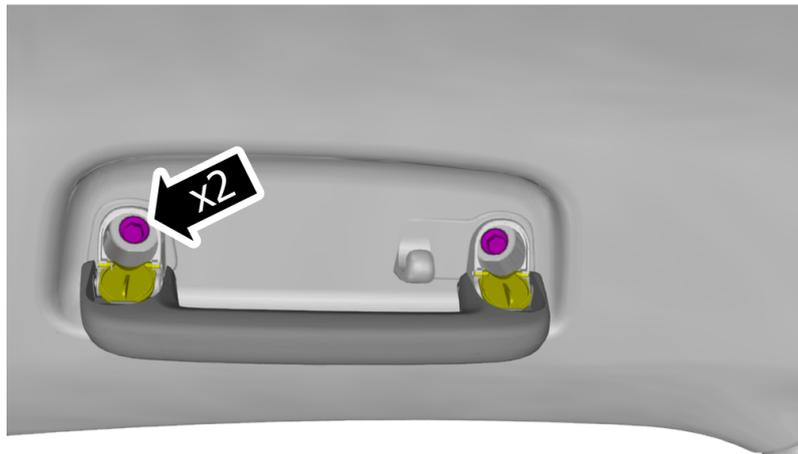
x4

Remove the screws.
On both sides.

Torque:
M6 , 10 Nm

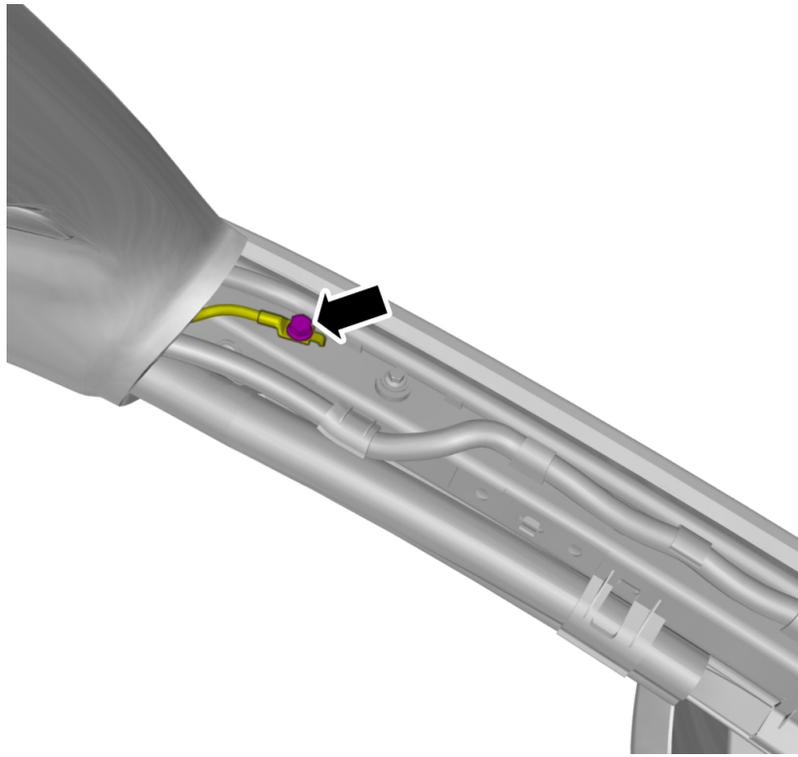
Remove the screws.

Torque:

M6 , 10 Nm

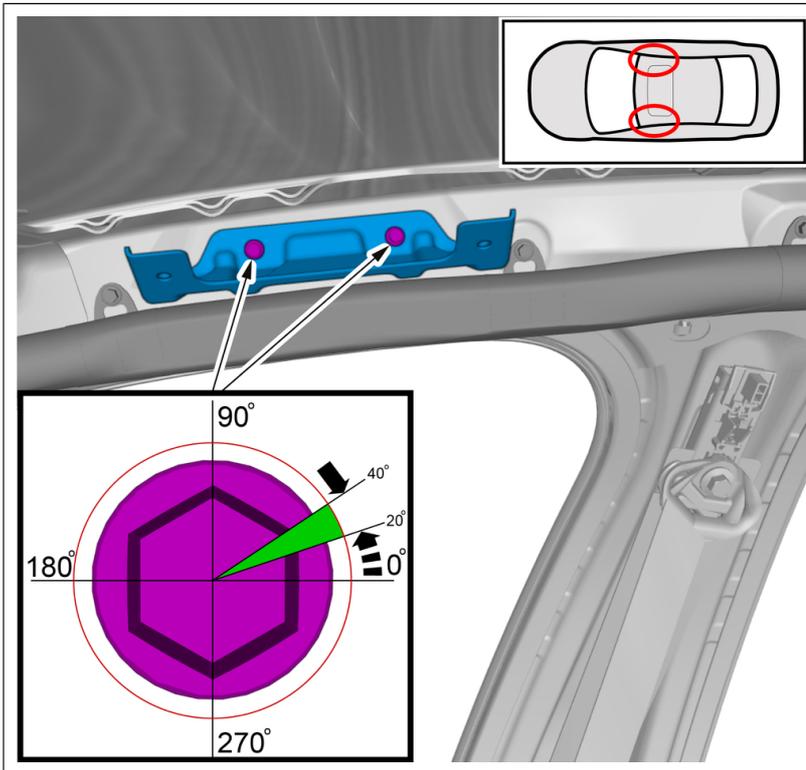
Warning! Loosen the screw between 20-40 degrees.

Warning! Do not re-tighten the screw after it has been loosened 20-40 degrees!

Note! Repeat the steps with the other marked screws.

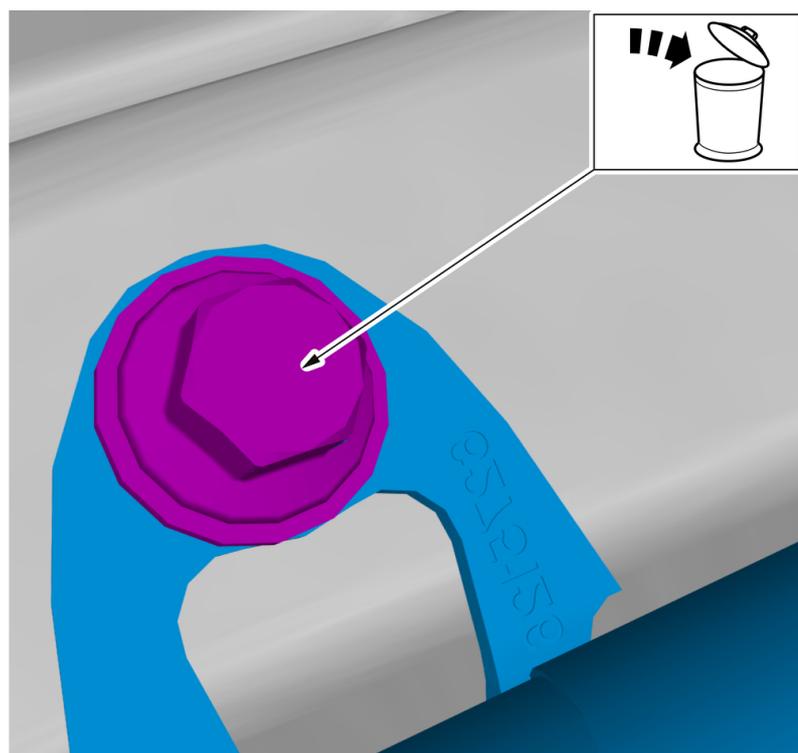
Remove the screws.

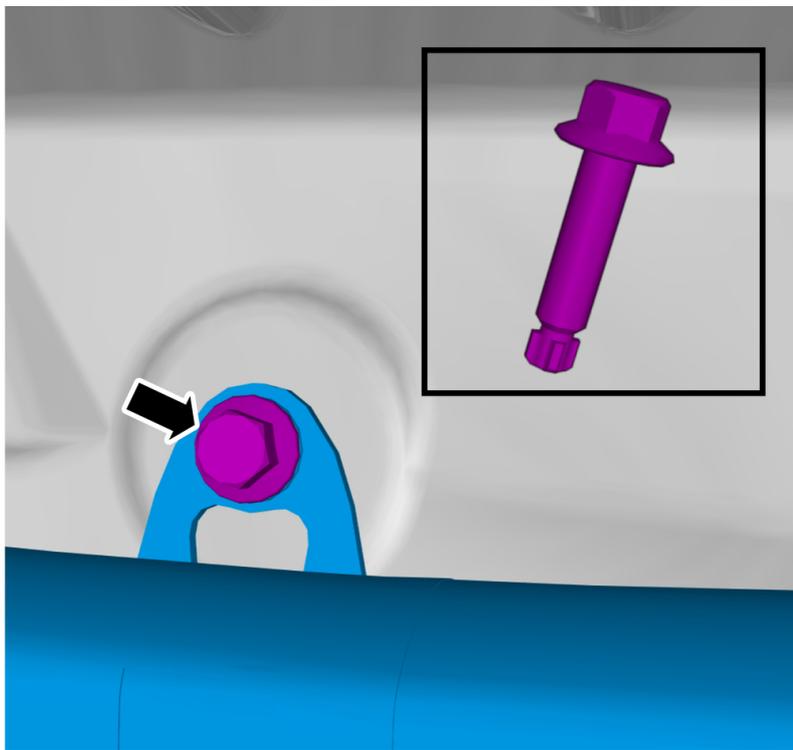
Caution! Make sure that new bolts are installed.

Note! Repeat the steps with the other marked screws.

Torque:

Inflatable curtain to the body , 6 Nm
