Safety Recall

Code: 01B8

Subject	Tire Information Label
Release Date	March 29, 2017
Affected Vehicles	U.S.A. & CANADA: 2017 MY Volkswagen Jetta <i>Check Campaigns/Actions screen in Elsa on the day of repair to verify that a VIN qualifies for repair under this action. Elsa is the <u>only</u> valid campaign inquiry & verification source.</i> <ul style="list-style-type: none">✓ Campaign status must show "open."✓ If Elsa shows other open action(s), inform your customer so that the work can also be completed at the same time the vehicle is in the workshop for this campaign.
Problem Description	The maximum vehicle load weight printed on the tire information label is incorrect (too high). If someone were to rely on the label information to load the vehicle, the vehicle may be overloaded. Overloading may damage the vehicle and may make it less stable, difficult to steer and could impact the stopping distance, increasing the risk of a crash.

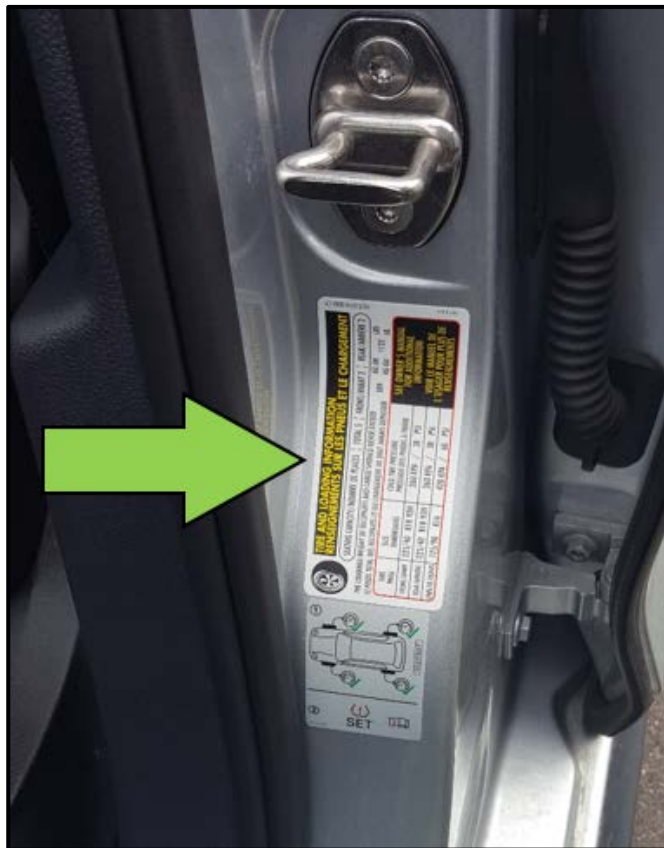
- Open the driver front door.
- Locate the "Tire and Loading Information" label on the B-pillar.
- Clean the surface of the existing label.
- Peel the replacement label off the backing paper.
- Affix the replacement label <arrow> over the existing label.

- The surface of the existing label must be clean, dry, and free from oil residue prior to applying the replacement label.
- The replacement label **MUST** cover the existing label completely.
- Handle the replacement label carefully. Do not touch the adhesive backing.
