September 4, 2019

Version 3

Safety Recall: Front Passengers Airbag Assembly May Contain a Takata Inflator That Can Be Over-Pressurized

Supersedes 17-024, dated December 7, 2018 to revise the information highlighted in **yellow**

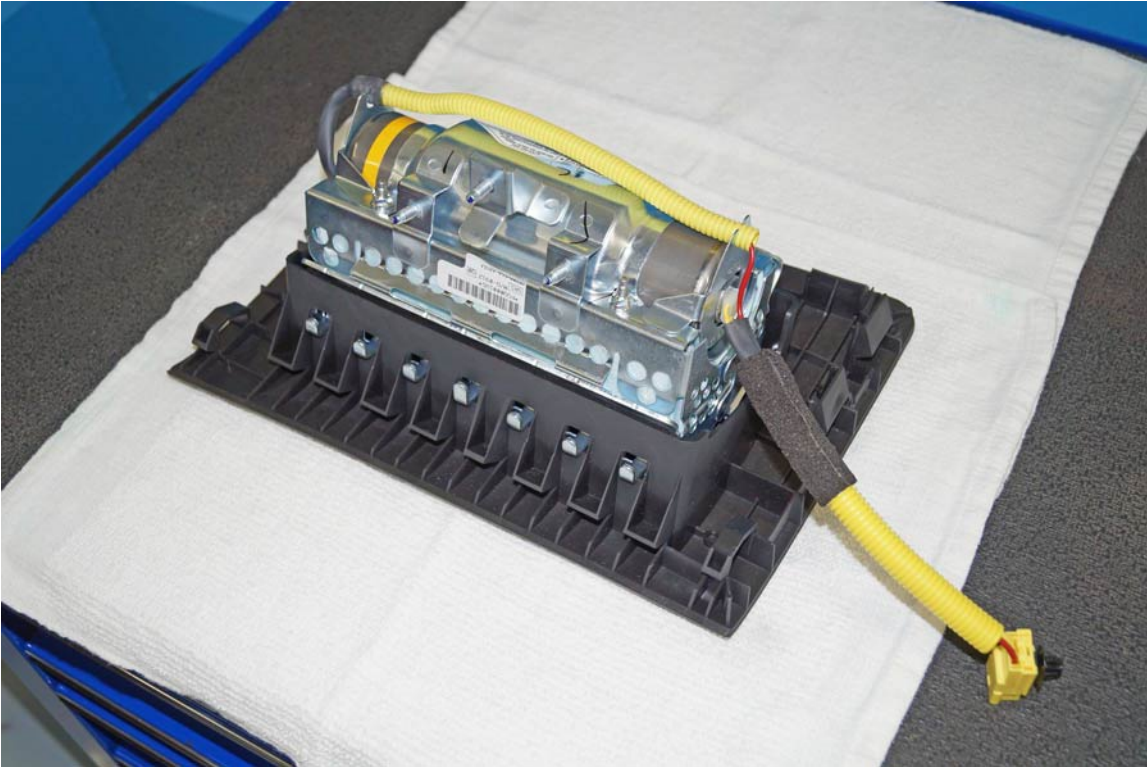
2. Disconnect the battery negative cable and wait at least 3 minutes before continuing.
3. Remove the front passenger's airbag.
4. Place the airbag, face-down, on a clean shop towel.

- The orientation of the airbag is critical because if the inflator is installed incorrectly, the harness will be too short when you reinstall the airbag.
- The brackets between the various models are similar but may differ from the example shown.

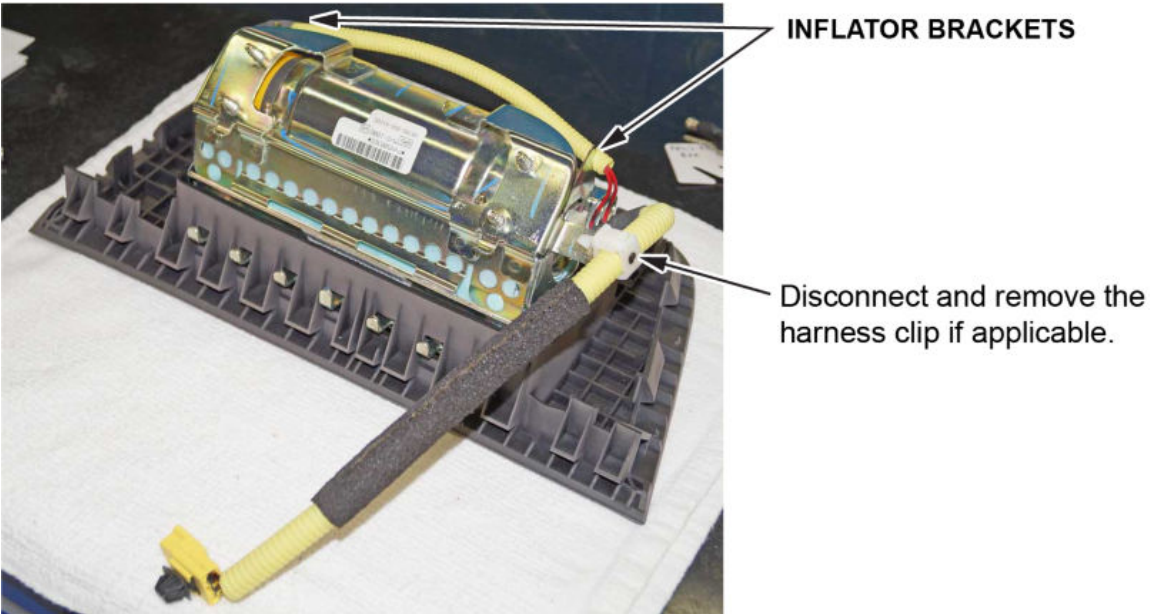
7. Remove the harness from both ends of the inflator bracket.

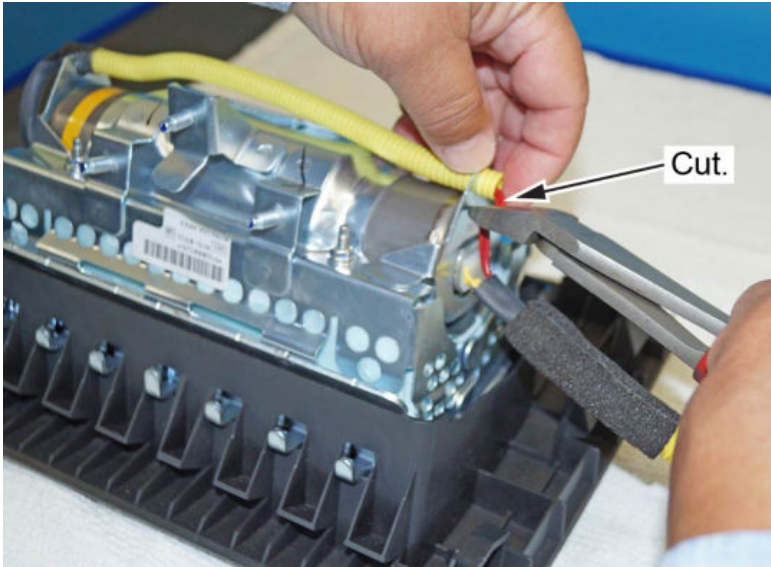
You must cut and short the wires as indicated to prevent accidental deployment.

8.1. Cut the red wires as shown.

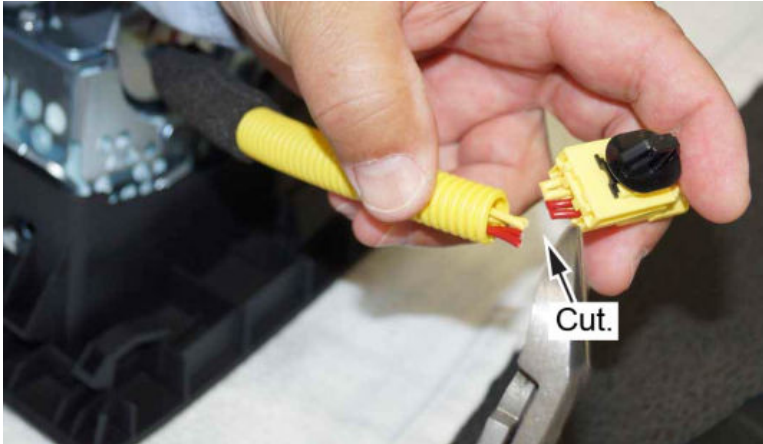
9.1. Cut all four wires to remove the connector.

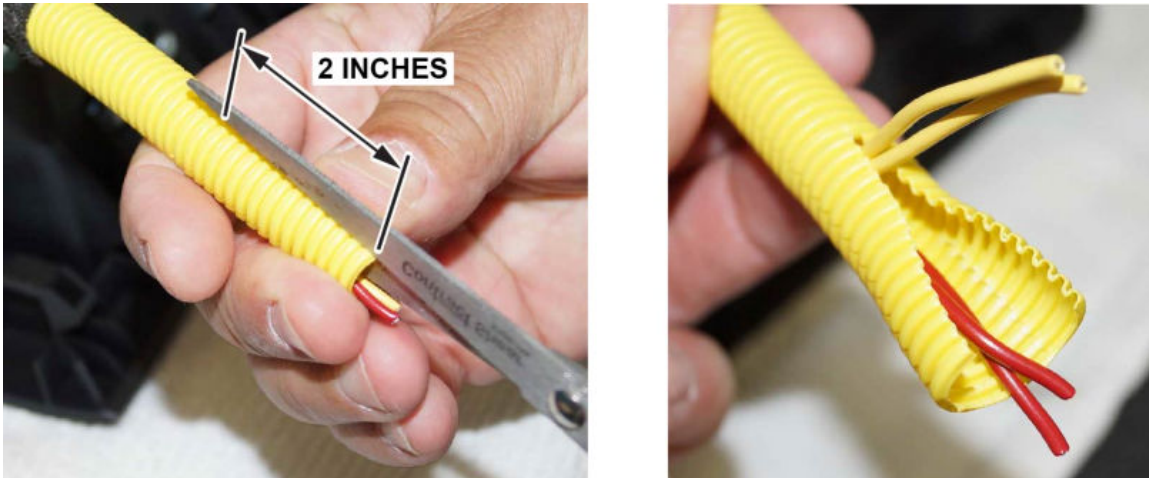
9.2. Cut about 2 inches of the corrugated tube, then pull out the yellow wires.

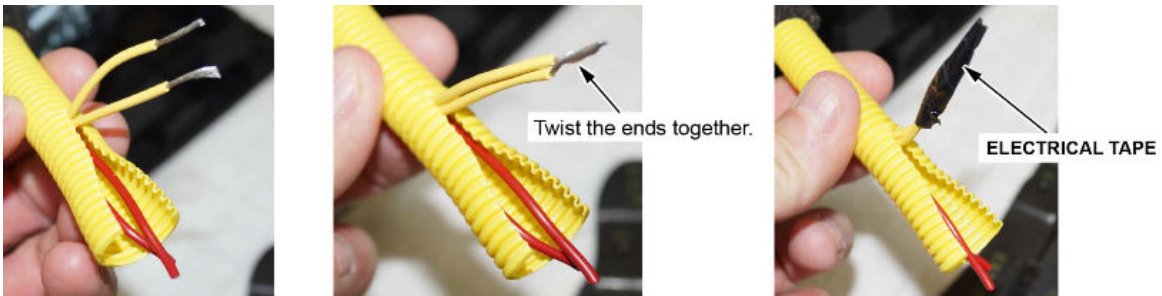
9.3. Strip away about an inch of the wire insulation, then twist the wires together.

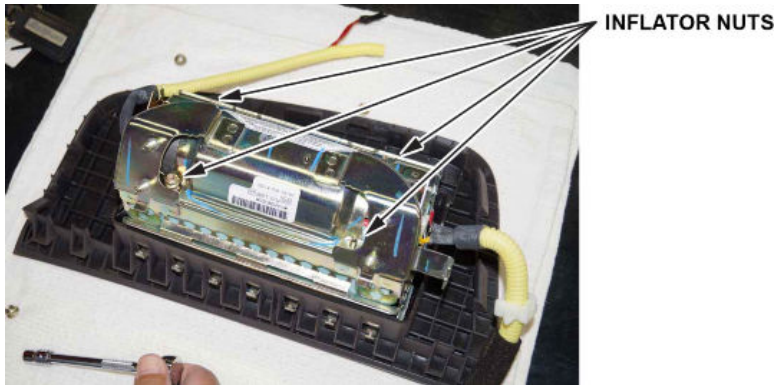
10. Remove the four inflator nuts.

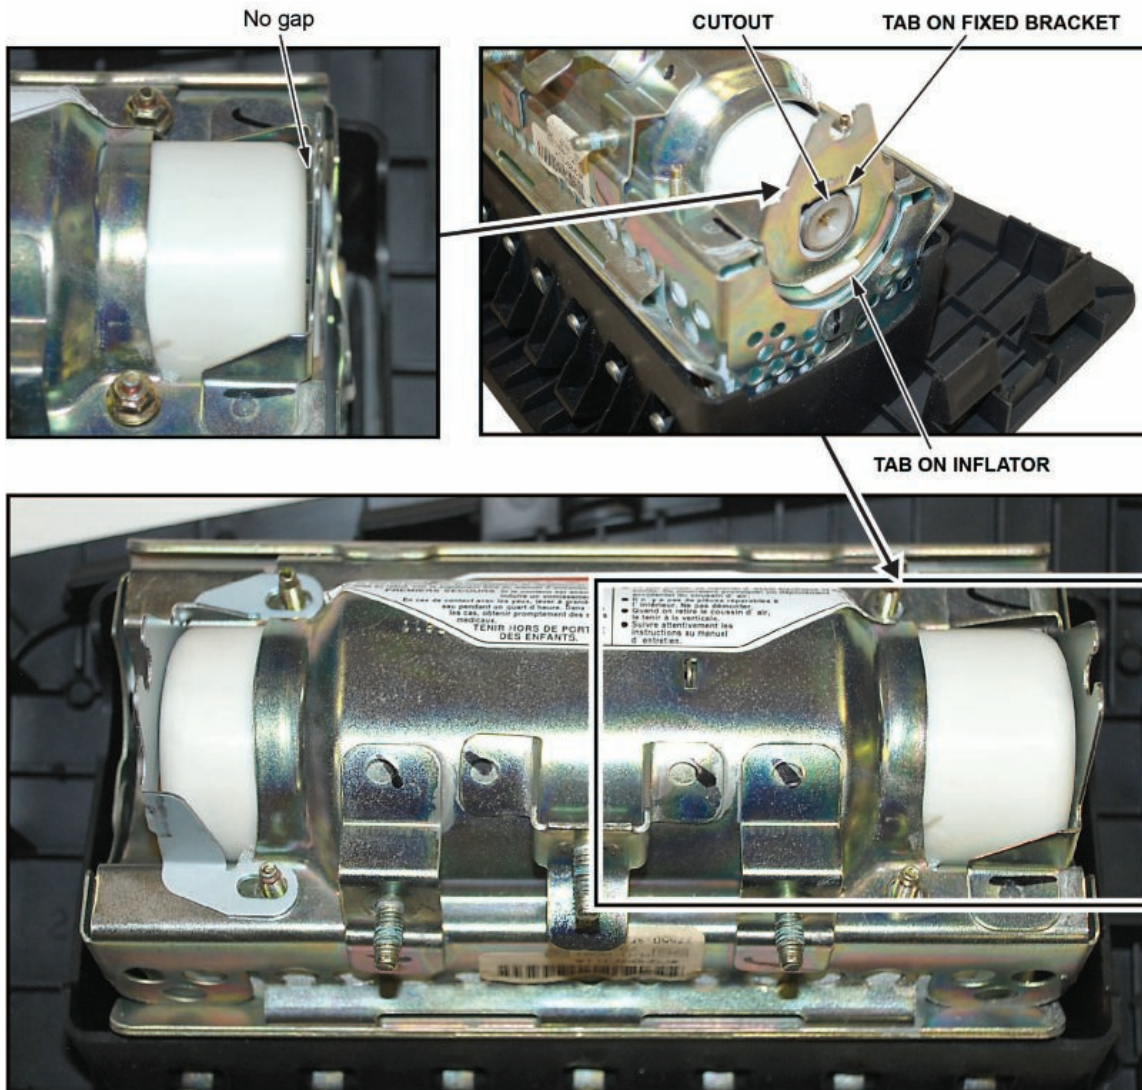
FIXED BRACKET END

13.3. Slide the inflator in until the plastic cutout and the small flat spot align with the tab on the bracket. There should be no space or gap between the inflator and bracket.

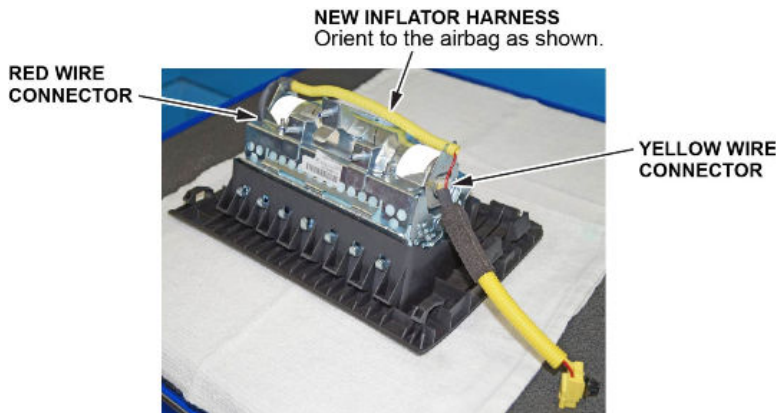
17.1. Make sure the airbag and harness are aligned as shown.

- **Make sure you have the orientation correct as shown below.** If you connect the harness incorrectly, the harness cannot be removed, and you will not be able to reinstall the airbag because the harness will be too short.
- On the replacement inflators with plastic collars, connect the red wire connector to the connector with the red dot.

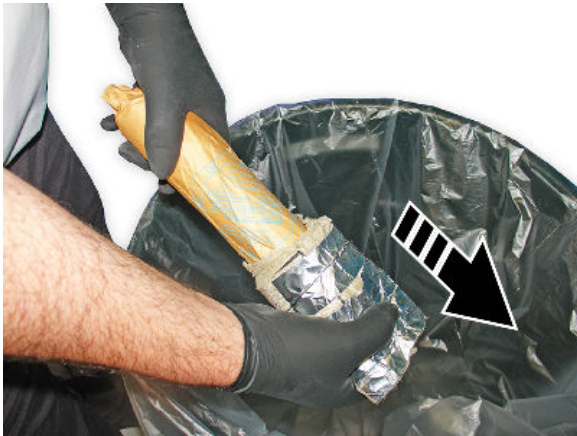
2. Hold the paper wrapping the inflator with one hand and slide the insulation off into the trash.

The insulation is securely wrapped around the inflator. You may have to use some force to slide the insulation off. Do not cut the insulation and be careful that you do not move the white or orange plastic ends.

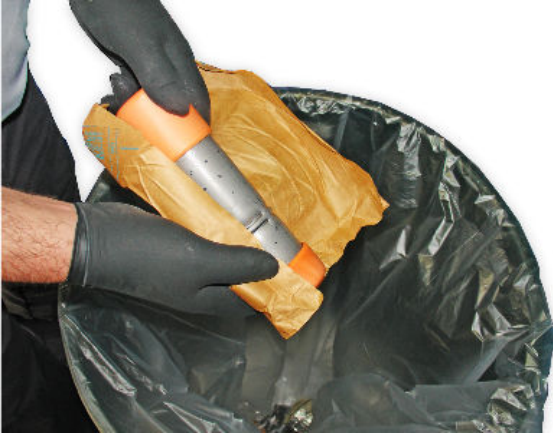
3. Remove the wrapping paper and drop it into the trash.
