May 18, 2017

06558 Version 2

## Safety Recall: 2017 CR-V Certification Label

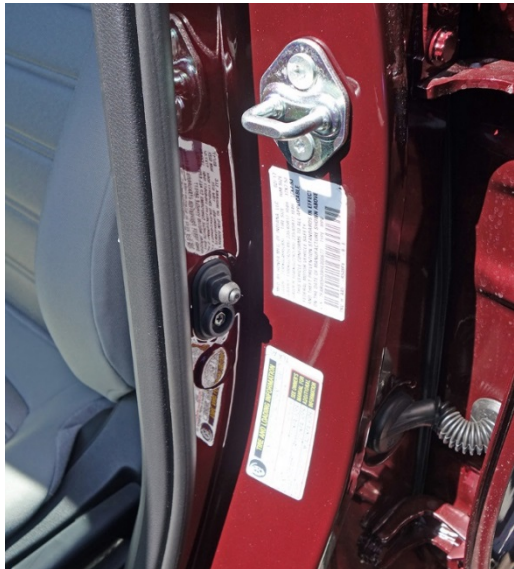
1. Open the driver's door, and locate the certification label.

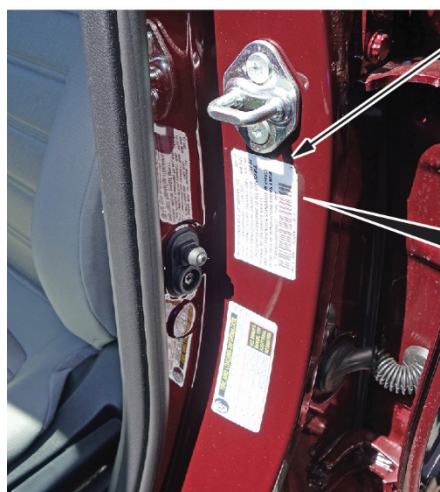
2. Confirm the VIN on the dashboard matches the VIN on the new certification label. Also, make sure the VIN and manufacture date on the new label matches the old label.

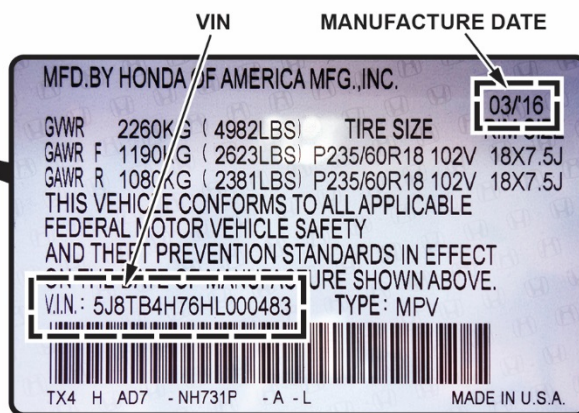
The certification label is located on the driver's side doorjam below the striker.

Confirm that the VIN and the Manufacture Date match those on the replacement label.

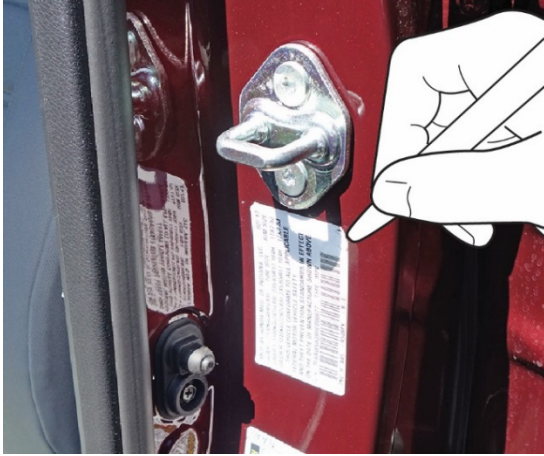
3. Use a plastic tool to remove the label. Be careful not to scratch or damage the paint.

NOTE: Applying heat with a heat gun may make the label easier to remove.

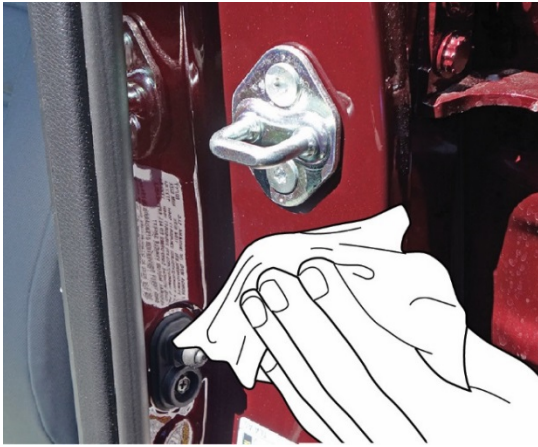
4. After the label is removed, using isopropyl alcohol on a lint free cloth, thoroughly clean the area where the new label will be attached. Make sure there is no residue from the old label, and allow the alcohol to dry.

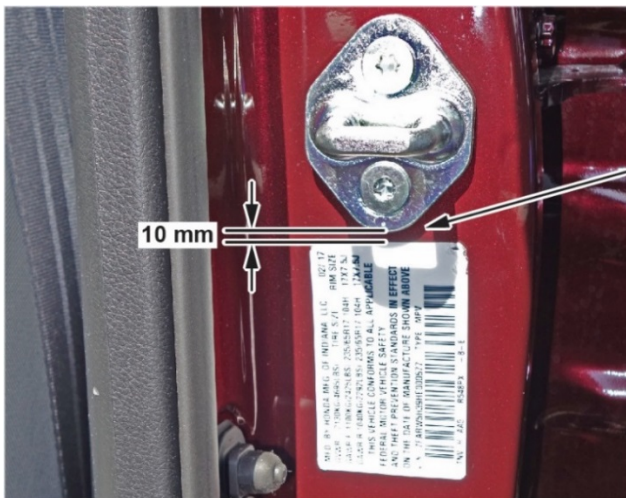
5. Apply the new certification label 10 mm below the striker. Make sure the label is applied in the same orientation as the removed label.

NOTE: Make sure the label is properly applied to the body, and make sure there are no wrinkles, tears, or bubbles on the new label.

Mount the new label  
10 mm below the striker.
