BISON V.I.N. TAG REPLACEMENT INSTRUCTIONS 9011

The VIN tag is broken into 3 different labels you will need to replace both on the sidewall and the one on the entry door so that all information is updated correctly.

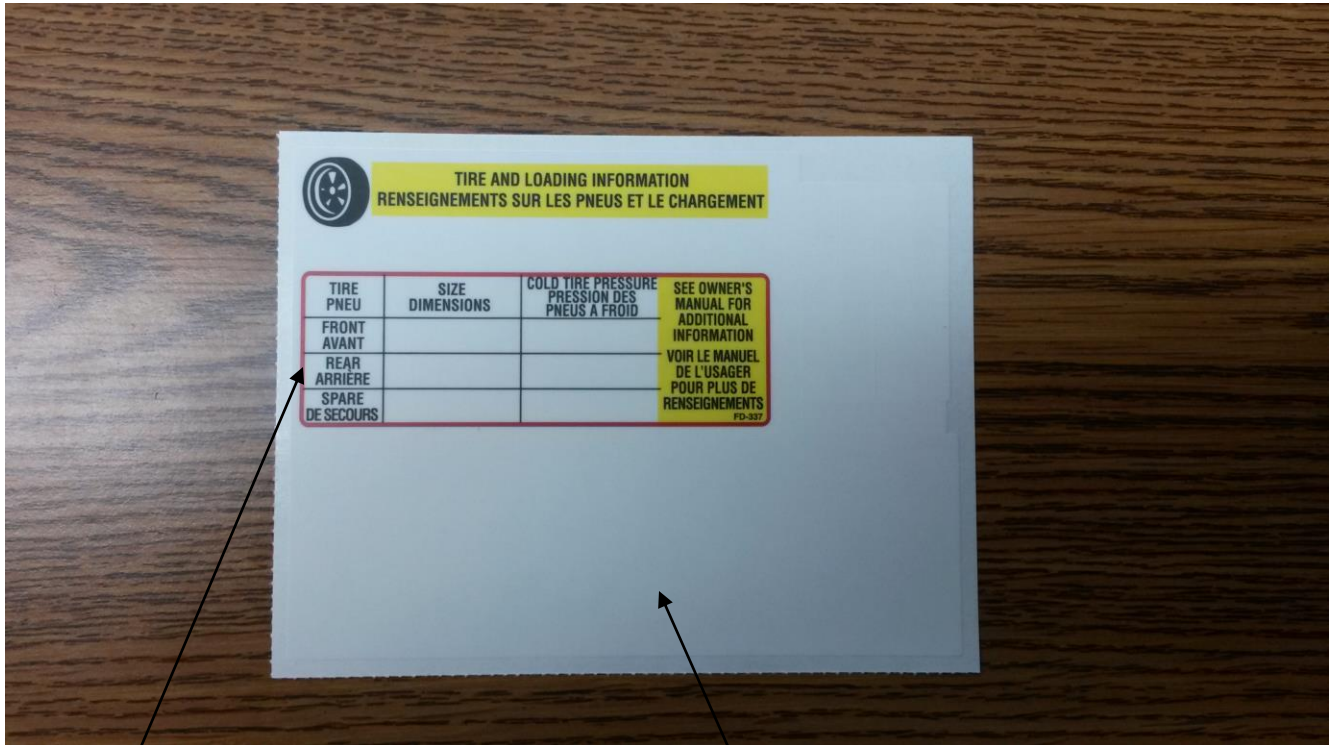
● Section 1 – Tire & Load information

● Section 2 – Federal Certification label
(blank for information only)

Section 3 – Load label (not pictured)

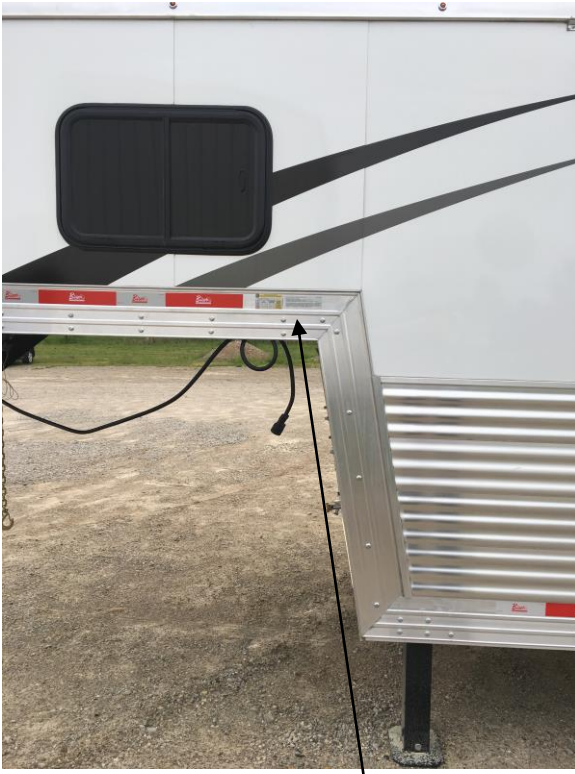
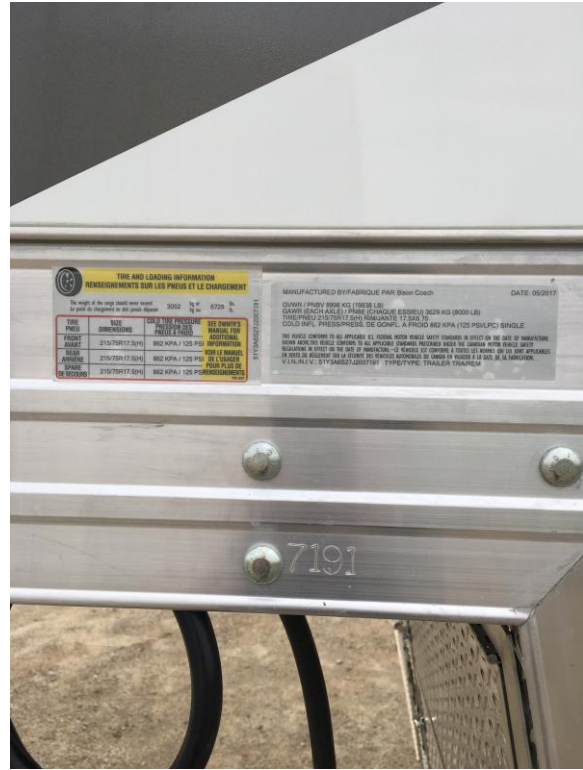
For aluminum frame trailers the label will be installed on the trim rail as shown above.

Apply the new label directly over the area of the old label, both labels must be replaced. See the following for proper location of the labels. The VIN label will come with a clear cover to put on top of the label.

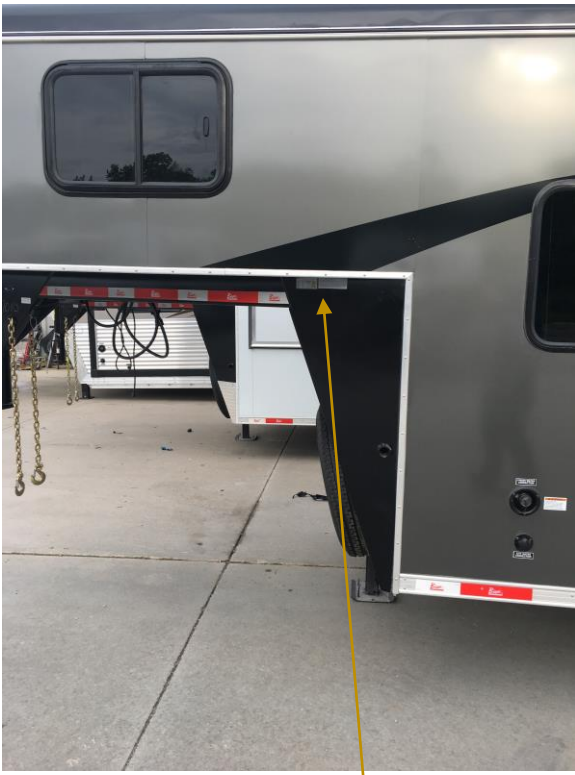
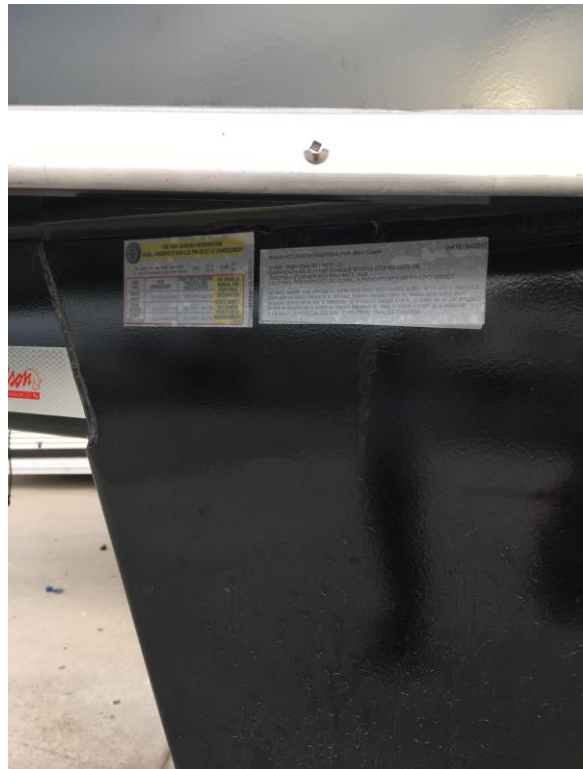
For steel framed trailers the labels are on the steel portion of the frame as shown above.

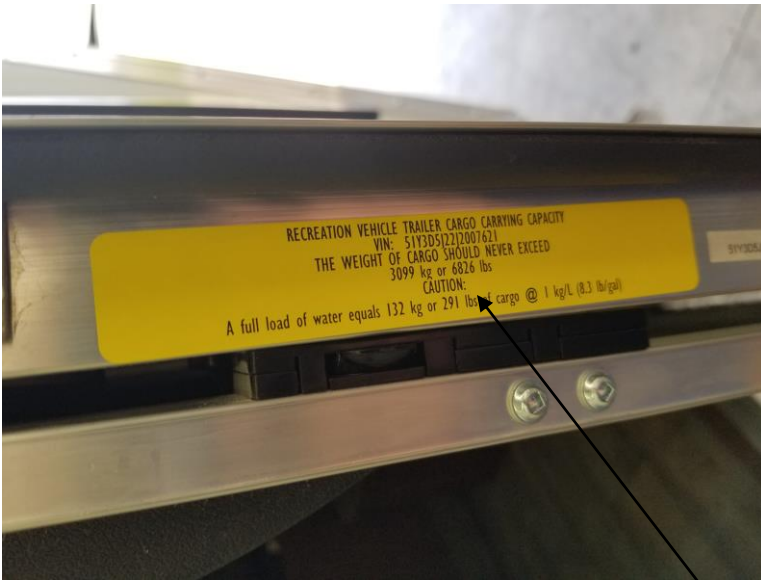
Load label is placed on the inside frame of the entry door.
