**UPDATE!** **RECALL 17V-379: CHECK AND REPLACE LEFT REAR LAMP**

F01 (7 Series)	F02 (7 Series)
----------------	----------------

BMW AG is conducting a Voluntary Non-Compliance Recall (effective June 14, 2017) on Model Year 2013 – 2015 BMW 7 Series (including ActiveHybrid 7) involving the left rear lamp. Please check and if necessary, replace.

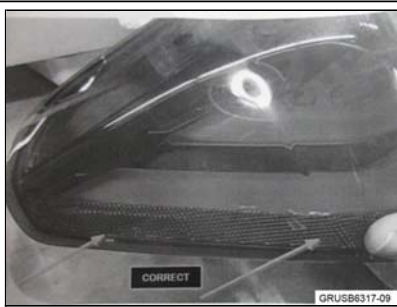
<p>Check left rear light in the side panel. Is the rear reflector and the Society of Automotive Engineers identification present as shown in picture? YES: No further repair is required. The Recall is completed.</p>

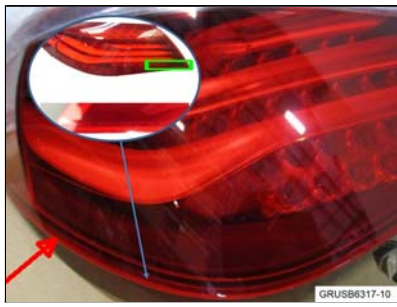
The left rear light in the side panel, which may have been installed as a spare part during a dealer service visit, does not include a reflector.

<p>No: If they are not present (as shown in picture), then follow next step: Follow ISTA REP 63 21 180 “Removing and installing/replacing left or right rear light (in side panel)”. Replace the left rear light to complete the recall.</p>

Check the left rear light in the side panel and replace it if it is missing the reflector (wrong part in the vehicle).
