2014-2016 MAZDA3, 2014-2015 MAZDA6
MECHANICAL REAR PARKING BRAKE STICKING CONCERN

SAFETY RECALL 1217F

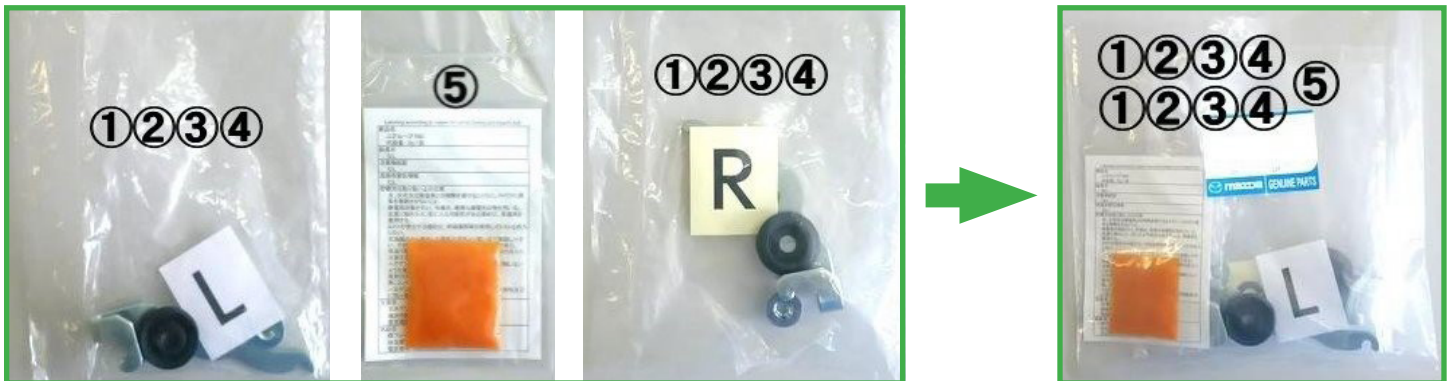
How the boot kit is packed.

* Boot Kit Components

Mazda6: G4YG-26-45Z (LH & RH set)

LH & RH set is available only for Mazda6

No.	Part Name	Qty
1	Operating Lever (RH & LH) Yellow mark (A) on front side R stamped on RH backside L stamped on LH backside	2
2	L-shaped washer	2
3	Boot	2
4	Nut	2
5	Grease (Orange)	1

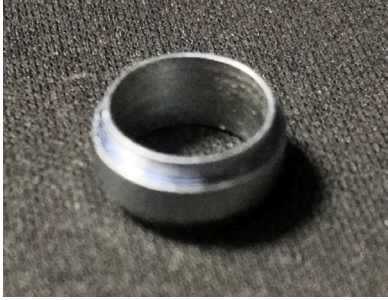
Name	Image	Note
Washer guide jig

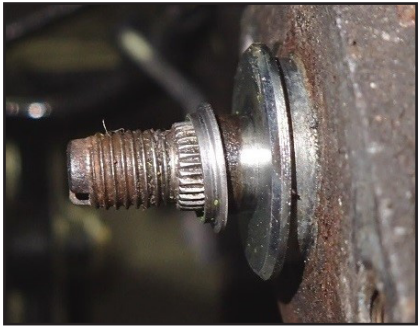
1. Temporarily set the L-shaped washer to the ramp shaft.

Caution: Set the flange side of L-shaped washer to the caliper side.	
	Correct	Incorrect

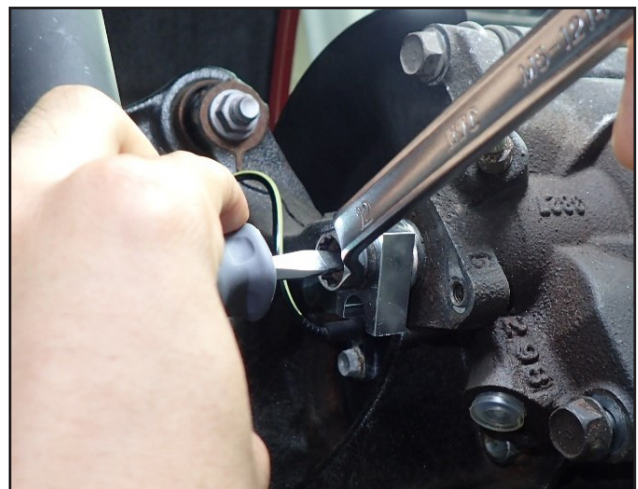
4. Use a flathead stubby screw driver to hold the groove of the ramp shaft head. Then, press the L-shaped washer into the ramp shaft by tightening the nut (Hold the ramp shaft with a flathead stubby screwdriver while tightening the nut.)

- Use a flathead stubby screw driver whose head width is smaller than the inner diameter of the nut, so that they would not make contact.
- Do not fully tighten the nut during this step.

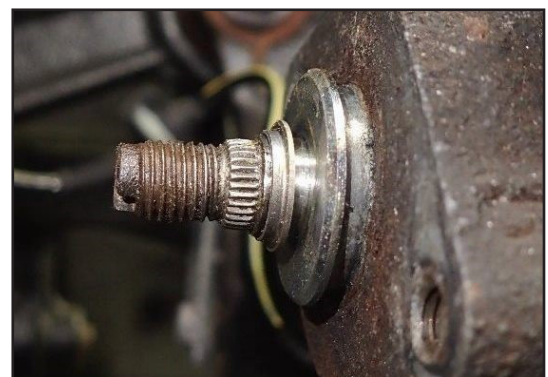
9. Wipe and remove the adhesive by using the toothbrush.
If there is any foreign material remains on the ramp shaft, remove it with a toothbrush.
10. Go to F. L-SHAPED WASHER INSTALLATION INSPECTION

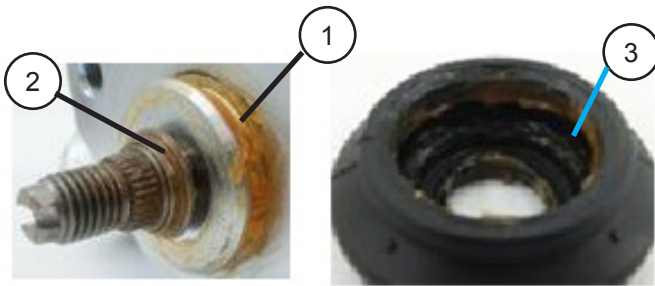
1. Apply the grease (orange) to the following areas.

1	Caliper body (where the boot is hooked)
2	L-shaped washer (outer part)
3	Inside the new boot

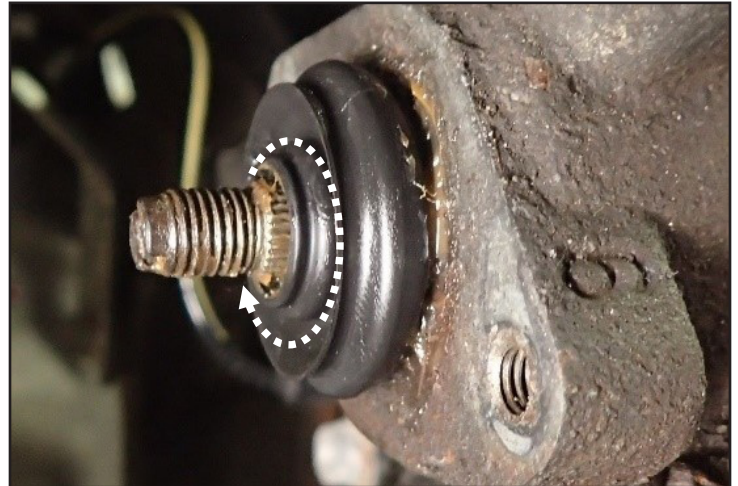
2. Install the new boot to the caliper body.

- Do not use pliers or do not pinch it by your nail. Otherwise, the boot may be damaged.
- After installing the boot, rotate it 360 degrees and confirm that it does not come off.

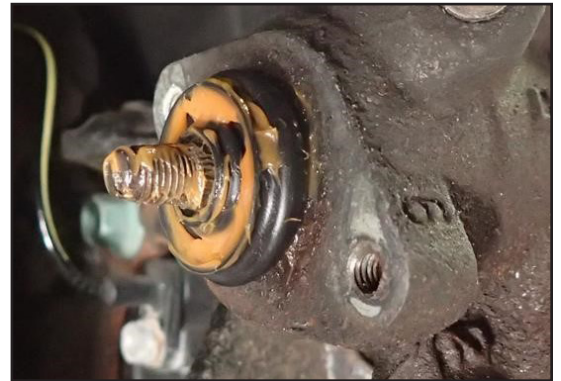
3. Apply the grease (orange) to the boot and the thread of the ramp shaft as shown.

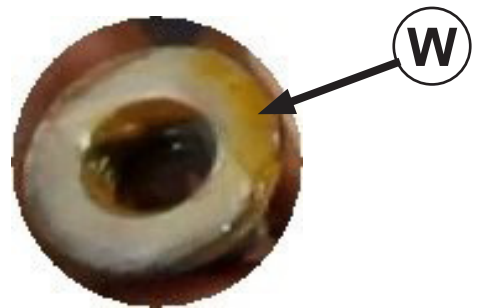
6. Apply the grease (orange) (W) to the backside of the nut which is originally installed to the vehicle.

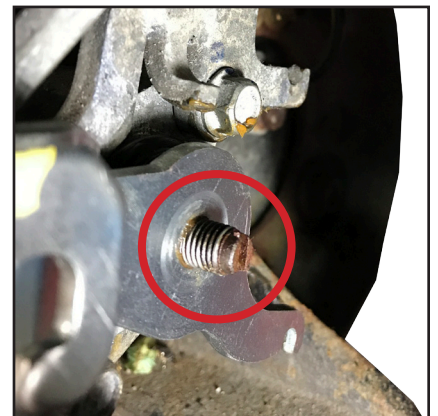
10. Loosen and remove the nut. Then, wipe the grease which remains at the ramp shaft. (Spray brake parts cleaner to a waste cloth, then wipe it using waste cloth.)
