Compliance Recall

Code: 45G6

Subject	Brake Lights Don't Activate During Emergency Brake Application
Release Date	October 25, 2018
Revision Summary	Updated photo in work instructions to reflect that the “Flash” operating mode must be used.
Affected Vehicles	U.S.A. & CANADA: Certain 2016-2017 MY Audi Q3 <i>Check Campaigns/Actions screen in Elsa on the day of repair to verify that a VIN qualifies for repair under this action. Elsa is the <u>only</u> valid campaign inquiry & verification source.</i> <ul style="list-style-type: none">✓ Campaign status must show “open.”✓ If Elsa shows other open action(s), inform your customer so that the work can also be completed at the same time the vehicle is in the workshop for this campaign.
Problem Description	If the parking brake is used during emergency braking, the brake lights on the vehicle will not activate. Following road users would be unaware of the emergency braking that is taking place, which could increase the risk of a rear-end crash causing injury and/or damage to property. This makes the vehicle non-compliant with regulatory requirements.

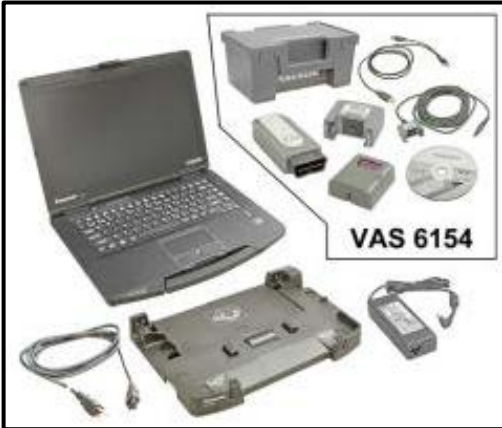
- VAS6150D - Diagnostic Tester (or equivalent)
- VAS6154 - Vehicle Communication Interface (or equivalent)

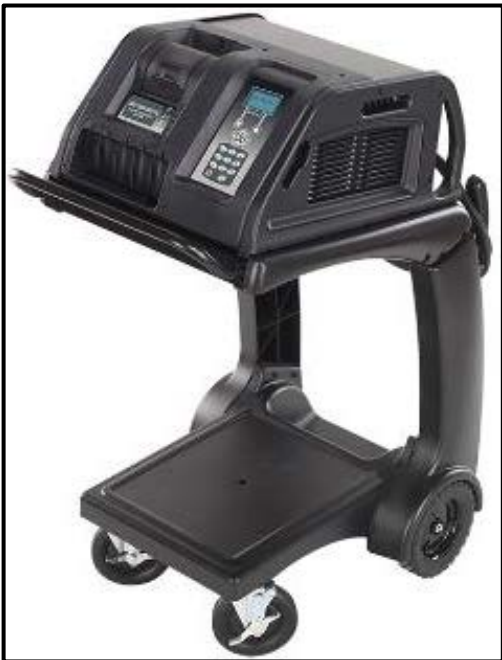
- GRX3000VAS – Battery Tester/Charger (or equivalent)

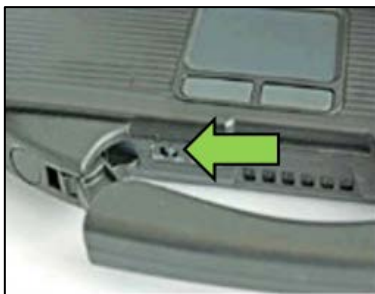
VAS 6150 & VAS 6150A
(Front panel behind handle)

- ✓ **The Bluetooth function of the scan tool is physically switched off <see pictures below>.**

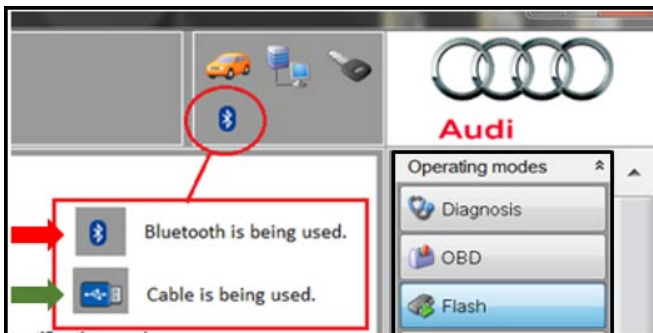
- Connect the VAS6150D Diagnostic Tester (or equivalent) to the vehicle.
- Start the ODIS program.
- Confirm that scan tool is communicating with the diagnostic head by USB <Green Arrow>.
 - If the Bluetooth symbol is shown <Red Arrow> then disconnect the diagnostic head from the vehicle and reconnect the USB cable to the diagnostic head and then reattach to the vehicle.
