SAFETY ADVISORY # 17-293

Avalanche 370 Slide Ram

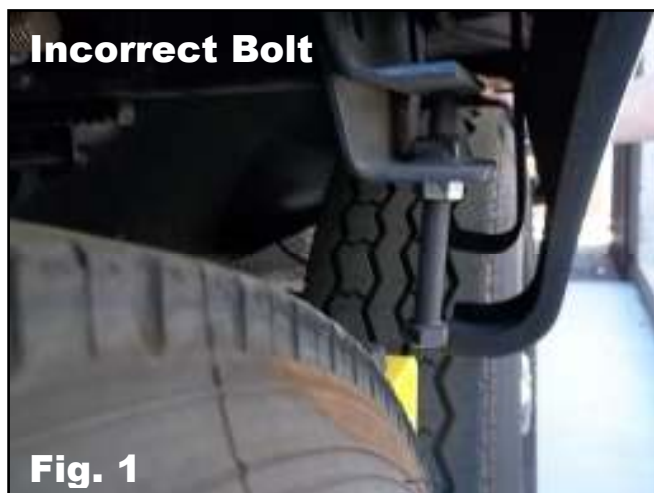
Keystone is conducting a voluntary RECALL notification campaign in accordance with the National Highway Transportation and Safety Act. It has been decided the vehicles in this recall population may have an adjustment bolt for the kitchen slide that can come into contact with the tire. The adjustment bolt and tires touching during travel may lead to an increased risk of loss of control and vehicle crash.

If there is less than 2 3/4" of space between the bolt head and tire replace the bolt with the part number provided above. See Figure 1 for incorrect bolt and Figure 2 for correct bolt. Using a ratchet and 3/4" socket, remove the existing bolt. Start the new bolt by hand and finish with the ratchet, install the bolt firmly against the adjustment plate.

Inspect the tire for any physical damage and touch up /spray paint the bolt as needed.
