Safety Recall

Code: 24DF

Subject	Engine Control Module (ECM) Software
Release Date	September 06, 2017
Revision Summary	Affected vehicles information updated for Canada.
Affected Vehicles	U.S.A. : Certain 2017-2018 MY Audi A3 Cabriolet & A3 Sedan with 2.0T Gasoline Engine and Front Wheel Drive CANADA: Certain 2017-2018 MY Audi A3 Sedan with 2.0T Gasoline Engine and Front Wheel Drive <i>Check Campaigns/Actions screen in Elsa on the day of repair to verify that a VIN qualifies for repair under this action. Elsa is the <u>only</u> valid campaign inquiry & verification source.</i> <ul style="list-style-type: none">✓ Campaign status must show "open."✓ If Elsa shows other open action(s), inform your customer so that the work can also be completed at the same time the vehicle is in the workshop for this campaign.
Problem Description	On certain vehicles, during engine start-up or low RPMs, the engine air/fuel burning stability strategy may not be robust enough. This could cause the system to misinterpret conditions as the dual mass flywheel begins to rotate, which could result in a loss of motive power, increasing the risk of a crash causing injury and/or damage to property.

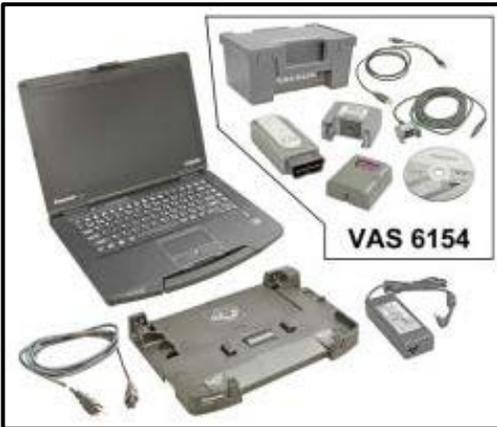
- VAS6150D - Diagnostic Tester (or equivalent)
- VAS6154 - Vehicle Communication Interface (or equivalent)

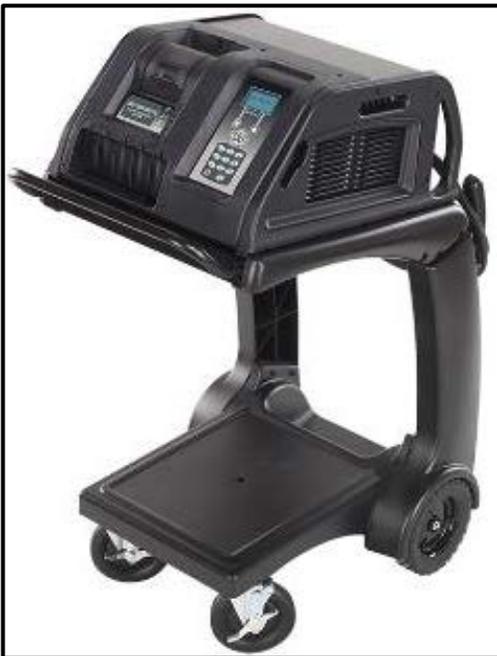
- GRX3000VAS – Battery Tester/Charger (or equivalent)

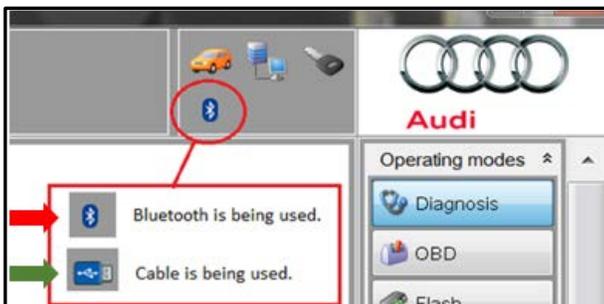
- Connect the VAS6150D Diagnostic Tester (or equivalent) to the vehicle.
- Start the ODIS program.
- Confirm that scan tool is communicating with the diagnostic head by USB <Green Arrow>.
 - If the Bluetooth symbol is shown <Red Arrow> then disconnect the diagnostic head from the vehicle and reconnect the USB cable to the diagnostic head and then reattach to the vehicle.
