Brake Activation Wire in Wrong Location

Description

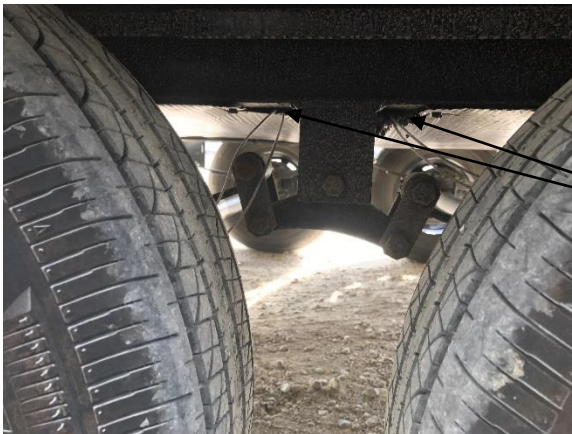
1. Wires in wrong location: if your trailer has the wiring routed here next to the center axle hanger, the wires are in the wrong location. If they are not routed here but rather above the axle the trailer needs no repair. – file claim for inspection only.

This photo is of an incorrect routing. Wiring should not be located here.

File Recall Inspection warranty claim using warranty code 99.01.36.L for 0.10 hours.

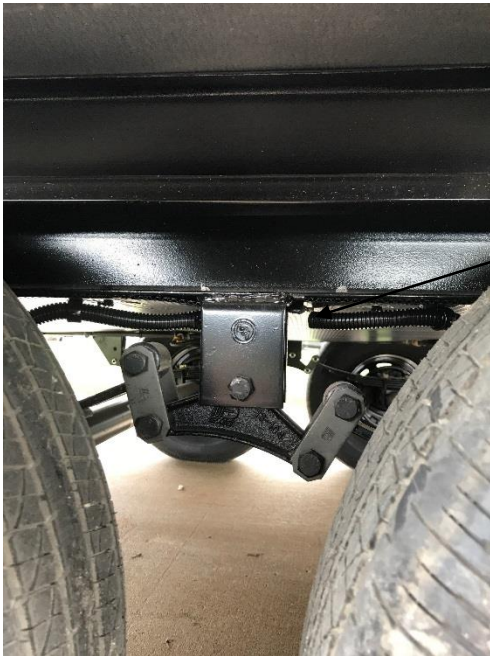
Loom the wire and attach using P style clamps up and away from Shackle.

2. Attach loom over wire from the top of the axle to the underbelly, and tape off ends with electrical tape.
3. Install P bracket over wire and attach to frame.
 - a) Be sure that wiring and bracket cannot be hit if shackle contacts frame.
 - b) Be sure to remove all slack from wire.
