17-097

Safety Recall: Outer Second Row Seats Tip During Braking

Year	Model	Trim	VIN Range
2011–17	Odyssey	ALL	Check the iN VIN status for eligibility

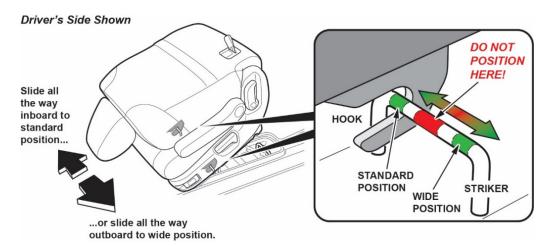
- 2. Slide the seat into either the standard or wide position:
 - Pull the seat out to the wide position, or push the seat into the standard position until it stops (identified in green).
 - Do not position the seat hooks in the middle of the striker. The seat will not lock into position (identified in red).

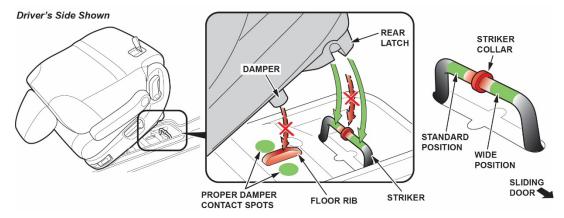
- 3. Lower the rear of the seat. There is both a rib on the floor and a collar on the rear metal striker. Check that the rear latch and damper are inside or outside of the rib and collar (identified by the green highlight in the illustration):
 - The rib and collar separate the standard and wide seat positions.
 - Do not attempt to latch the seat in the middle (identified in red); the damper and rear latch will rest on the rib and collar and will not lock.
