07740 Version 3

Safety Recall: Outer Second Row Seats Tip During BrakingSupersedes 17-097, dated December 2, 2017 to revise the information highlighted in **yellow****AFFECTED VEHICLES**

Year	Model	Trim	VIN Range
2011–17	Odyssey	ALL	Check the iN VIN status for eligibility

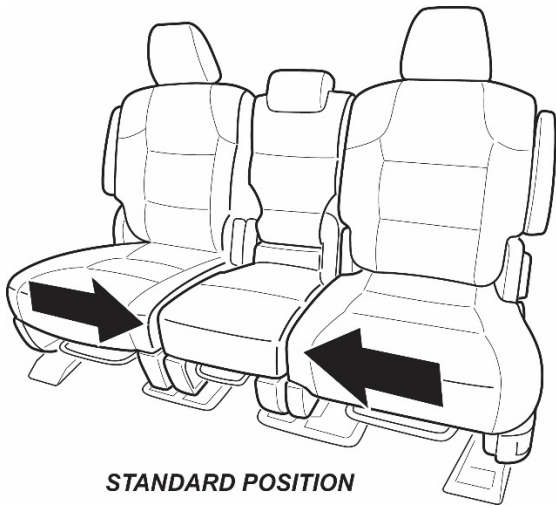
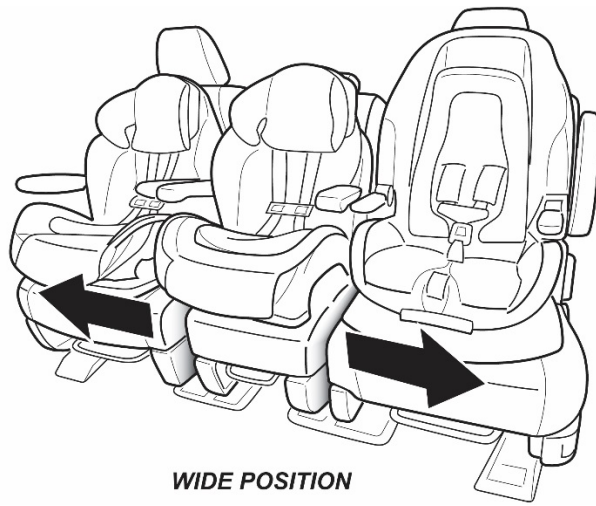
Second Row Outer Seat Positions

The two second row outer seats can be installed in two positions, standard and wide:

In the standard position, the seats are located inward for:

- Easier access to the third row
- Maximizing second row outer seat passenger headroom

In the wide position, the seats are located outward for:

- Installation of three car seats in the second row
- Additional hip and shoulder room for passengers in the second row seats

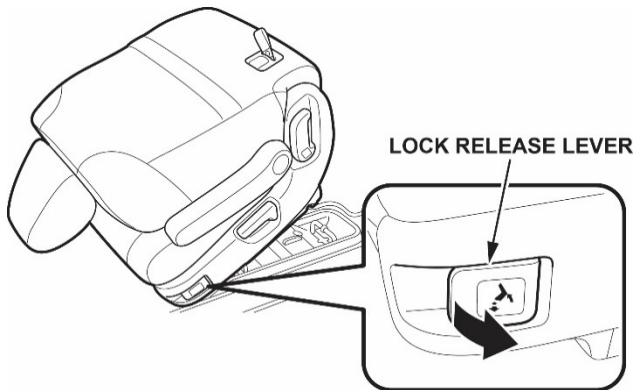
1. Insert the front seat hooks into the front floor strikers.

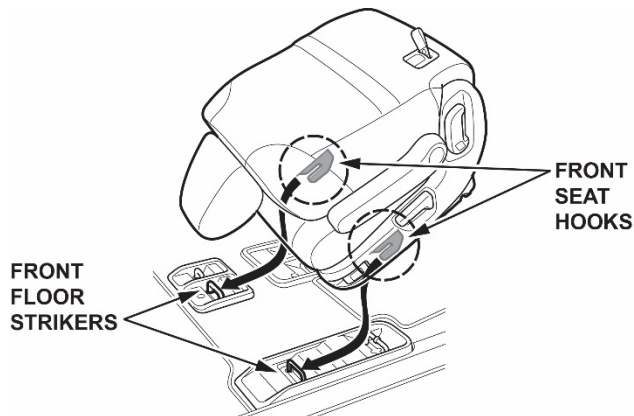
Driver's Side Shown

2. Slide the seat into either the standard or wide position:

- Pull the seat out to the wide position, or push the seat into the standard position until it stops (identified in green).
- **Do not position the seat hooks in the middle of the striker.** The seat will not lock into position (identified in red).

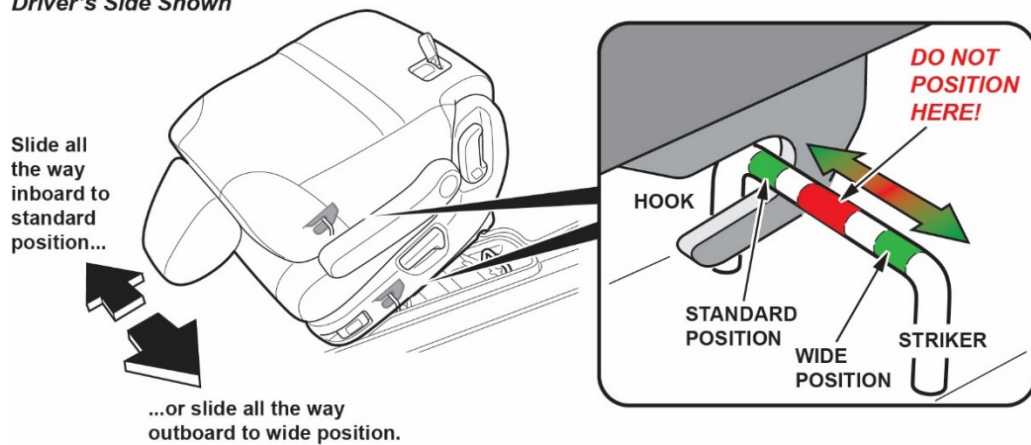
Driver's Side Shown

3. Lower the rear of the seat. There is both a rib on the floor and a collar on the rear metal striker. Check that the rear latch and damper are inside or outside of the rib and collar (identified by the green highlight in the illustration):

- The rib and collar separate the standard and wide seat positions.
- Do not attempt to latch the seat in the middle (identified in red); the damper and rear latch will rest on the rib and collar and will not lock.

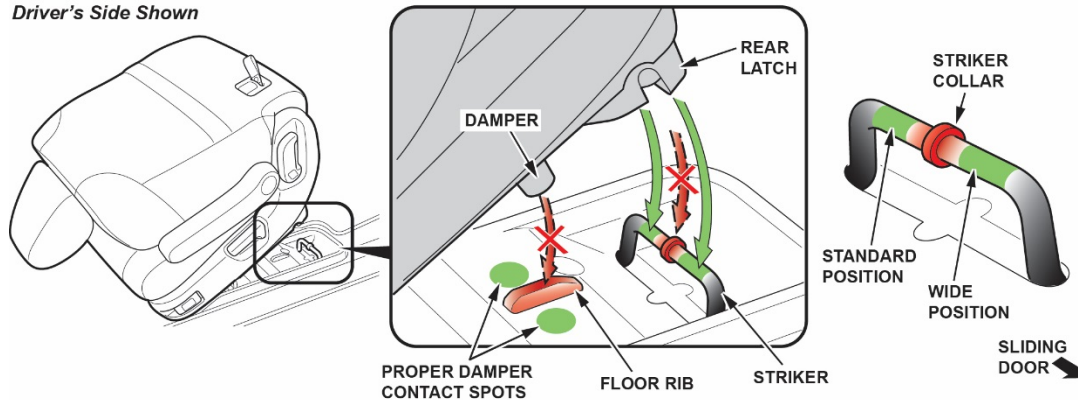
4. Press down on the rear part of the seat to set both rear latches. The latches click as they engage the floor strikers.

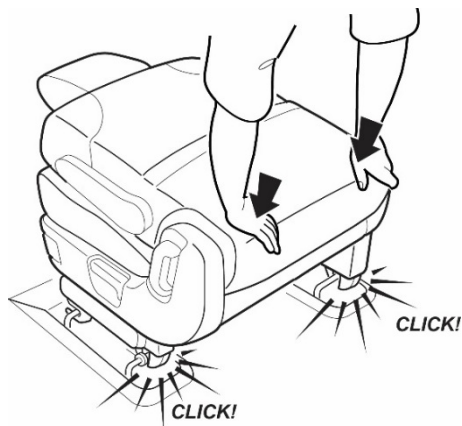
5. Raise the seat-back to an upright position, then rock the seat back and forth, trying to tilt it forward, and make sure both the inner and outer latches are locked in position.

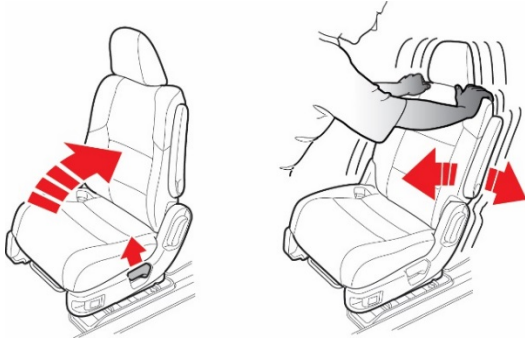
The two outer second row seats are equipped with a third row access feature that is activated by pulling the third row access lever or strap.

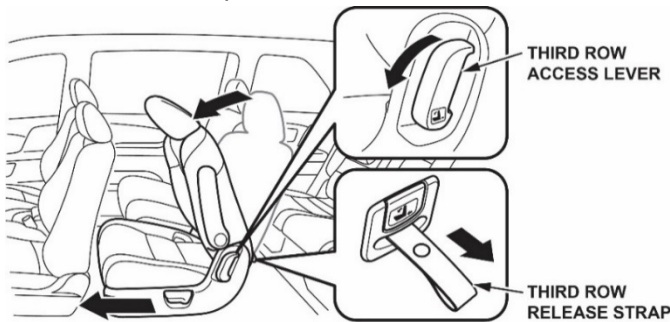
When a child seat is installed in the outer second row seats (typically using the LATCH anchors), the child seat prevents the seat-back from folding forward, which limits access to the third row. Some owners use the seat lock release lever to tip the entire seat forward with the child car seat installed to gain access to the third row.

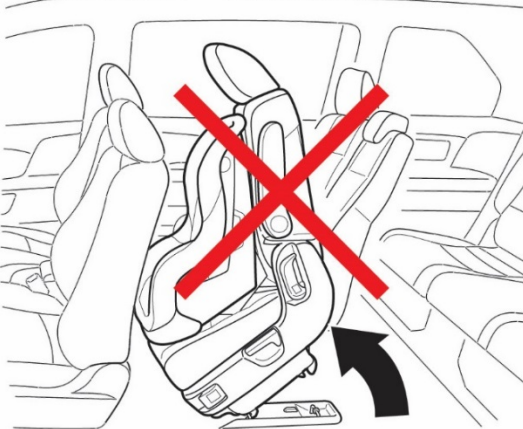
American Honda does not recommend using this method to access the third row seats. When the second row outer seat is tipped forward, the seat may slide into the area between the standard and wide positions that prevents the seats from latching. Therefore, using this method of access increases the risk of having an unsecured second row outer seat.

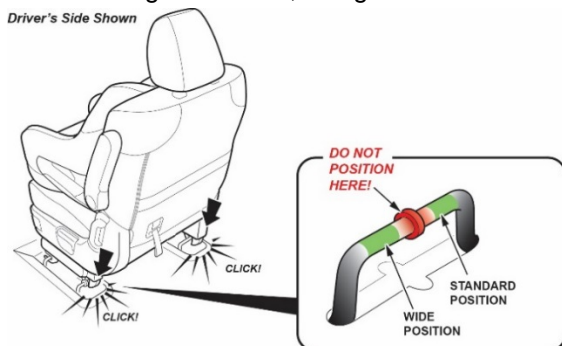
If despite the risks, a customer chooses to tip the entire second row seat forward to access the third row, they need to make sure the seat is in the standard or wide position when lowering and latching the seat.

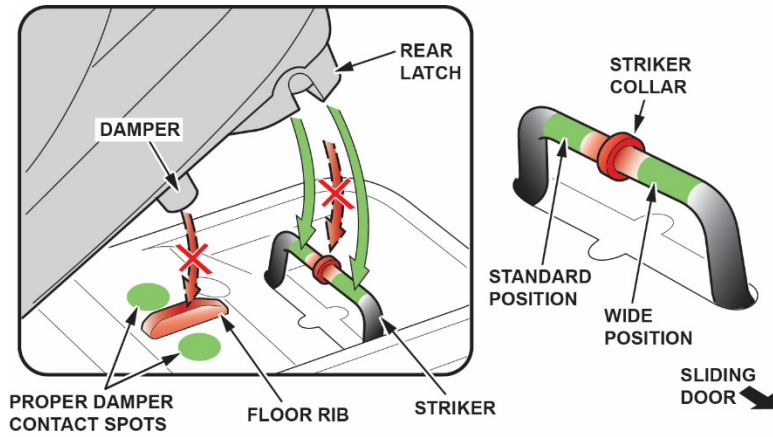
Check that the seat is latched by rocking the seat back and forth, trying to tilt it forward, and make sure both the inner and outer latches are locked and the front seat hooks are under the front latches.
