RECALL BULLETIN:
171208REV

Fleetwood brand:
Axon, Bounder, Discovery (Product Code 734 only) Flair, Pace Arrow, Pace Arrow LXE, Southwind;
Holiday Rambler brand:
Endeavor XE, Navigator, Navigator XE, Reno, Vacationer, Vacationer XE;
affected vehicles were manufactured 10/19/2017 - 11/22/2017 and equipped with a King Tailgater Stationary Satellite System

SUBJECT:
Correction of Satellite Dish Mounting

ISSUE DATE:
February 2018

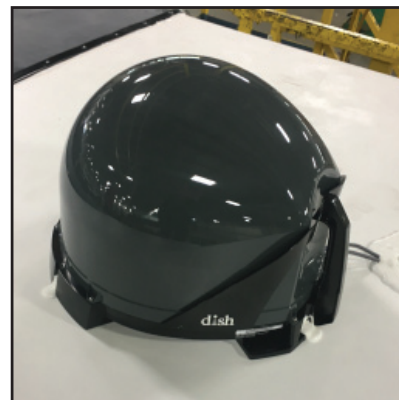
2. Block wheels to prevent movement.
3. Use a ladder to access the roof. Bring along 1 tube of white Dicor 502-LSW Self-Leveling sealant, one recall parts kit, and tools. See TOOLS and PARTS lists on Page 4 for detailed specifications.
4. Locate the King Tailgater satellite dish on the roof. See Figure 1 for reference.
