**Subject: RECALL R17YY, Vision Chassis Mounted Battery Box Supports**

# VISION CHASSIS MOUNTED BATTERY BOX SUPPORT

**Models Affected: Certain 2015 through 2018 Model Year Vision Buses with Chassis Mounted Battery Box**

The chassis mounted battery box support brackets may develop cracks or fracture and could allow the battery box to separate from the chassis and fall.

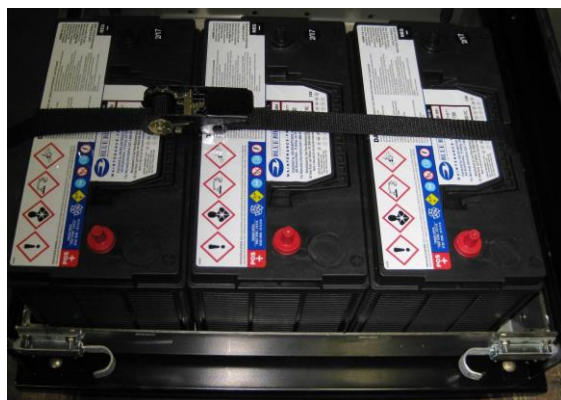
THREE GROUP 31 BATTERIES

### BATTERY IDENTIFICATION

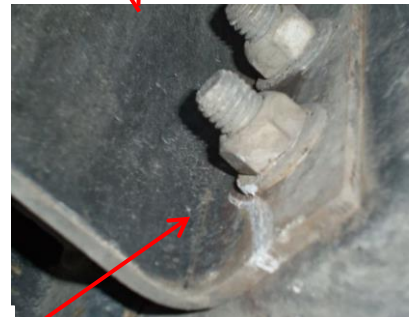
Crack may be in vertical bend.

Example shown of vertical crack at lower hole. Cracks may be vertical or horizontal to one or more holes.

Inspect for loose front brace and cracked support brackets. From matrix in instructions, select the correct repair for your bus which includes removing braces, and may include adding reinforcements or replacing front or front and rear support brackets.

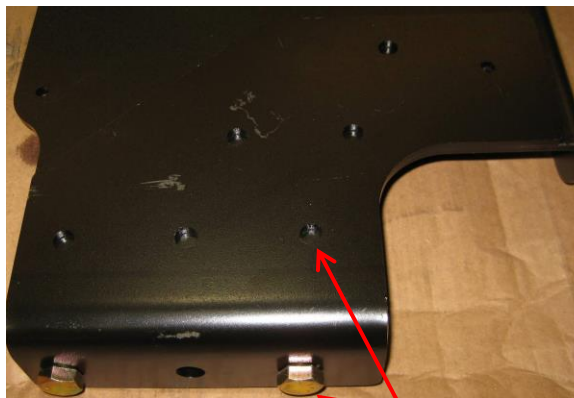
Temporary install two 1/2 inch capscrews with standard nuts and tighten. Drill six 3/8 inch diameter holes using the reinforcement as guide.

2. On the bench, assembly install new high strength steel front frame battery bracket 10049663 and front (LH) reinforcement bracket 10054519 together with two (2) 1/2 inch capscrews 00803239 and standard nuts (not included in kit) and tighten nuts.

3. Using the front (LH) reinforcement bracket 10054519 as a guide, drill six (6) 3/8 inch diameter holes.
4. Install six (6) 3/8 inch capscrews 00559195, flat washers 01107085, and flange locknuts 00543934. Install one (1) 1/4 inch capscrew 00870477, flat washer 01991108, and locknut 02001345. Leave all fasteners loose; do not torque until assembly has been installed on the chassis.

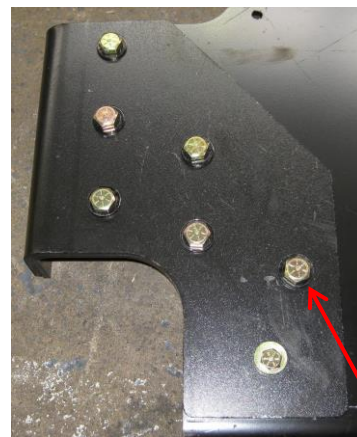
Install all the fasteners attaching the reinforcement to the front frame battery bracket and leave loose until installed onto chassis frame.

5. Remove two (2) 1/2 inch capscrews 00803239 and standard nuts (not included in kit) nuts. Reuse two (2) 1/2 inch capscrews 00803239 to install assembly to frame rail.
