DATE: September 11, 2023
TO: Blue Bird Owners
SUBJECT: Recall R17YY, Vision Chassis Mounted Battery Box Supports

**NHTSA Recall Number: 17V-100 School Bus
NHTSTA Recall Number: 17V-101 Non-School Bus**

VISION CHASSIS MOUNTED BATTERY BOX SUPPORT

The chassis mounted battery box support brackets may develop cracks or fracture and could allow the battery box to separate from the chassis and fall.

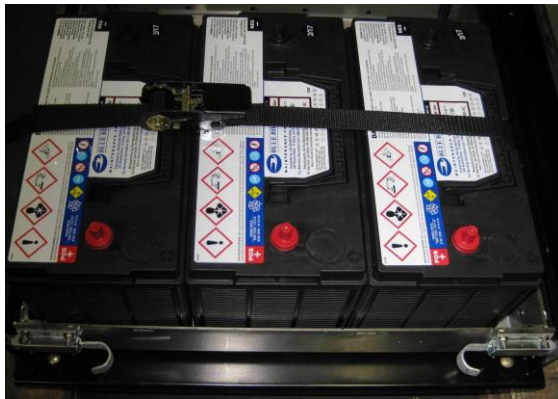
THREE GROUP 31 BATTERIES

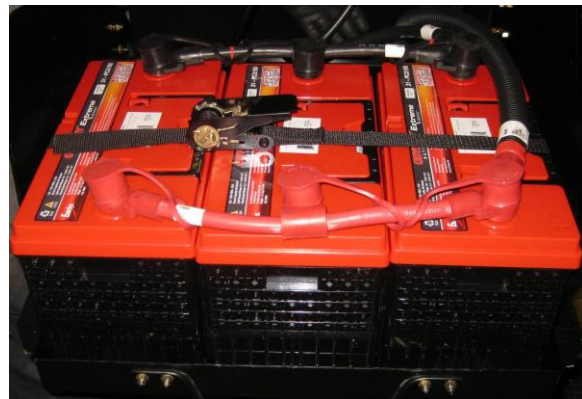
THREE ODYSSEY BATTERIES

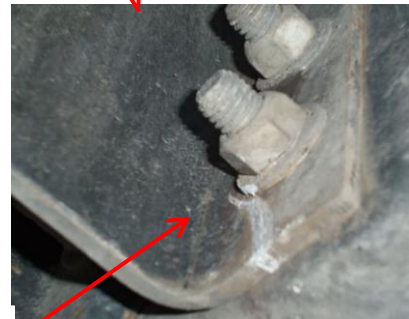
Inspect front and rear frame battery box brackets for cracks around the fasteners and in the vertical bend.

Crack may be in vertical bend.

Example shown of vertical crack at lower hole. Cracks may be vertical or horizontal to one or more holes.

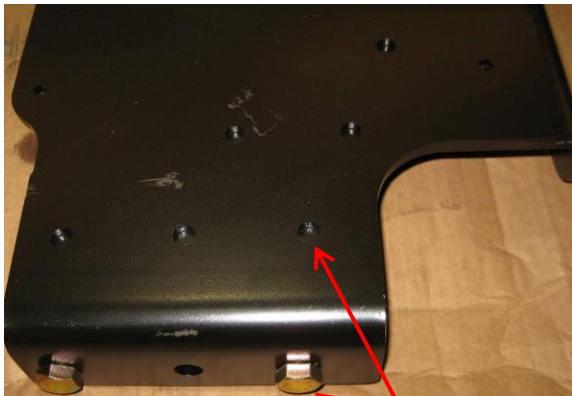
BENCH ASSEMBLY

Temporary install two 1/2 inch capscrews with standard nuts and tighten. Drill six 3/8 inch diameter holes using the reinforcement as guide.

2. On the bench, assembly install new high strength steel front frame battery bracket 10049663 and front (LH) reinforcement bracket 10054519 together with two (2) 1/2 inch capscrews 00803239 and standard nuts (not included in kit) and tighten nuts.

3. Using the front (LH) reinforcement bracket 10054519 as a guide, drill six (6) 3/8 inch diameter holes.
4. Install six (6) 3/8 inch capscrews 00559195, flat washers 01107085, and flange locknuts 00543934. Install one (1) 1/4 inch capscrew 00870477, flat washer 01991108, and locknut 02001345. Leave all fasteners loose; do not torque until assembly has been installed on the chassis.

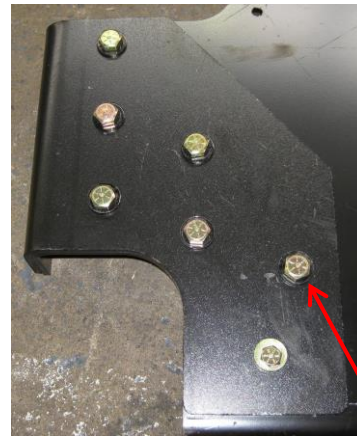
Install all the fasteners attaching the reinforcement to the front frame battery bracket and leave loose until installed onto chassis frame.

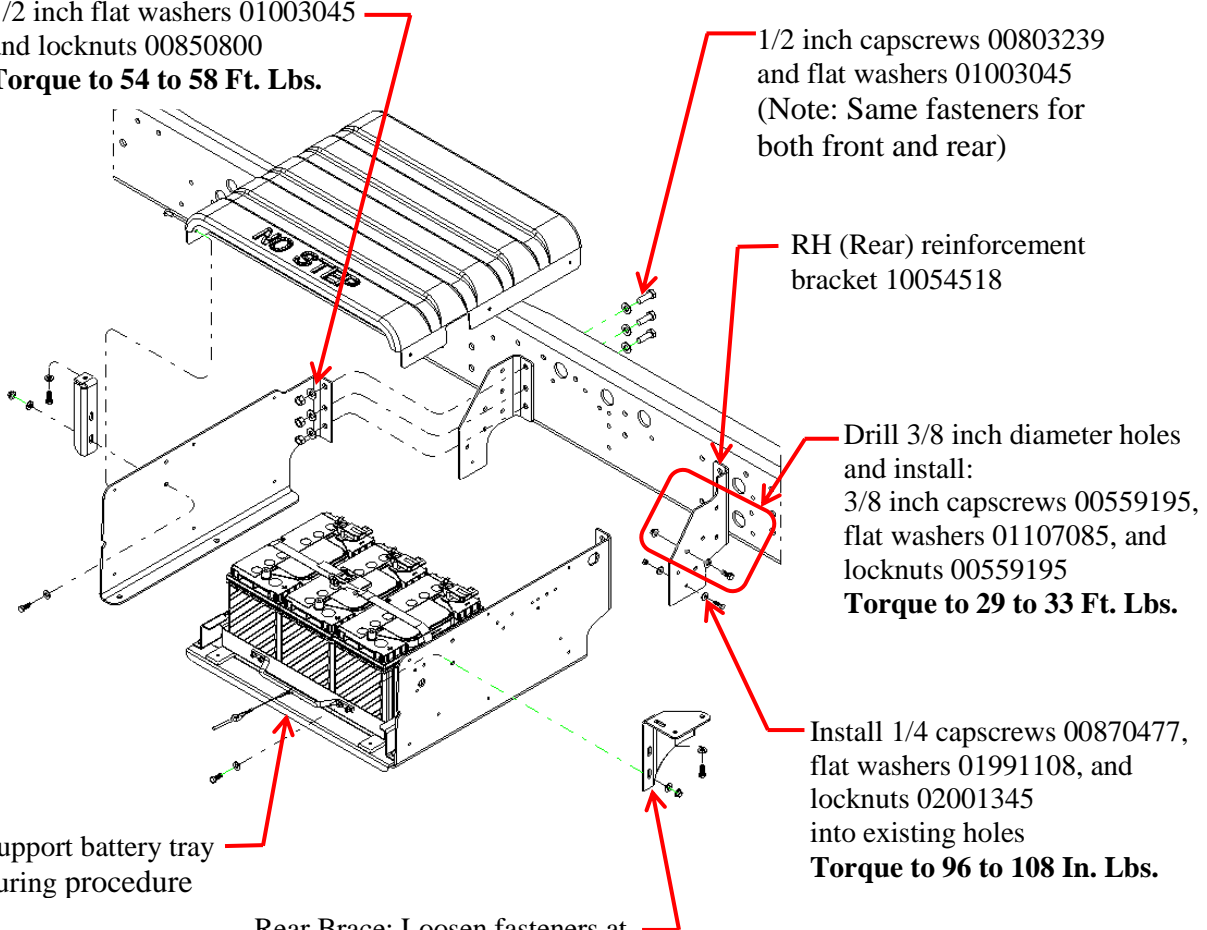
INSTALL REINFORCEMENTS AND FRONT BATTERY BOX FRAME MOUNTING BRACKET

1/2 inch flat washers 01003045 and locknuts 00850800
Torque to 54 to 58 Ft. Lbs.

1/2 inch capscrews 00803239 and flat washers 01003045
(Note: Same fasteners for both front and rear)

RH (Rear) reinforcement bracket 10054518

Drill 3/8 inch diameter holes and install:
3/8 inch capscrews 00559195, flat washers 01107085, and locknuts 00559195
Torque to 29 to 33 Ft. Lbs.

Install 1/4 capscrews 00870477, flat washers 01991108, and locknuts 02001345 into existing holes
Torque to 96 to 108 In. Lbs.

Support battery tray during procedure

Rear Brace: Loosen fasteners at beginning of procedure. At end of procedure remove and discard.
DO NOT REINSTALL
